# Impact of Fixed Ventilation on Fire Damage Patterns in Full-Scale Structures

Daniel Madrzykowski  
Craig Weinschenk

UL Firefighter Safety Research Institute  
Columbia, MD 21045

April 18, 2019

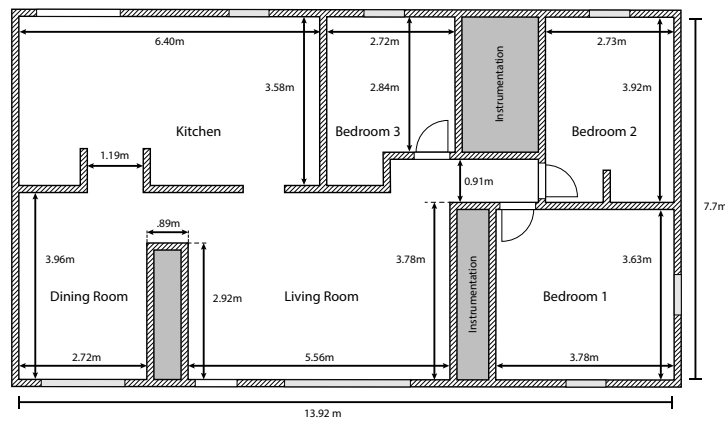
Figure 1: Plan-view dimensioned drawing of the single story structure.

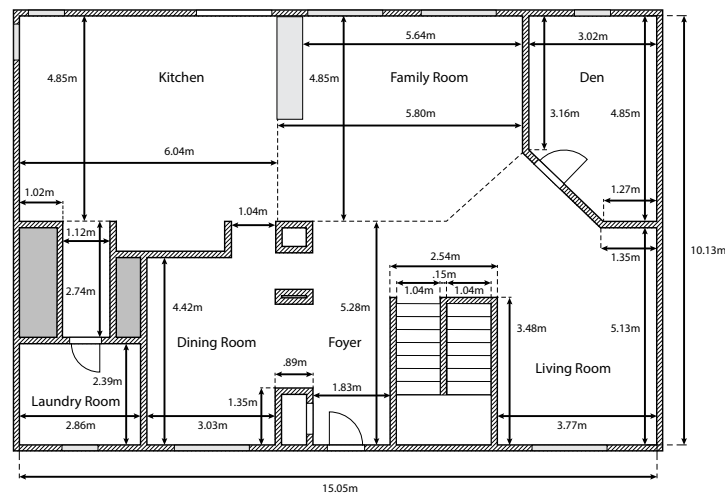
Figure 2: Plan-view dimensioned drawing of the first floor of the two story structure.

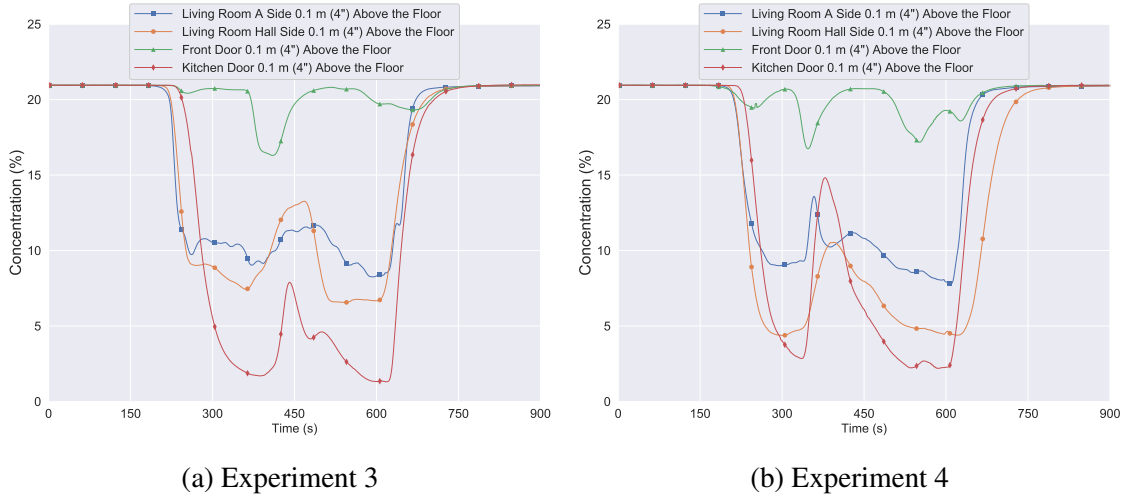
Figure 7: Comparison of open door oxygen concentrations at 1.2 m above the floor.

In both experiments, post-flashover, the oxygen levels measured at 1.2 m above the floor at locations bounding the living room decreased to 5%–8% as shown in Figure 7, recovered to approximately 15% as the fire decayed, and again dropped to 5%–8% as the fire recovered. The oxygen levels measured at 0.1 m above the floor in similar locations, Figure 8, showed a similar trend for the living room and kitchen: There was a decay to between 5%–10%, a recovery, and then a second decay before a full recovery to ambient levels following suppression. The oxygen sampling position near the floor by the front door did not see as significant of decay in either experiment as the door fluctuated between exhaust and intake. Although each of the oxygen concentration values between are not exact matches, the trends are similar, and the relationship between oxygen values and the increase and decrease in temperatures in the living room are consistent.

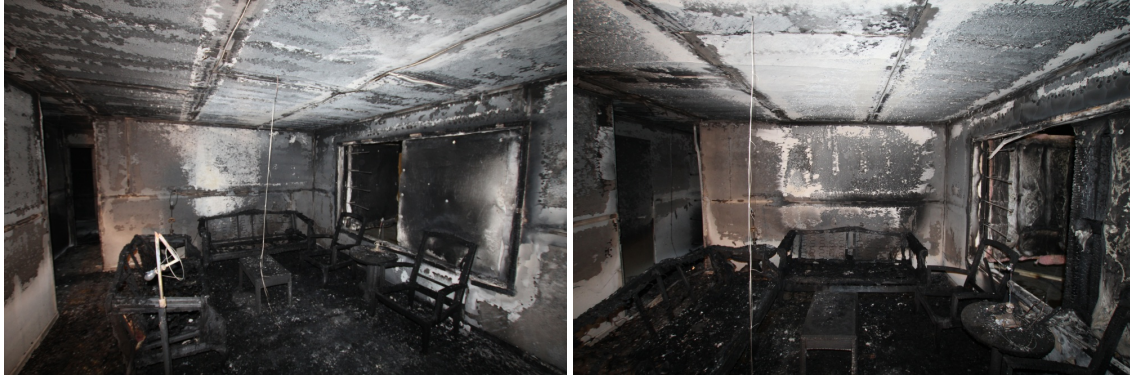
(a) Experiment 3

(b) Experiment 4

Figure 9: Post-suppression comparison of living room area of origin, with open door.

Figures 9 and 12 show the post fire suppression photographs of the living rooms that burned with the front door open. Both rooms burned for approximately seven minutes post-flashover.

The first two sets of photographs show the area of origin (see Figures 9 and 10). These two living rooms have many similarities. The wall behind the ignition sofa and the floor area under the sofa have fire damage patterns above and below the outline of the sofa that frame the point of origin. Both walls have a vertical damage pattern starting above the back of the sofa and continuing toward the ceiling.

Both ceilings have had most of face paper of the gypsum board burned off over the full length and width of the living room. The carpet and padding had been burned with the exception of some small protected areas, such as under a solid object like the base of the floor lamp or the TV stand. The sub-floor was charred from the ignition wall to the front door and from the second sofa to the front wall. The horizontal line of demarcation on the left wall was approximately 0.75 m (2.5 ft) above the floor in both experiments.

All of the upholstered furniture had been burned to the wood frame, which was charred. There was no directionality to the fire damage of the furniture, as there had been in the two living room experiments with all of the exterior vents closed. All four sides of the wood moulding surrounding the living room window opening was charred. The exposed moulding around the front door was also charred. The moulding on the hinge side of the door had less damage along the lower half of the door than the rest of the door moulding. The baseboard moulding along the floor under the window was charred along its length except where it was protected by a chair or toward the corner near the ignition sofa. The baseboard moulding along the left wall was undamaged, and the baseboard on the ignition wall and the TV wall only had charring in the area behind the sofa or behind the TV stand.

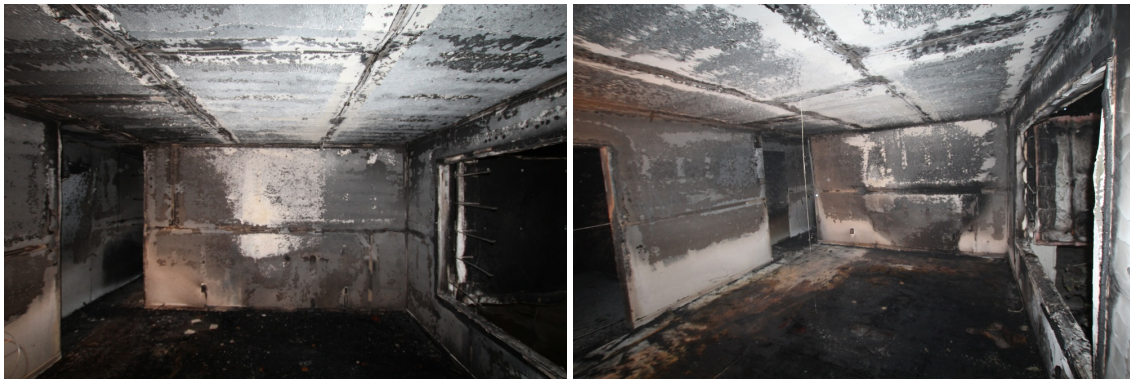
(a) Experiment 3

(b) Experiment 4

Figure 10: Post-overhaul comparison of living room area of origin, with open door.

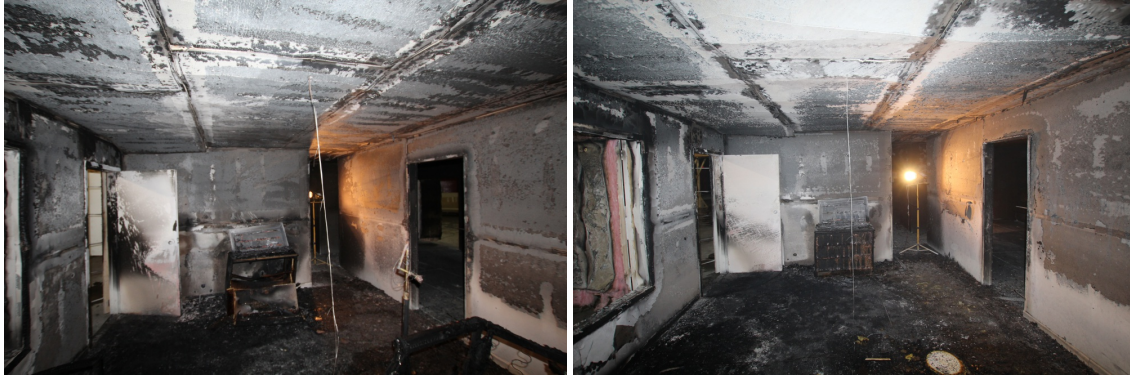
(a) Experiment 3

(b) Experiment 4

Figure 11: Post-suppression comparison of living room wall opposite the area of origin and adjacent to front door with open door.

Figures 11 and 12 show the area adjacent to the front door. Both walls show a dark pattern on the wall in the area of the TV stand. There is an area in the center of each pattern that has additional burn damage, some portions of it clean burned. On the right side of each of the patterns is a dark plume mark that sweeps over and up the right side. This collection of damage was likely caused by the intake air from the door, which enabled the TV stand to burn later into the fire event, resulting in a clean burn in the middle of a pre-flashover soot pattern, and the flow of the intake air caused the combustion products from the burning TV stand to flow toward the inside of the house. If the outward plume pattern was caused by an obstruction and not impacted by the ventilation, two equal plumes on both sides of the TV stand would be expected.

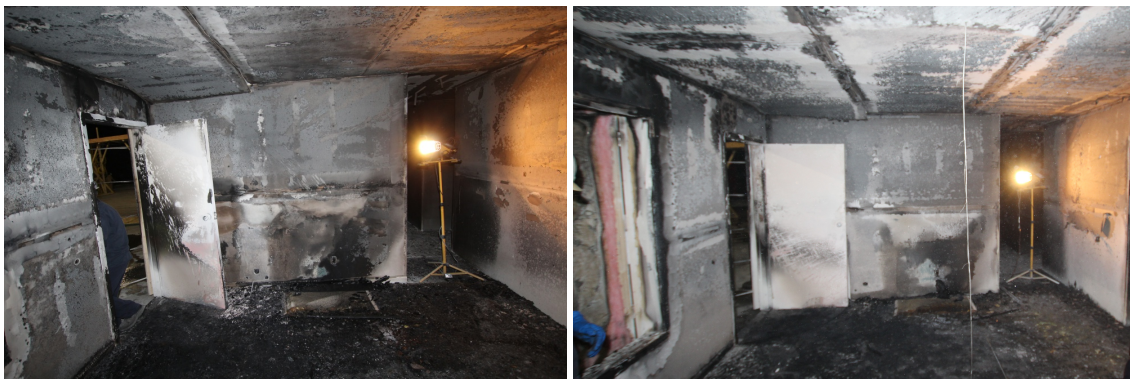
(a) Experiment 3

(b) Experiment 4

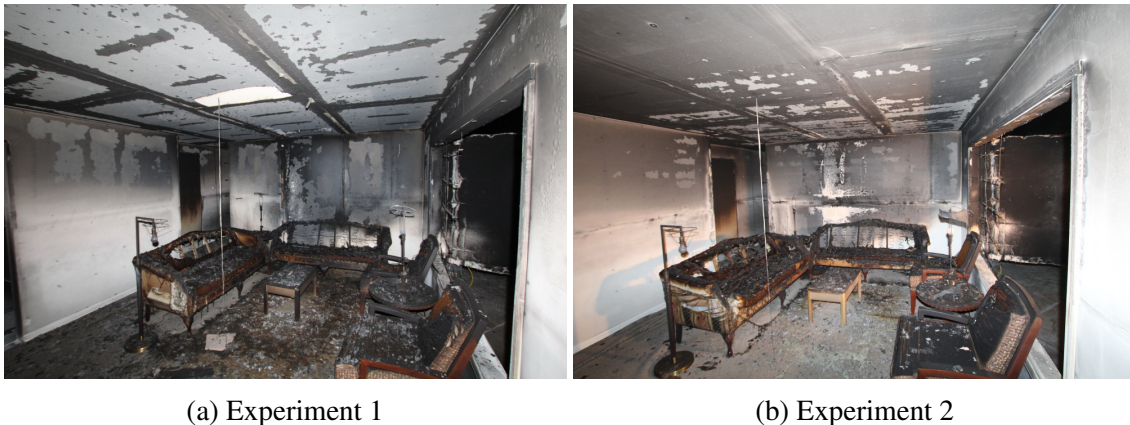
Figure 13: Post-suppression comparison of living room area of origin, with closed door.

Figures 13 and 14 show the post fire suppression photographs of the living rooms that burned with no open exterior vent and with front door open, respectively. The difference in the extent of the fire damage is clear. The open door provided an exhaust vent for oxygen depleted combustion products and an intake vent for air. The continued supply of air supported combustion for a longer period of time. During that time, the combustion zone moved from the area of origin toward the open front door, and then later in the experiment the fire began to move back toward the area of origin.

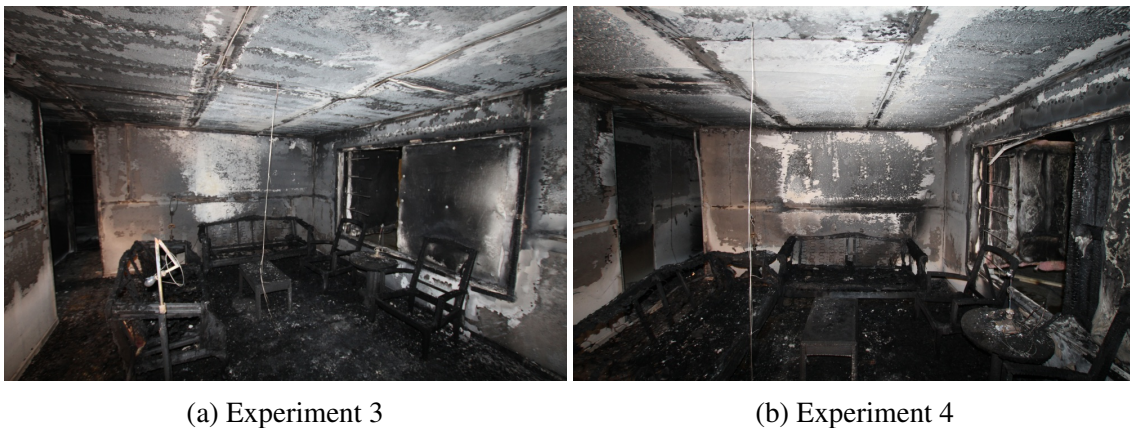
Figure 14: Post-suppression comparison of living room area of origin, with open door.

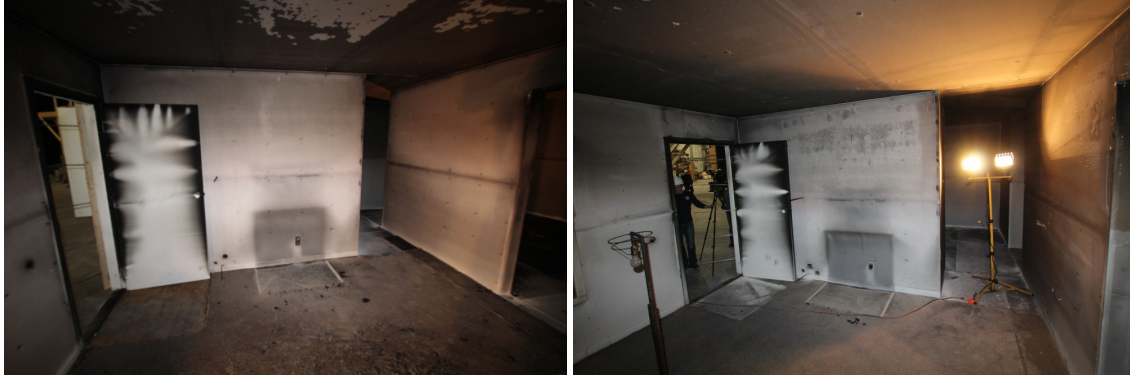
(a) Experiment 1

(b) Experiment 2

Figure 15: Post-overhaul comparison of living room wall opposite the area of origin and adjacent to front door with closed door.

In the open door experiments, when the combustion moved toward the front door, the TV stand was ignited. The difference in the fire patterns created on the wall near the front door depending on whether the door was opened or closed appears in Figures 15 and 16. The ventilation impacted fire damage patterns generated by the burning dresser next to door with an air velocity of 1.4 m/s (3 mph) entering the lower portion of the open doorway (see Figure 16).

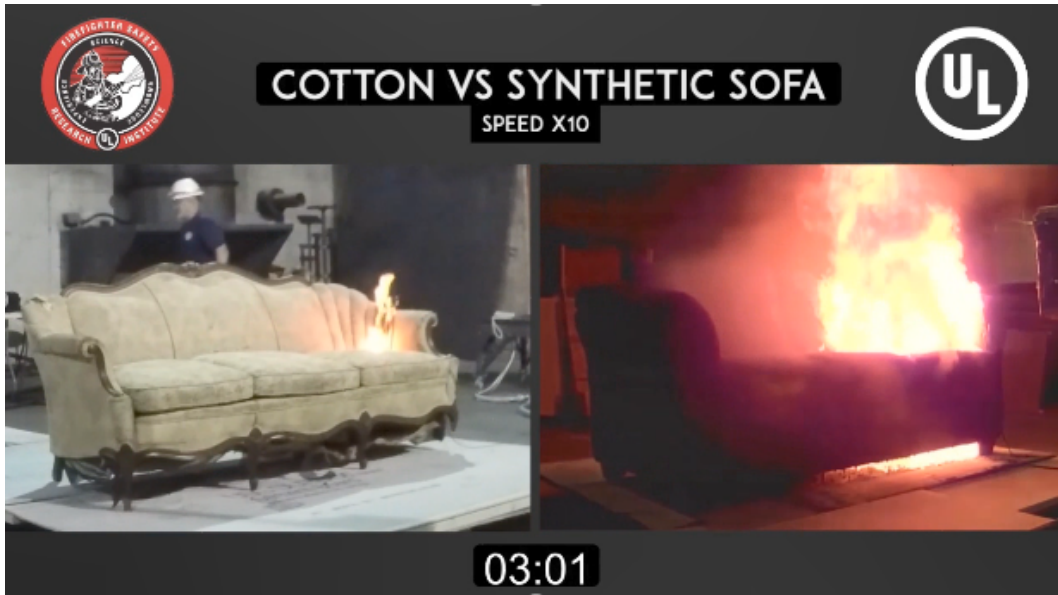
Figure 1.1: Comparison of upholstered sofas: cotton versus polyurethane foam. Images recorded approximately 180 seconds after ignition.

Given the differences in fire development between a sofa with cotton padded cushions and a sofa with polyurethane cushions, it was not surprising the sofa made with foam plastic cushions had the potential to flashover a well-ventilated compartment in a short period of time. The paper, “Analysis of Changing Residential Fire Dynamics and Its Implications on Firefighter Operational Timeframes,” examined this [21]. Kerber conducted a series of compartment fire experiments to examine the difference in time to flashover between a room furnished with legacy fuels and a room furnished with modern fuels. Legacy fuels meant furnishings made from wood, steel, and cotton. Modern fuels are characterized by polyurethane foam, polyester fiber and fabric, engineered wood, and plastics in many different forms. Each room was ignited by a small open flame from a candle on the sofa. The flashover times for the modern room averaged 235 s after ignition. Only two of the three legacy room fires resulted in flashover. The average flashover times for the two legacy rooms was 1,912 s after ignition. It took eight times longer for the cotton sofa to generate enough

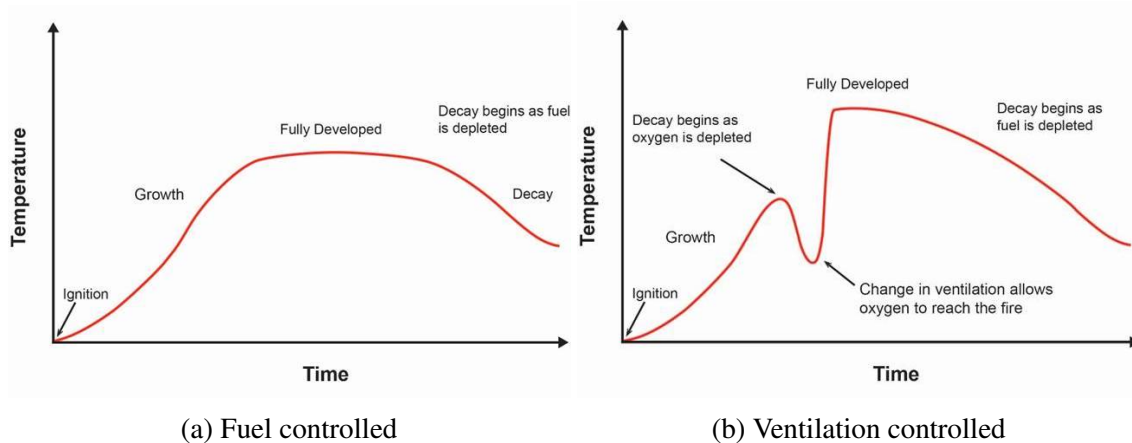
Figure 1.3: Idealized fire curves: fuel versus ventilation controlled.

The differences in the behavior of a ventilation-controlled fire appear in Figure 1.3. The curves shown are idealized representations of a fuel-controlled fire and a ventilation-controlled fire within a compartment or structure. The heat release rate of the fuel-controlled fire is limited by the amount of fuel burning at any given time, because in this scenario the fire has adequate oxygen available to support flaming combustion. In the ventilation-controlled case, the heat release rate of the fire is limited by the amount of oxygen available for combustion.

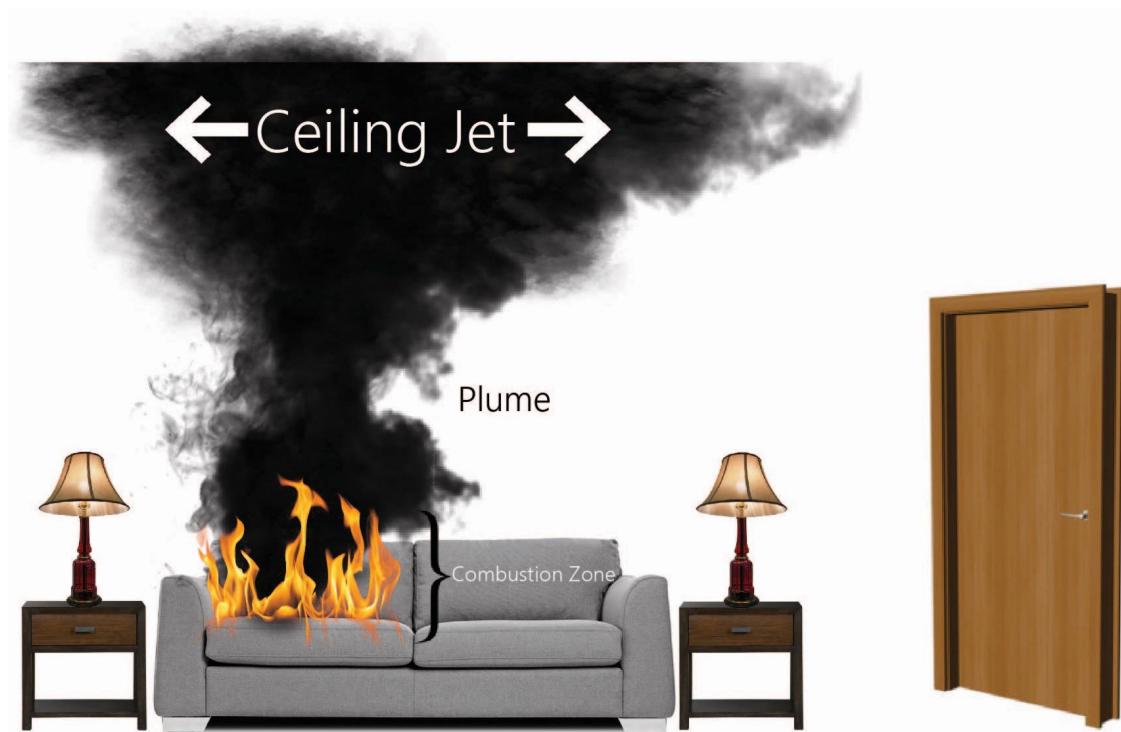
Figure 1.4: Drawing of the growth stage of a compartment fire, highlighting the thermal plume and the ceiling jet.

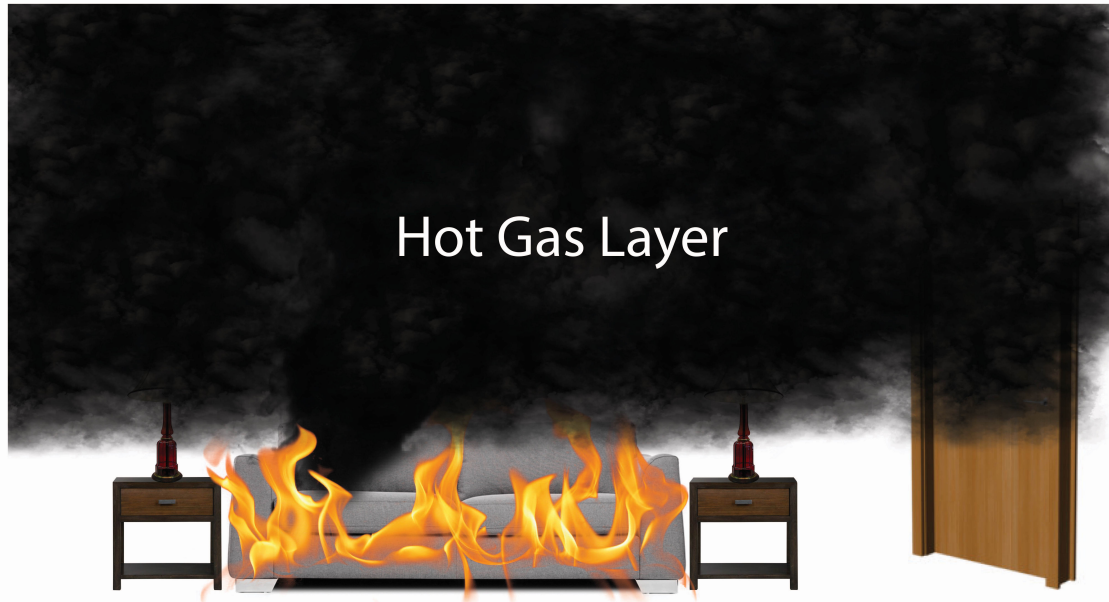
Figure 1.5: Drawing of the hot gas layer in a compartment fire.

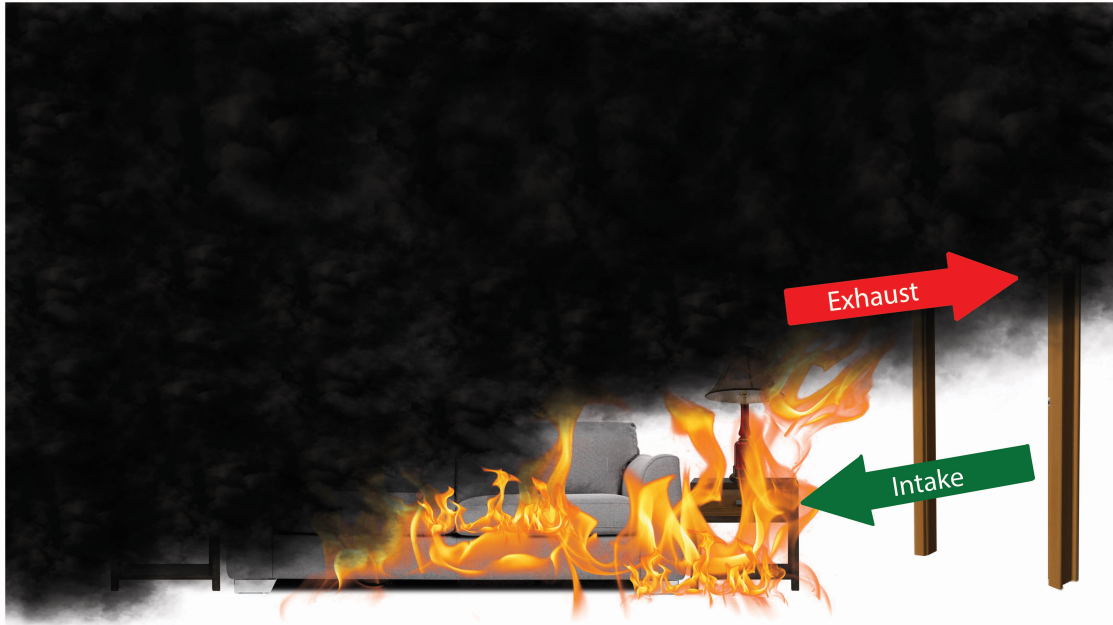
Figure 1.6: Drawing of the air and smoke flow in a compartment fire with an open doorway. The higher pressure hot gases flow out of the top of the doorway and cooler, denser fresh air flows into the lower portion of the doorway to supply oxygen to the fire.

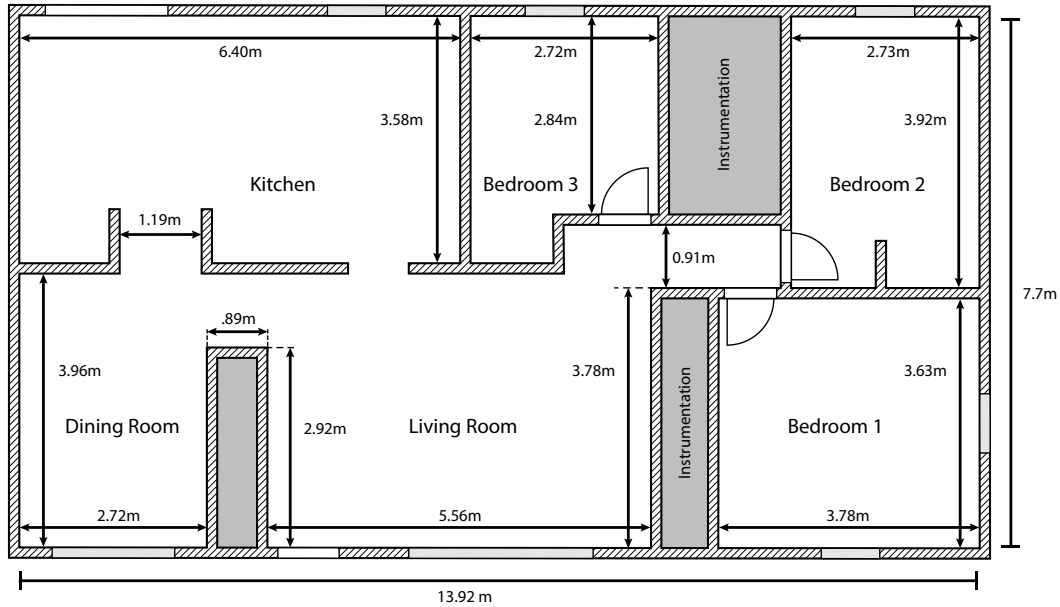
Figure 3.1: Plan view dimensioned drawing of the single story structure.

The single story, ranch-style structure had overall interior dimensions of 13.92 m (46 ft) by 7.7 m (25 ft). The layout of the structure included three bedrooms, a living room, a dining room, and a kitchen. There were also areas, normally designed as a bathroom and closets, that were walled-off from the structure that provided protection to the installed instrumentation. Figure 3.1 shows a dimensioned plan view drawing of the ranch structure indicating major interior dimensions.

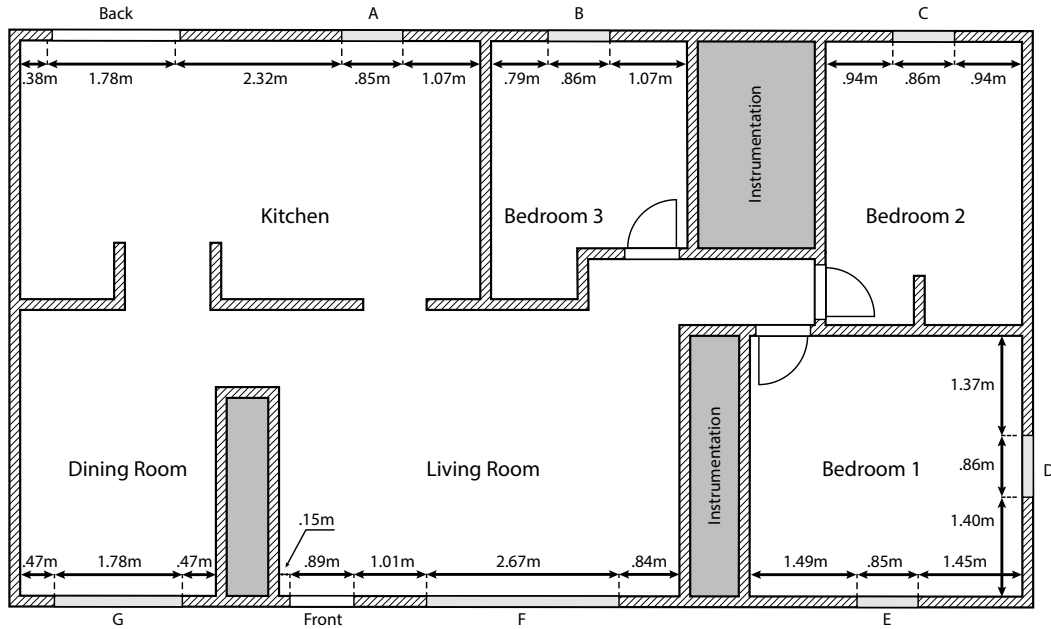
Figure 3.2: Plan view dimensioned drawing of the vents in the single story structure.

The single story structure had two exterior doors (front and back), three bedroom doors, and a doorway that led to the kitchen. All doors/doorways had a height of 2.05 m (6 ft, 8 in.). The interior doors, were purchased hollow-core wood frame doors. To repeatably control ventilation (i.e., size and timing of opening), the exterior vent enclosures (windows) were purpose-built as side-hinged shutters. Each shutter was wood-framed and finished with a layer of insulation on the inside with a layer of 12.7 mm (0.5 in) plywood on the outside. The shutters were affixed to the exterior of the framed window openings. For windows greater than 1.0 m in width, shutters were installed on each side of the opening and met in the middle when closed. Note that one of the two shutters had a lip installed to overlap the gap where two shutters would meet. These shutters allowed for the windows to be manipulated open and closed as many times as needed during the experimental series. The ability of the shutter to open fully at a designated time was a particular benefit to this design. This functionality is not possible with a standard glass window insert. Window shutters like this are common in fire service training props. Figure 3.2 shows the location of the interior and exterior vents in the single story structure, with Table 3.3 showing the size of the windows.

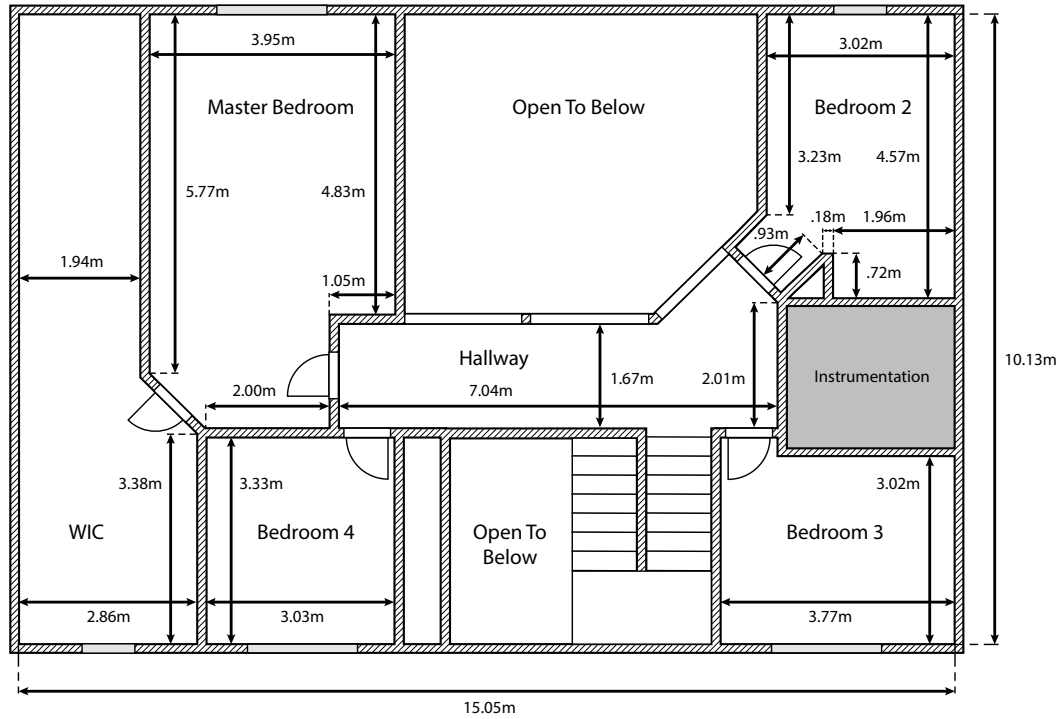
Figure 3.4: Plan view dimensioned drawing of the second floor of the two story structure.

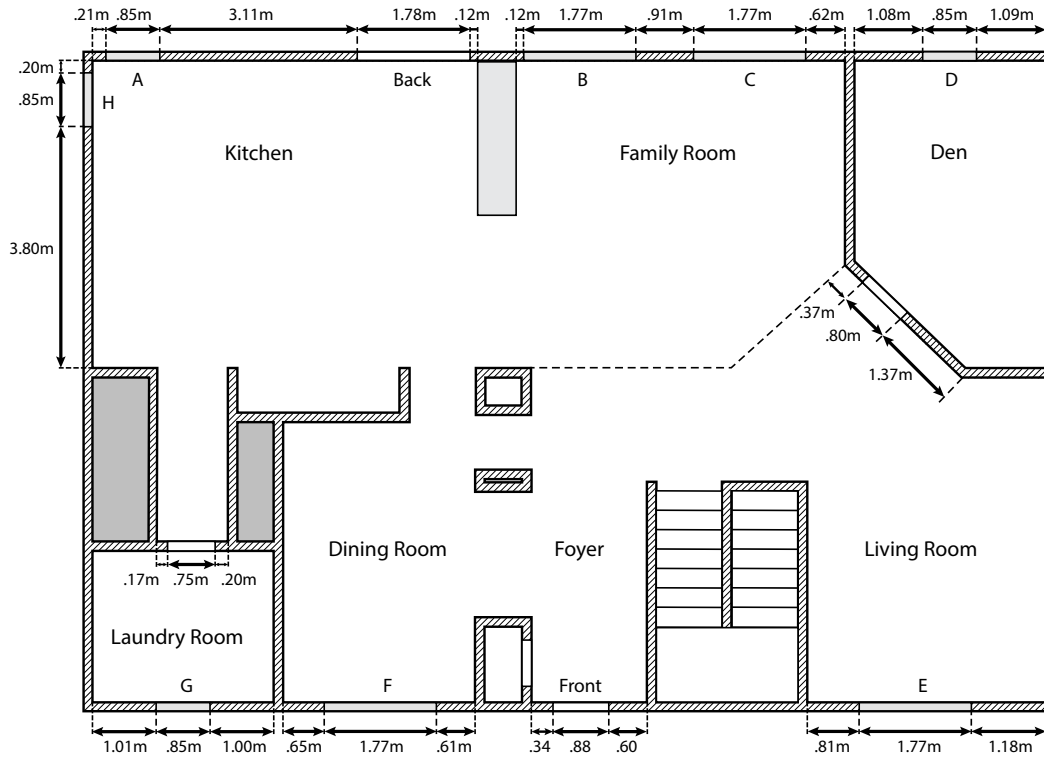
The two story structure had two exterior doors (front and back) and six interior doors (four bedrooms, laundry room, and den). All doors had a height of 2.05 m (6 ft, 8 in). The interior doors, were purchased, interior, hollow core, wood frame doors. To repeatably control ventilation size and timing of opening, the exterior vents (doors and windows) were purpose built in the same fashion as the single story structure. Figure 3.5 shows the location of the interior and exterior vents in the first floor of story structure, with Table 3.4 showing the size of the windows.

Figure 3.5: Plan view dimensioned drawing of the vents in the first floor of the two story structure.

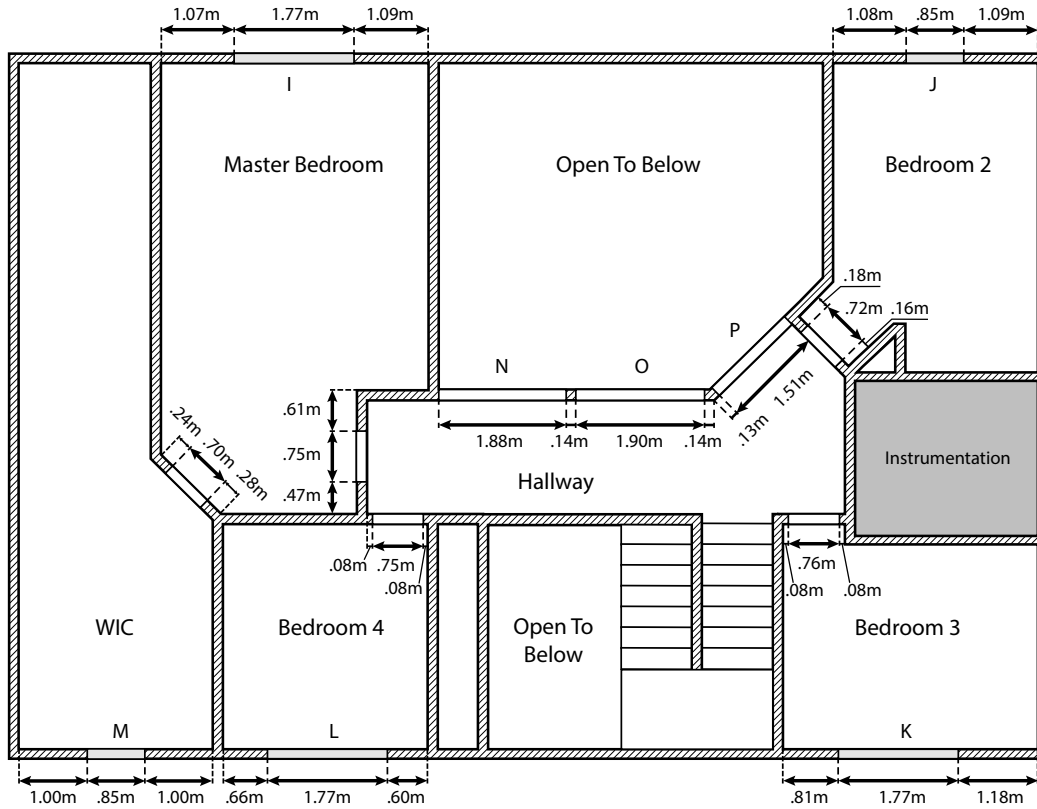
Figure 3.6: Plan view dimensioned drawing of the vents in the second floor of the two story structure.

Figure 3.6 shows the location of the interior and exterior vents in the second floor of the two story structure with Table 3.5 showing the size of the windows. For the second story hallway, the height of the interior wall that opens to the first floor was 0.95 m (37 in.) as shown in rows N, O, and P in Table 3.5.

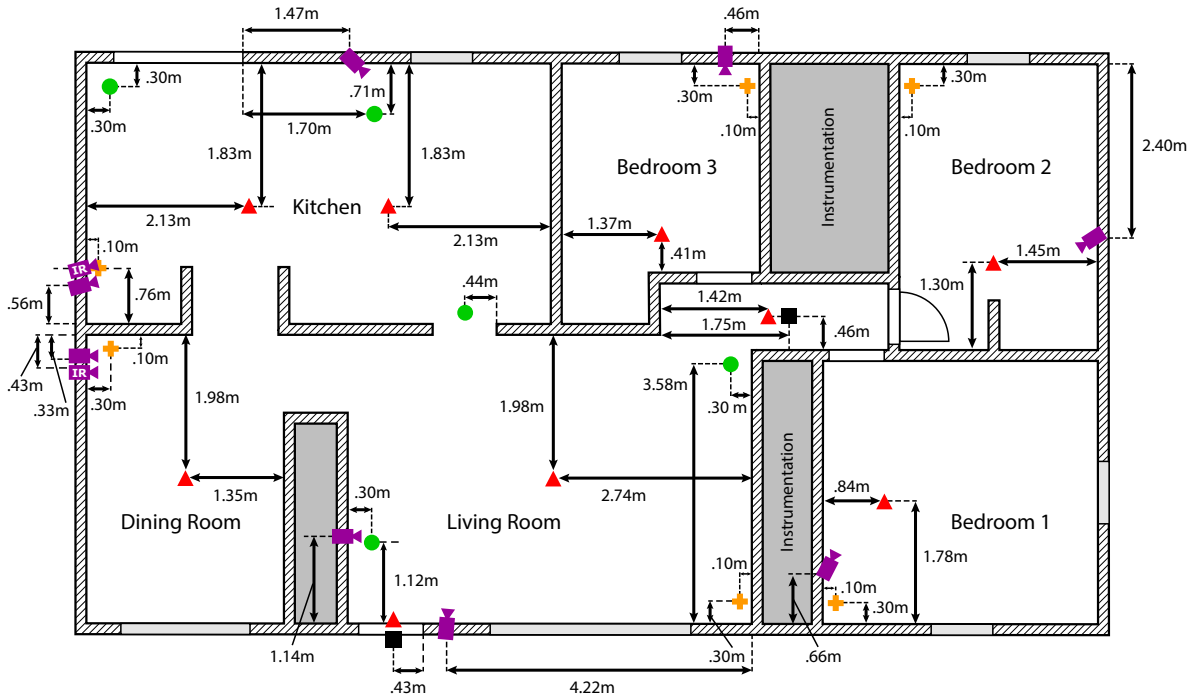
Figure 3.9: Plan view dimensioned drawing of instrumentation in the single story structure for kitchen fires.

Figure 3.9 shows the dimensioned instrumentation locations for the experiments with a kitchen ignition. Similar to the living room and bedroom 1 fires, oxygen sensors were installed at the front door and kitchen doorway at 10 cm (4 in) above the floor and 121 cm (4 ft) above the floor. To capture oxygen depletion toward the bedrooms, the 10 cm (4 in.) above the floor probe was installed in the hallway. The remaining three oxygen measurements locations were in the kitchen, at 10 cm (4 in) above the floor and at 121 cm (4 ft) above the floor probe in the far corner of the kitchen, as well as at 10 cm (4 in) above the floor probe installed through the lower kitchen cabinets.

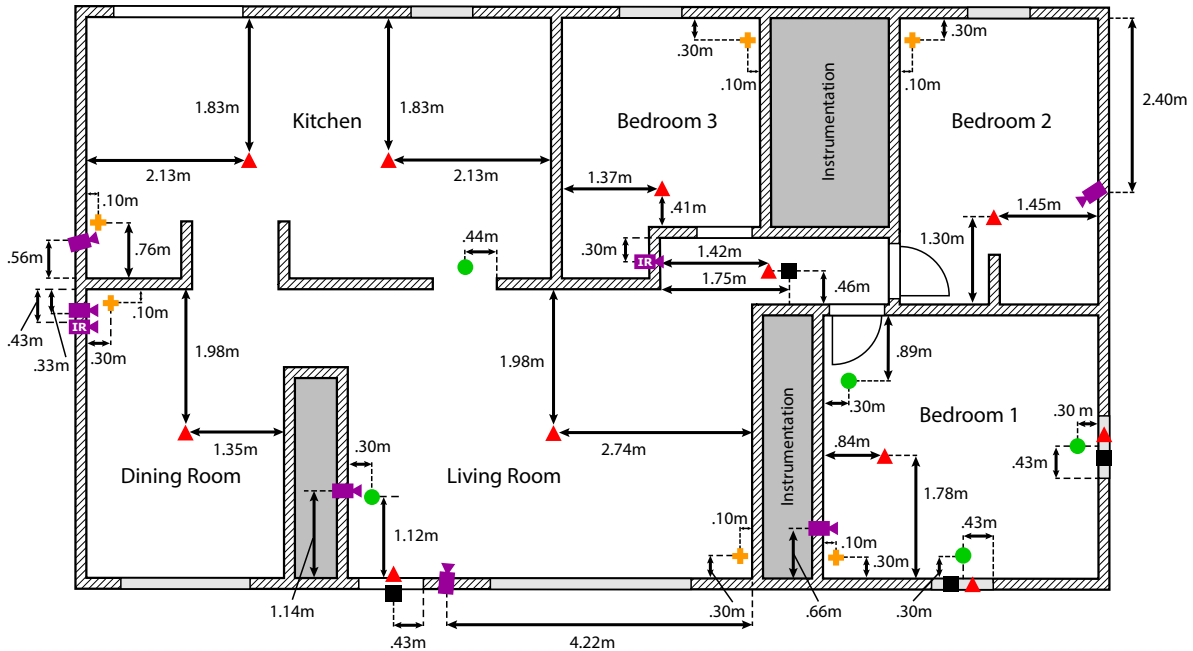
Figure 3.10: Plan view dimensioned drawing of instrumentation in the single story structure for bedroom 1 fires.

For the bedroom 1 fires, a dimensioned instrument plan appears in Figure 3.10. For the bedroom tests, there were five spatial locations for the eight available oxygen measurement points. The front door and kitchen doorway each had the same sampling points at the two elevations used in the living room fires: 10 cm (4 in) above the floor and 121 cm (4 ft) above the floor. The remaining four sampling points were installed at three locations within bedroom 1. At the bedroom doorway, there was a sampling point at 10 cm (4 in) above the floor. The final two measurement points were installed 10 cm (4 in) above the floor, one below the front window and one below the side window.

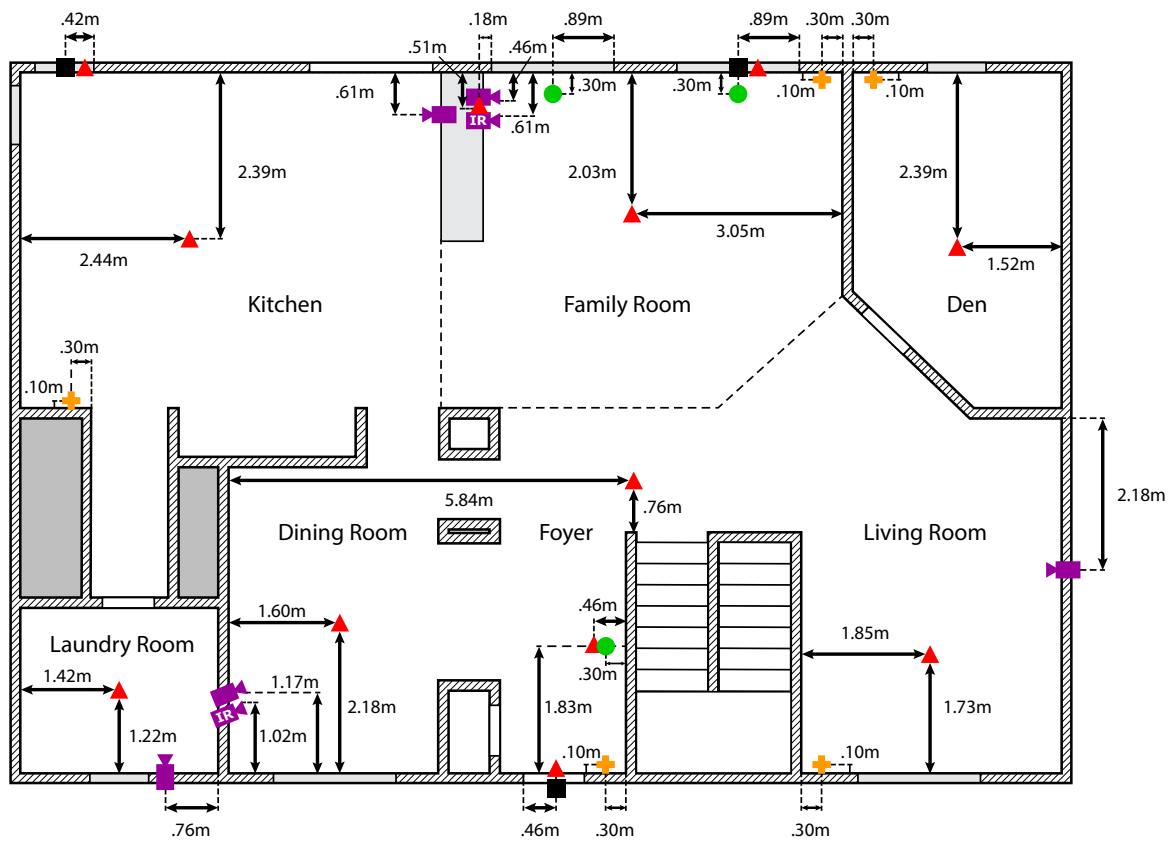
Due to the limited number of oxygen sensors and IR cameras, those sensors were relocated based on the location of the ignition. Recall from Table 3.2 that five experiments were conducted in the two story structure with an ignition in the family room. For four of the five experiments, the oxygen sensors and IR cameras were in the same locations and only seven oxygen sensors were used. These experiments included: all vents closed, only the front door open, the front door and bedroom 3 window open, and the front door and family room window open. Figures 3.11 and 3.12 show the dimensioned instrumentation for the first and second floor of the structure, respectively. In these experiments, there were seven oxygen sensors on the first floor (Figure 3.11); four oxygen sensors at the left side of the family room as it transitioned into the kitchen at 10 cm (4 in.) and 1.22 m (4 ft) above the floor and at 10 cm (4 in.) and 1.22 m (4 ft) below the ceiling, one sensor on the right side of the family room at 10 cm (4 in.) above the floor and two sensors at the front door at 10 cm (4 in.) and 1.22 m (4 ft) above the floor.

Figure 3.11: Plan view dimensioned drawing of instrumentation of the first floor of the two story structure for family room fires.

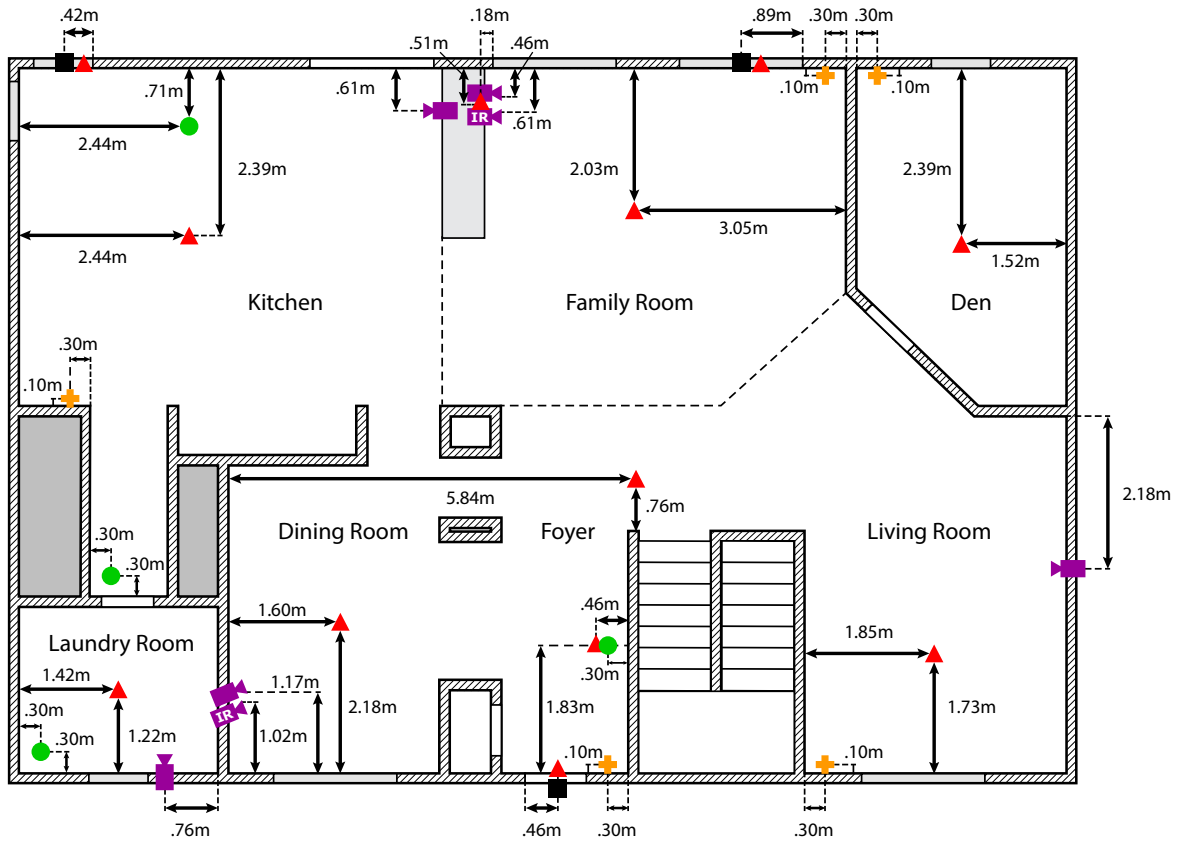
Figure 3.15: Plan view dimensioned drawing of instrumentation of the first floor of the two story structure for laundry room fire.

For the laundry room fire, the oxygen sensors were all paired at two elevations: 10 cm (4 in) and 1.22 m (4 ft) above the floor. The four locations were the front door, in the kitchen where cabinets along the back wall were installed for the kitchen fire experiments, the laundry room doorway, and in the corner opposite the door to the laundry room. A dimensioned layout of the first floor instrumentation used in the experiment with a laundry room ignition is included in Figure 3.15.

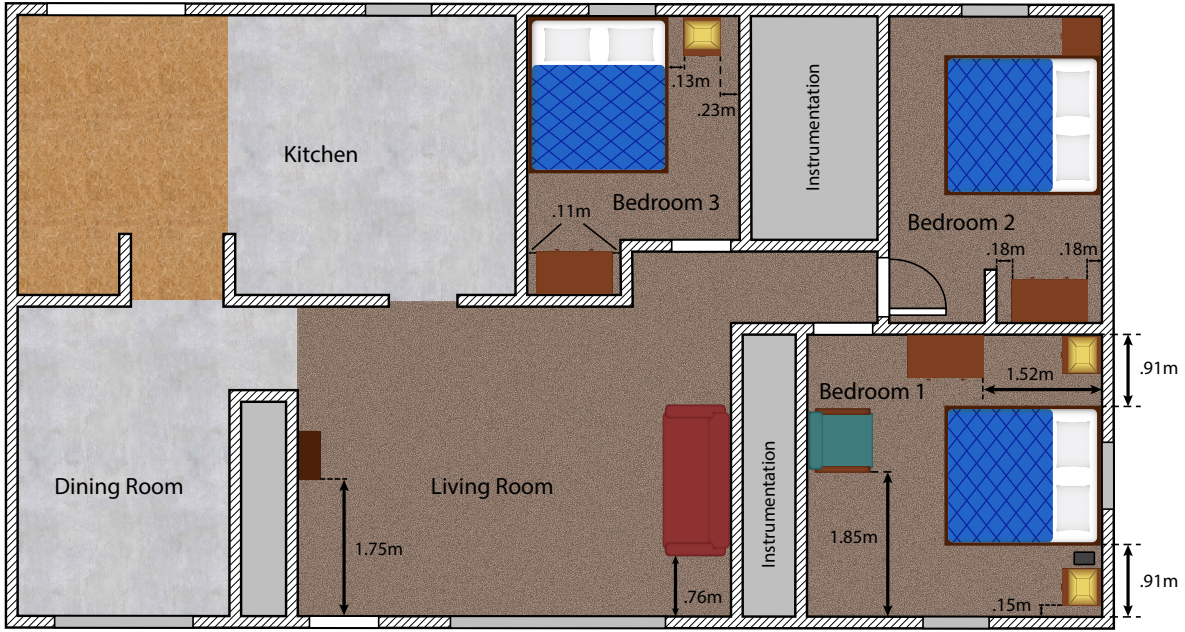
For the bedroom ignition experiments, the fire was always started in bedroom 1 even though each of the three bedrooms were furnished. Each bedroom had a unique fuel load based on the size of the bedroom. Bedroom 1 was furnished with a king-size bed with a puf pad and bedding, an upholstered chair, two night stands with lamps, a wood dresser, and carpeted floor. Figure 3.20 shows a dimensioned drawing of the fuel load for the bedroom ignition experiments, and more details about the fuel are included in Table 3.8. Similar to the kitchen experiments, there was a target sofa, bookcase, and carpeting in the living room.

Figure 3.20: Plan view drawing of fuel configuration in the single story structure for bedroom 1 fires.

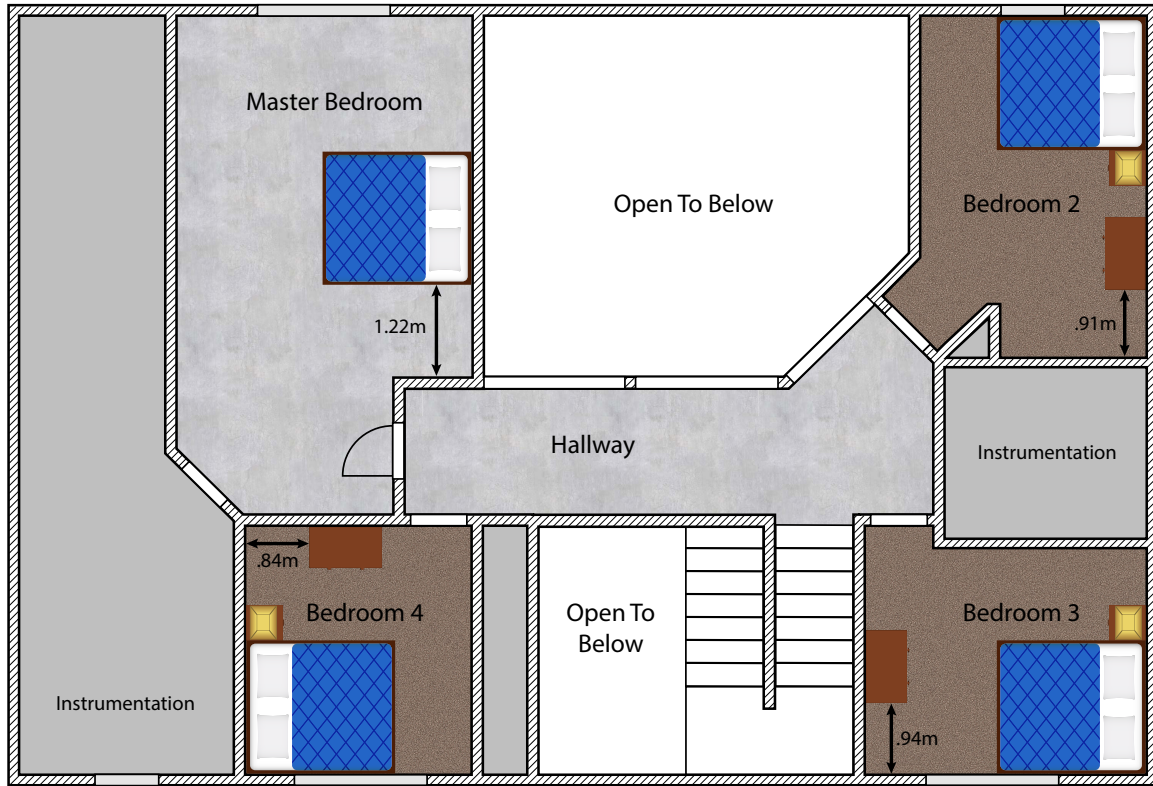
For all experiments in the two story structure, the fuel load on the second floor remained the same. Each bedroom had a king-size bed, while three of four bedrooms (bedrooms 2, 3, and 4) also had a nightstand, lamp, and dresser. A dimensioned plan view of the second story fuel load is included in Figure 3.25.

Figure 3.25: Plan view drawing of fuel configuration in the second floor of the two story structure.

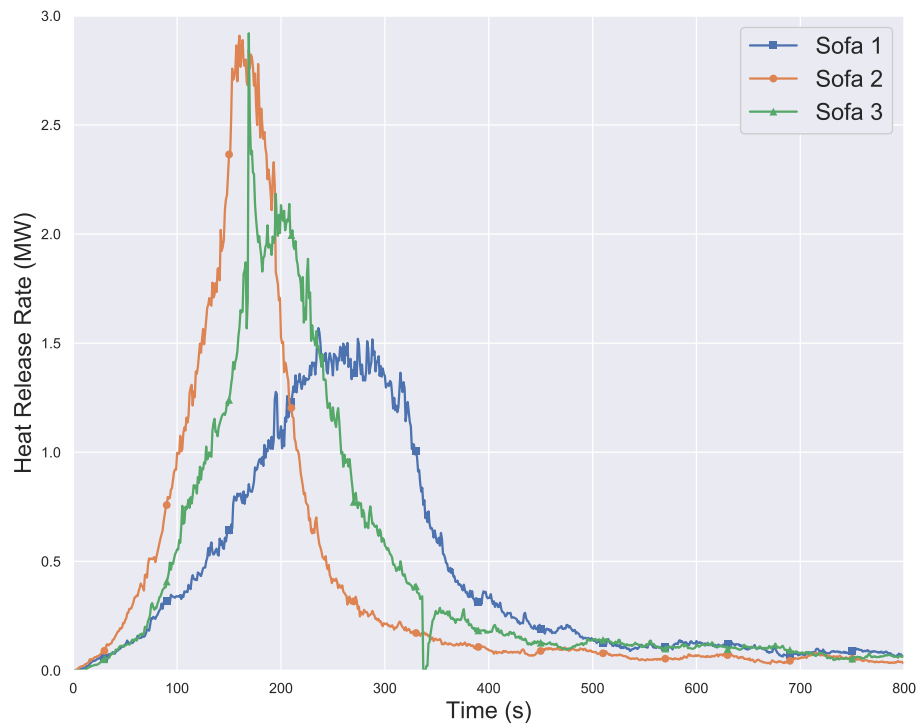
Three sofas were ignited and burned in the absence of a compartment and quantified using oxygen consumption calorimetry to understand the magnitude and repeatability energy release of one of the primary fuel packages used in these experiments. The heat release rate (HRR) as a function of time for the three sofas is included in Figure 3.26.

Figure 3.26: Three replicate heat release rate time histories of the sofas used for this experimental series.
