# Impact of Fixed Ventilation on Fire Damage Patterns in Full-Scale Structures

Daniel Madrzykowski  
Craig Weinschenk

UL Firefighter Safety Research Institute  
Columbia, MD 21045

April 18, 2019

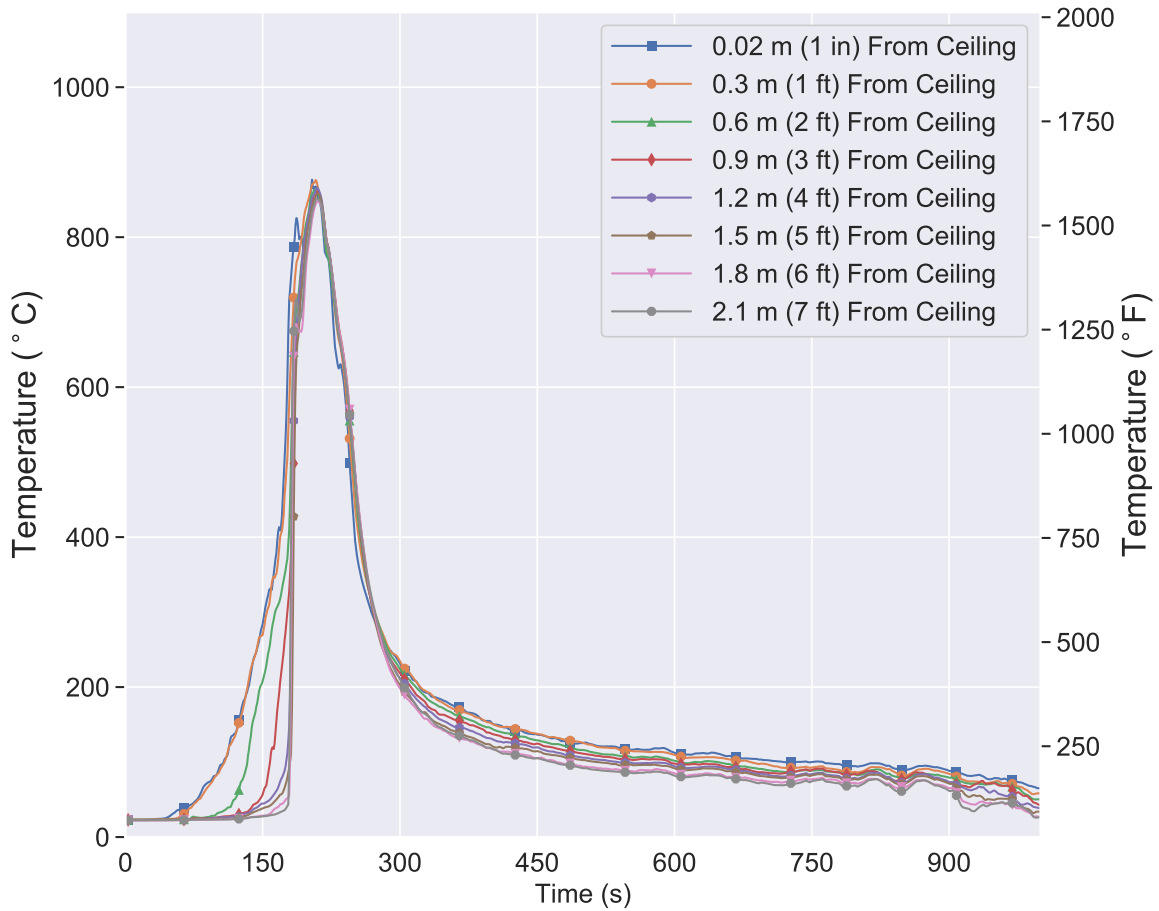
Figure 4.1 displays the time history of the thermocouple temperatures in the living room. The growth of the hot gas layer, starting at the ceiling and descending to within a 0.3 m (1 ft) above the floor occurred for the first 180 seconds. Seconds later, the temperatures rapidly increased to more than 800 °C (1470 °F). Temperatures higher than 600 °C (1112 °F) from ceiling down to the floor would meet the defined conditions for flashover. Within 30 seconds of the transition to flashover, the temperatures in the living had started to decrease. A minute later, the temperatures had all decreased by more than 500 °C (930 °F). The downward trend in temperatures continued until the end of the experiment.

Figure 4.1: Experiment 1, no exterior ventilation openings, living room temperature versus time.

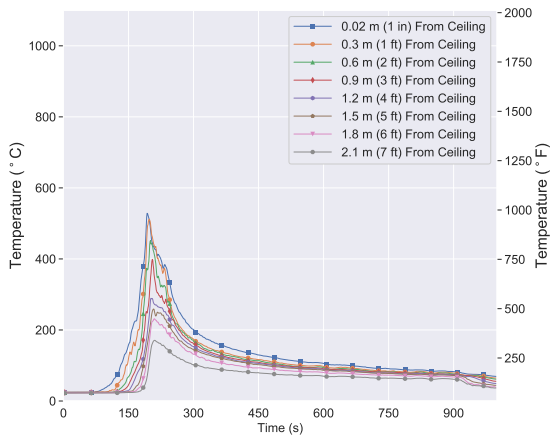
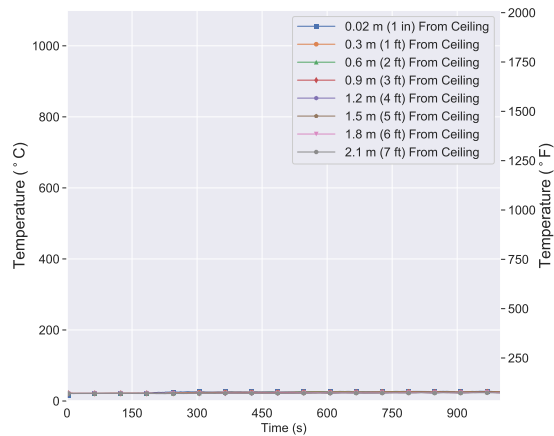
Figure 4.2 shows the temperature histories for all of the other instrument locations in the single story structure. The dining room, kitchen, hallway, and bedroom 2 are areas that were open to the living room, and as a result the temperature trends follow those of the living room. The hallway thermocouple array was located closest to the area of ignition while the bedroom 2, kitchen, and dining room thermocouples were further away. Being remote from the living room resulted in reduced peak temperatures. Only the hallway exceeded 600 °C (1112 °F) from ceiling down to the floor. The other rooms did not transition through flashover. The bedroom furniture in bedroom 2 did not ignite. The temperatures in the bedrooms with closed doors did not increase significantly.

Figure 4.2: Experiment 1, no exterior ventilation openings, temperature time histories for all of the rooms.

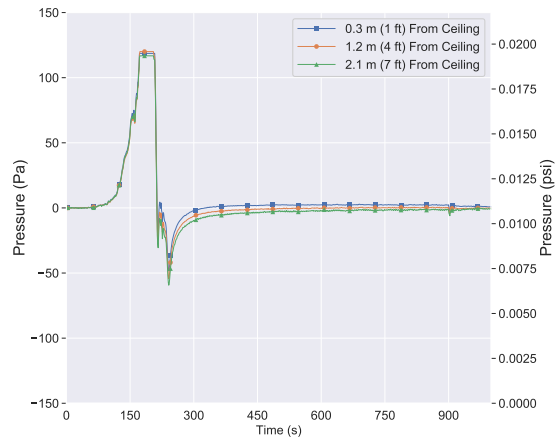
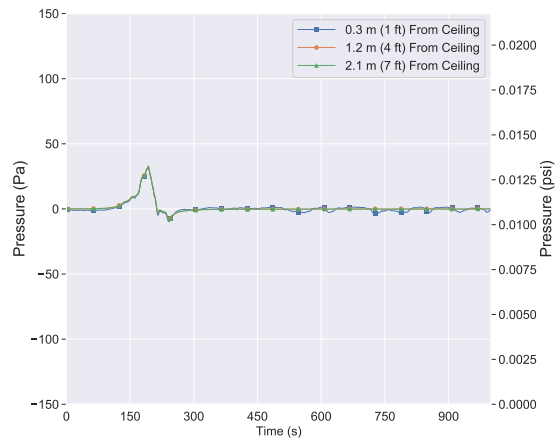
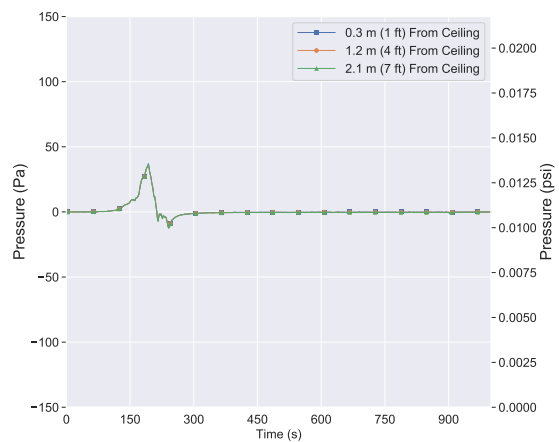
Figure 4.5 provides pressure time histories for all six rooms in the house. As the fire and the hot gas layer grew, the pressure levels throughout the structure increased. The rooms open to the living room had similar pressures. As flashover began, the pressure increased and exceeded the 125 Pa limit of the pressure sensors. As the flaming combustion ceased due to a lack of sufficient oxygen for combustion, and the gas temperatures decreased, the pressures also decreased. In fact, the pressures inside the structure decreased below the atmospheric pressure outside the structure. The combustion seemed to cycle once (i.e., increase then cease), and after that the pressure tended toward equalizing with the atmospheric pressure. The two bedrooms with closed doors were also impacted by the pressure increase but to a lesser amount. During the rapid pressure increase, smoke was pushed in to bedrooms 1 and 3, which in turn may have allowed fresh air to move in to the hallway and to the living room. This may have provided the oxygen for the combustion after the first large pressure drop.

Figure 4.5: Experiment 1, no exterior ventilation openings, pressures in all rooms.

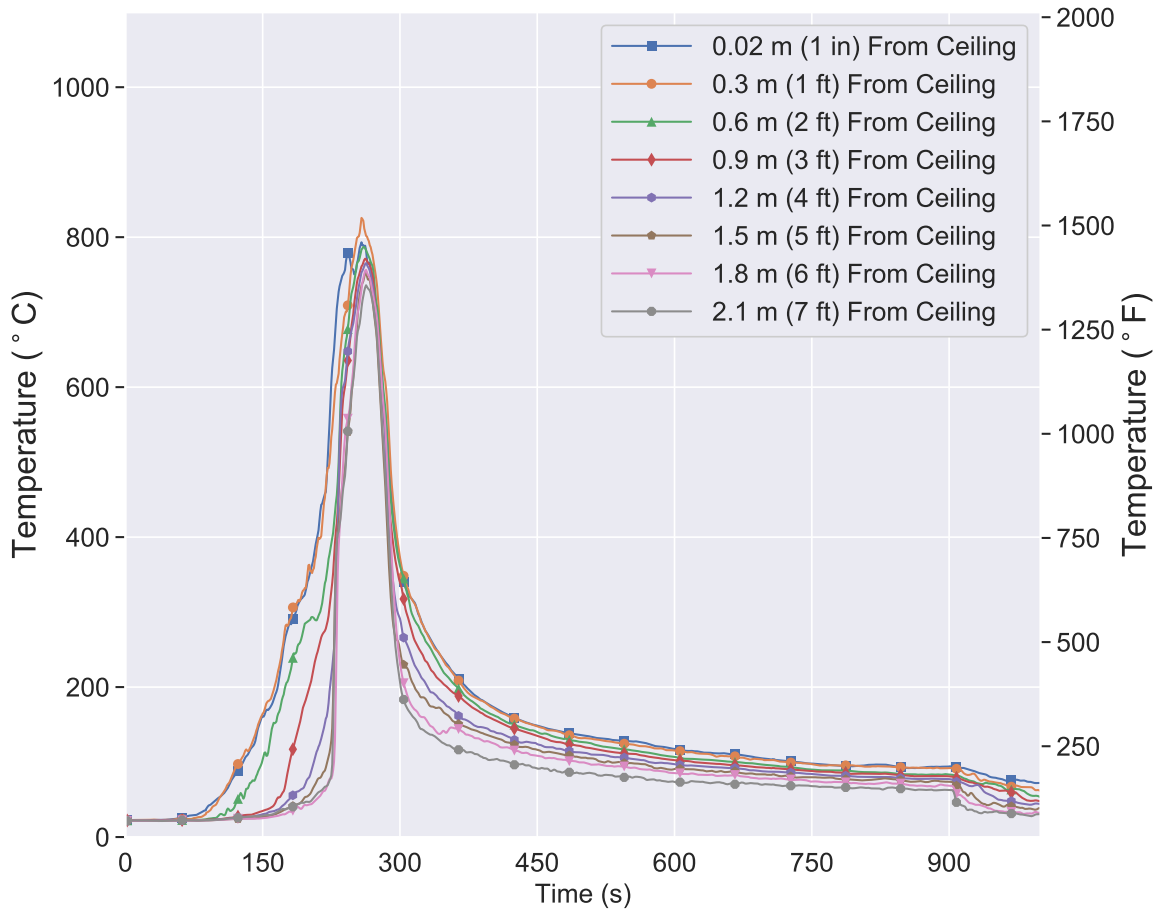
Figure 4.6 displays the time history of the thermocouple temperatures in the living room. The growth of the hot gas layer, starting at the ceiling and descending to within a 0.3 m (1 ft) above the floor, occurred for the first 220 s. Seconds later, the temperatures of the thermocouples closest to the floor rapidly increased to more than 800 °C (1470 °F). Temperatures higher than 600 °C (1112 °F) from ceiling down to the floor would meet the defined conditions for flashover. Within 40 s of the transition to flashover, the temperatures in the living room started to decrease. One minute later, the temperatures had all decreased by more than 400 °C (750 °F). The downward trend in temperatures continued until the end of the experiment. The trend of the temperatures was similar to Experiment 1.

Figure 4.6: Experiment 2, no exterior ventilation openings, living room temperature versus time.

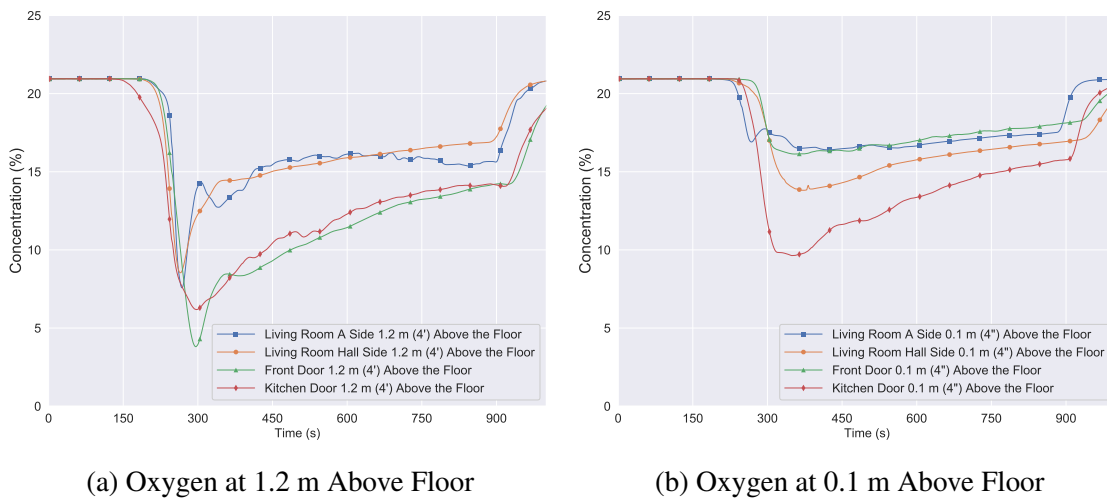
Figure 4.8 includes the time history of the eight oxygen meters. The sampling ports were positioned to surround the point of ignition. Four of the sampling ports were positioned at 1.2 m (4 ft) above the floor (see Figure 4.3a) and the other four were positioned under the upper sampling ports and 100 mm (4 in.) above the floor (see Figure 4.3b). The four meter sampling from 1.2 m (4 ft) above the floor measured a decrease in oxygen as soon as the hot gas layer covered the sampling port. The oxygen meters measuring conditions to the right of the ignition sofa exhibited the earliest decrease at each level, which started at approximately 135 s and 225 s after ignition for the 1.2 m (4 ft) and the 100 mm (4 in.), respectively. The remaining 1.2 m (4 ft) oxygen meters registered decreased oxygen concentrations starting at approximately 185 s after ignition. The oxygen meters that measured gases sampled at 1.2 m (4 ft) above the floor had minimum oxygen concentrations of less than 10%. The oxygen meters that measured gases sampled at 100 mm (4 in.) had minimum oxygen concentrations of 16.4% or less.

Figure 4.8: Experiment 2, no exterior ventilation openings, oxygen concentration versus time.

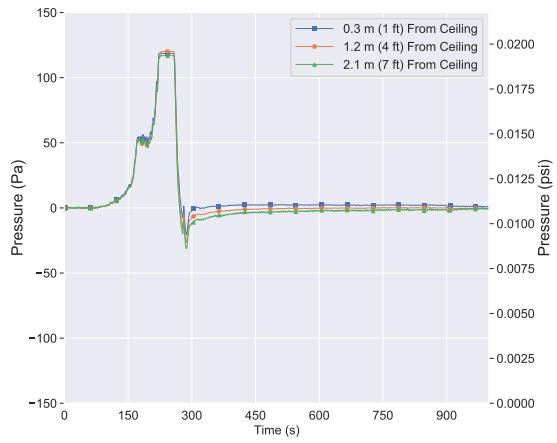
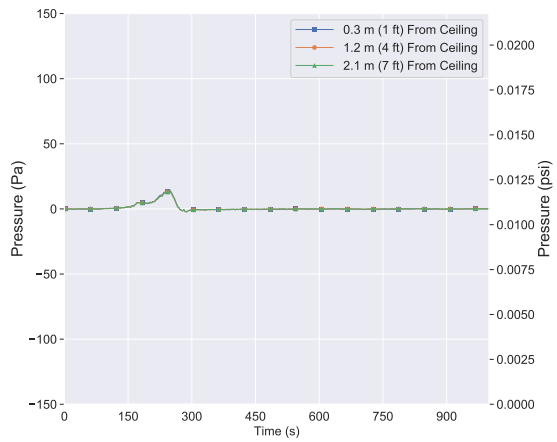
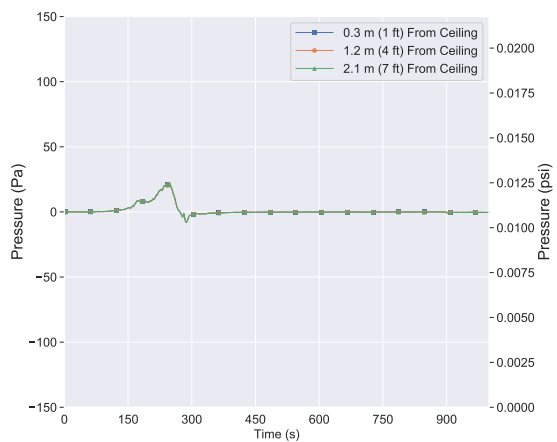
Figure 4.10: Experiment 2, no exterior ventilation openings, pressures in all rooms.

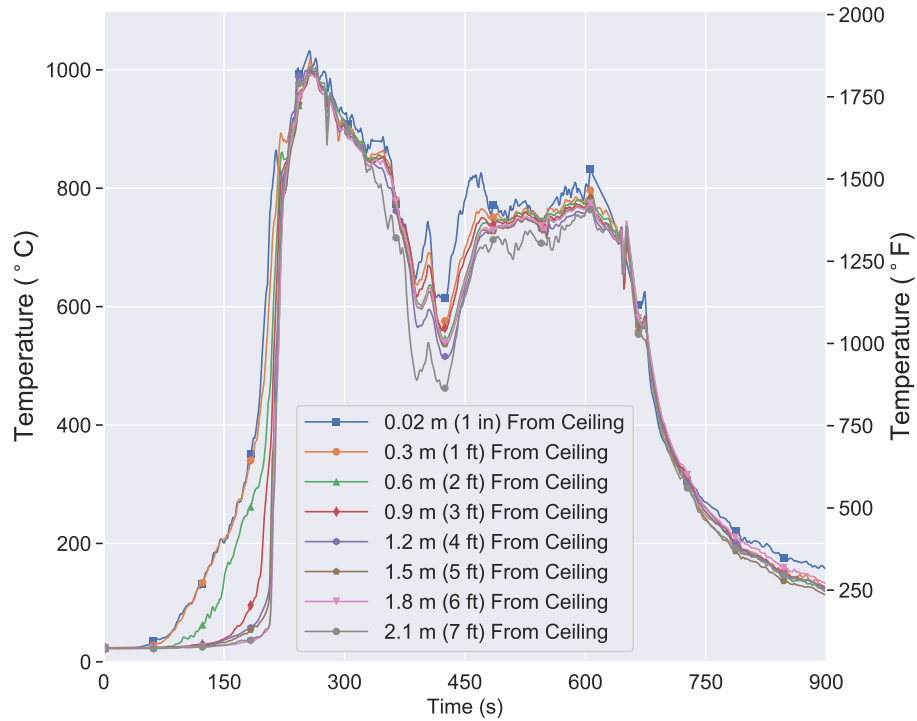
Figure 4.11: Experiment 3, front door open, living room temperature versus time.

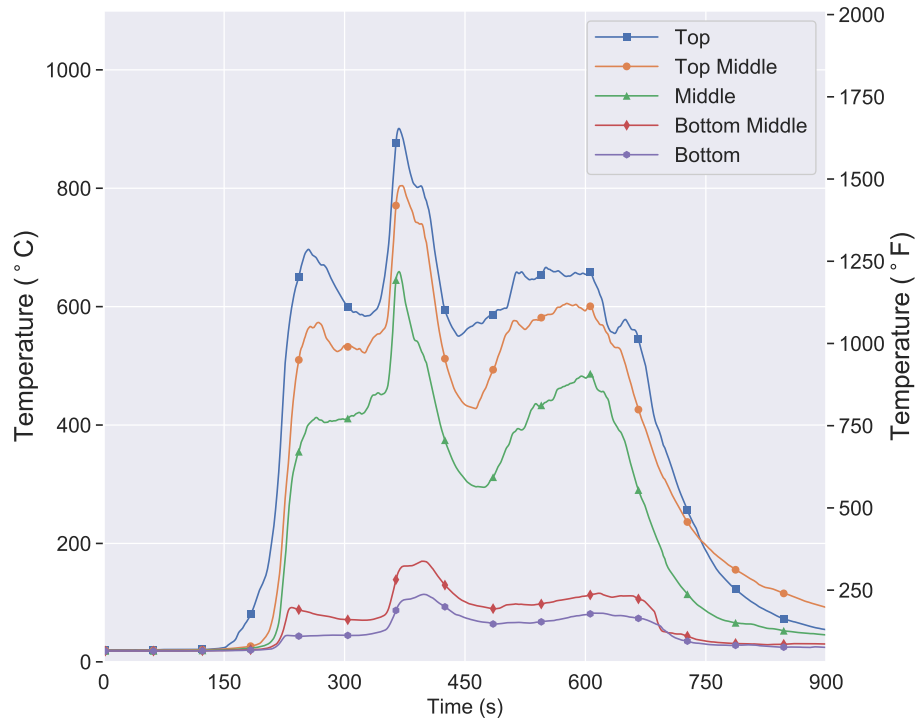
Figure 4.12: Experiment 3, front door open, front door temperatures versus time.

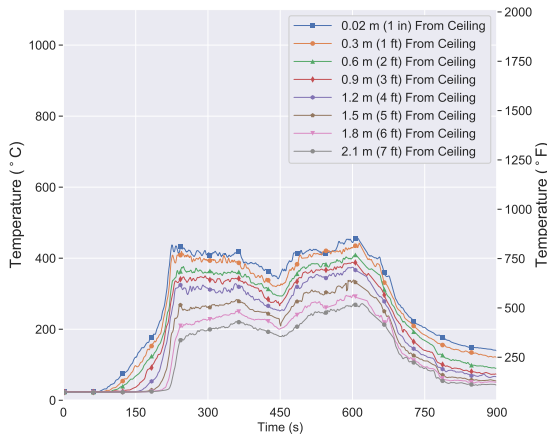
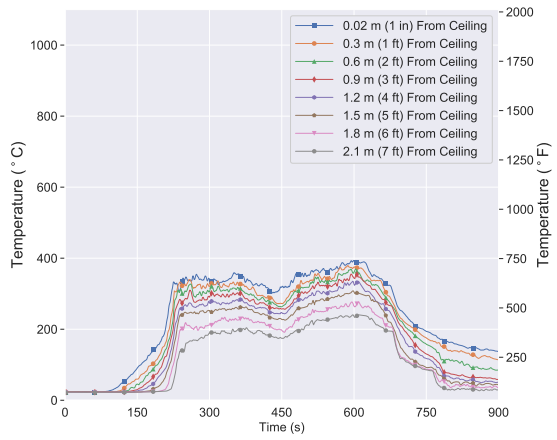
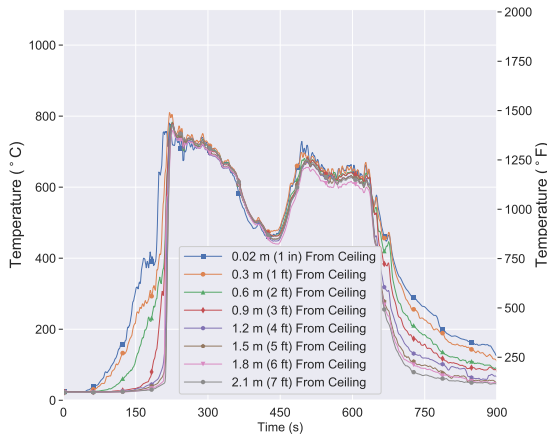
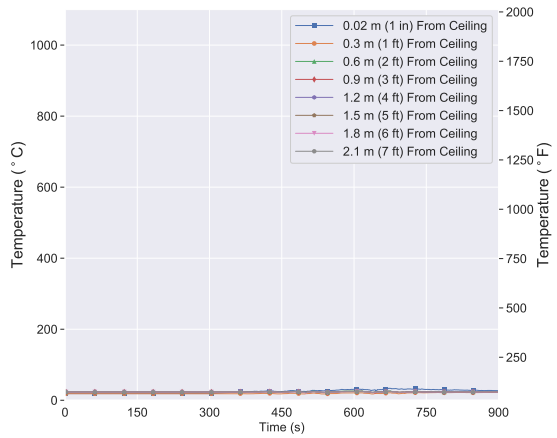
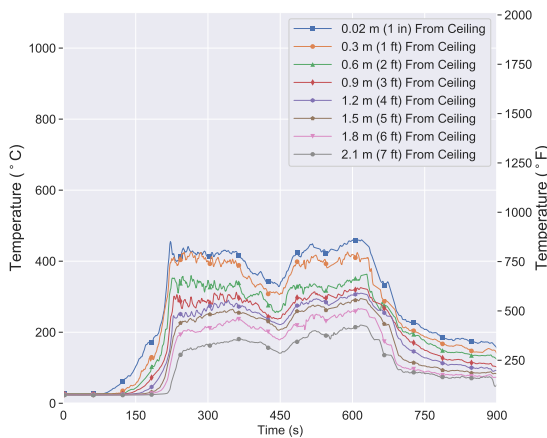
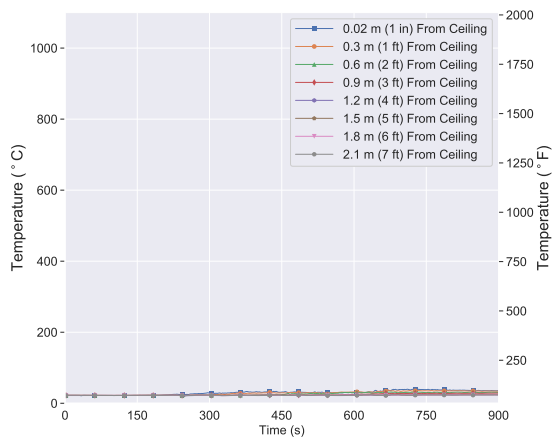
Figure 4.13 shows the temperature histories for all of the other thermocouple array locations inside the single story structure. The dining room, kitchen, hallway, and bedroom 2 areas were open to the living room, and as a result the temperature trends follow those of the living room. The hallway thermocouple array was located the closest to the area of ignition, while the bedroom 2, kitchen, and dining room thermocouples were further away. Being remote from the living room resulted in reduced peak temperatures. Only the hallway exceeded 600 °C (1112 °F) from ceiling down to the floor. The other rooms did not transition through flashover. The bedroom furniture in bedroom 2 did not ignite. The temperatures in the bedrooms with closed doors did not increase.

Figure 4.13: Experiment 3, front door open, time-temperature histories for all of the rooms.

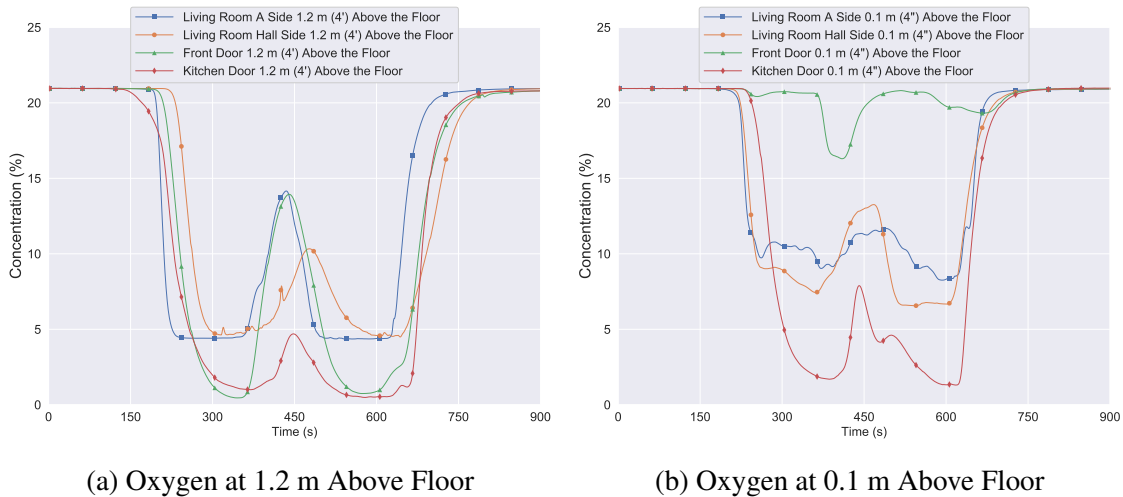
Figure 4.14 includes the time history of the eight oxygen meters. The sampling ports were positioned to surround the point of ignition. Four of the sampling ports were positioned at 1.2 m (4 ft) above the floor (see Figure 4.14a) and the other four were positioned under the upper sampling ports and 100 mm (4 in.) above the floor (see Figure 4.14b). The four meters sampling from 1.2 m (4 ft) above the floor measured a decrease in oxygen as soon as the hot gas layer covered the sampling port. The oxygen meters measuring conditions to the right of the ignition sofa exhibited the earliest decrease at each level, which started at approximately 150 s and 230 s after ignition for the 1.2 m (4 ft) and the 100 mm (4 in.), respectively. An important trend to recognize is the initial drop in oxygen at all sensor locations, the subsequent rise in oxygen at approximately 360 s, and the second drop in oxygen concentration at approximately 450 s. The first minimum value in oxygen corresponds to the drop in temperature. A lack of oxygen in the structure limited combustion, and therefore temperatures decreased. As combustion products exited the structure through the top of open front door, oxygen returned through the bottom portion of the doorway as seen by the rise in oxygen reaching a local peak at approximately 450 s. At this point, oxygen returned to levels to support combustion. The result was a second spike in temperature and subsequent drop in oxygen.

Figure 4.14: Experiment 3, front door open, oxygen concentration versus time.

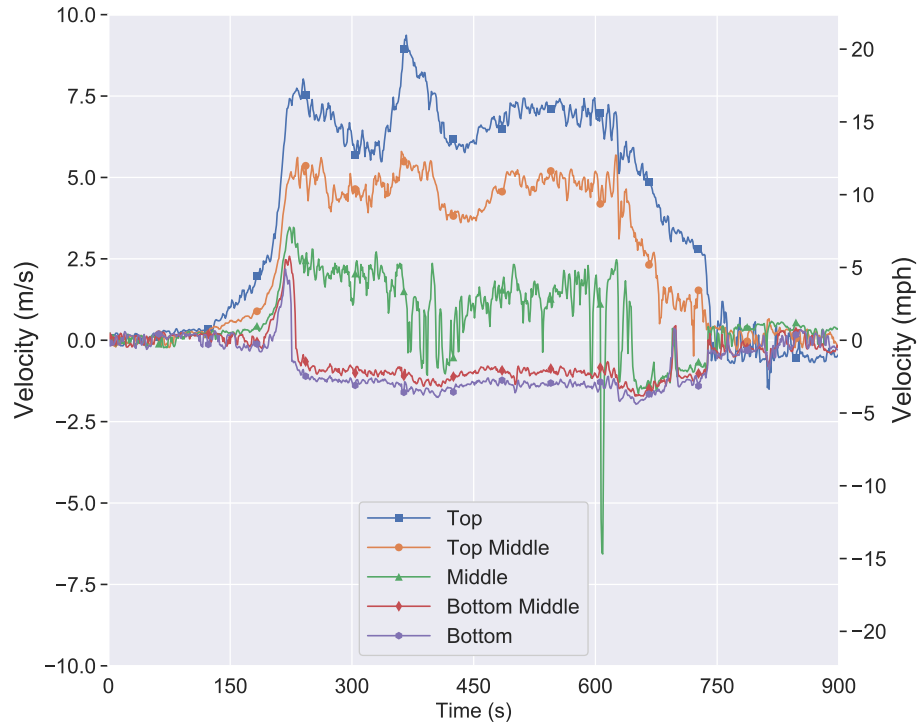
Figure 4.15: Experiment 3, front door open, front door velocity versus time.

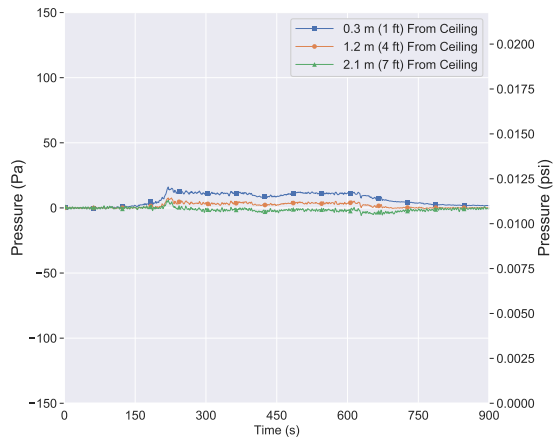
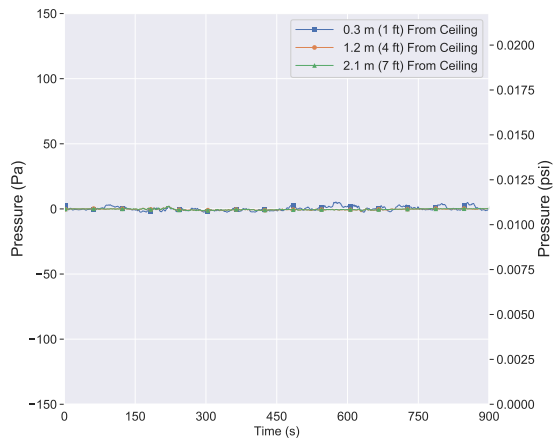
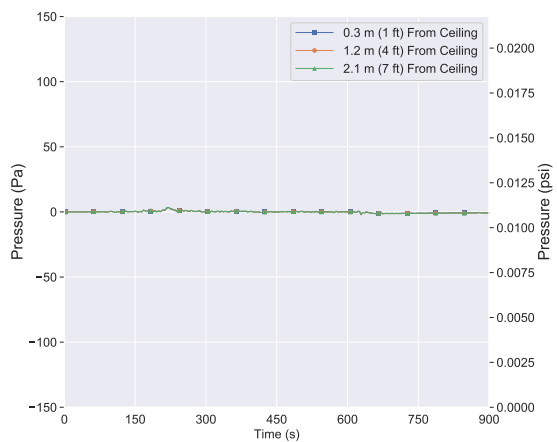
Figure 4.17 provides pressure time histories for all six rooms in the house. As the fire and the hot gas layer grew, the pressure levels throughout the structure increased. Unlike Experiments 1 and 2, pressures within the structure did not exceed 20 Pa because of the open front door. The rooms open to the living room had similar pressures. The two bedrooms with closed doors showed minimal pressure change.

Figure 4.17: Experiment 3, Front door open, pressures in all rooms.

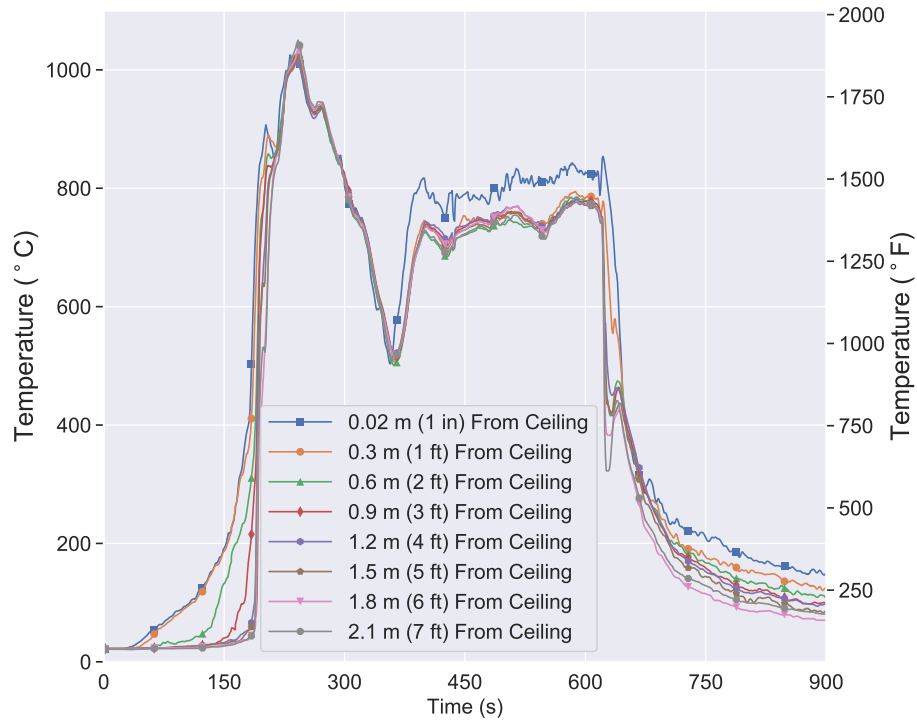
Figure 4.18 displays the time history of the thermocouple temperatures in the living room. The growth of the hot gas layer, starting at the ceiling and descending to within a 0.3 m (1 ft) above the floor appears for the first 180 s. Seconds later, the temperatures of the thermocouples closest to the floor rapidly increased to more than 800 °C (1470 °F). Temperatures higher than 600 °C (1112 °F) from ceiling down to the floor would meet the defined conditions for flashover. Shortly after the transition to flashover, the temperatures in the living started to decrease, dropping to 500 °C (932 °F). At this point, oxygen had recovered because of the open front door, and temperatures rose again, remaining above 600 °C (1112 °F) until suppression.

Figure 4.18: Experiment 4, front door open, living room temperature versus time.

During the initial fire growth and subsequent temperature rise in the living room (see Figure 4.18) the velocity profile at the front door shows that the door was completely an exhaust vent (see 200 s in Figure 4.22). The velocity profile at the interior hallway (Figure 4.23) at the same time shows the upper portion of the hallway flowing towards the bedrooms while the bottom probe indicates flow towards the fire. As the fire started to decay due to drop in oxygen concentration, the doorway velocity profile changed to a bi-directional flow with the bottom two probes indicating air flowed into the structure.

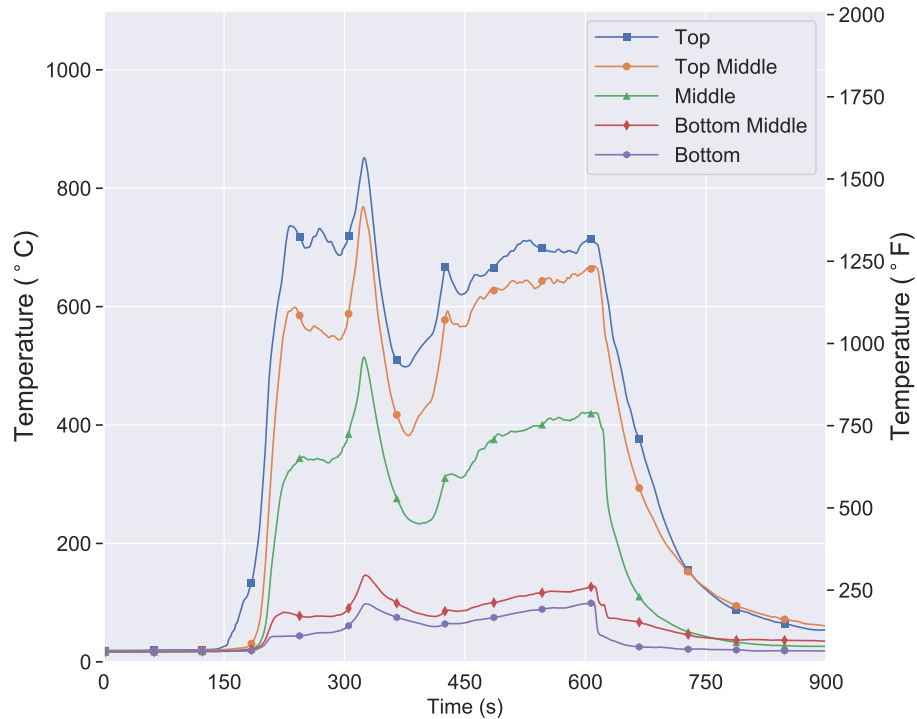
Figure 4.19 shows the temperature profile at the front door. Initially the doorway was in pure exhaust flow before returning to being a bi-directional vent, with flames and smoke exiting the upper half of the doorway and fresh air being entrained through the lower half. This is noticeable in the distinct group of temperatures between the upper half and the lower half of the doorway.

Figure 4.19: Experiment 4, front door open, front door temperature versus time.

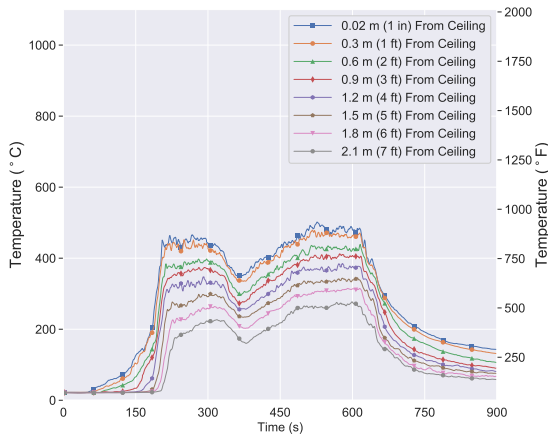
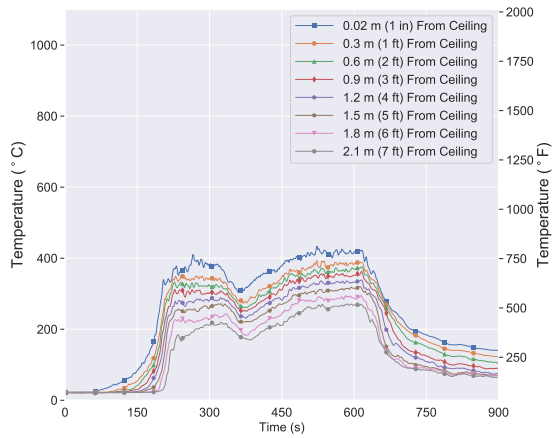
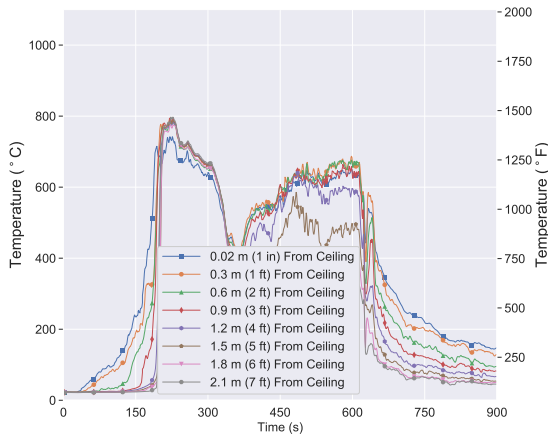
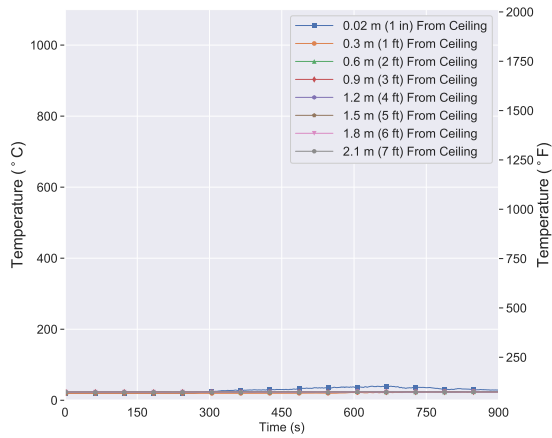
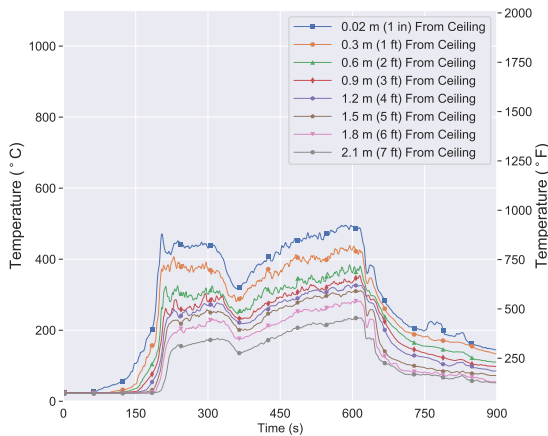
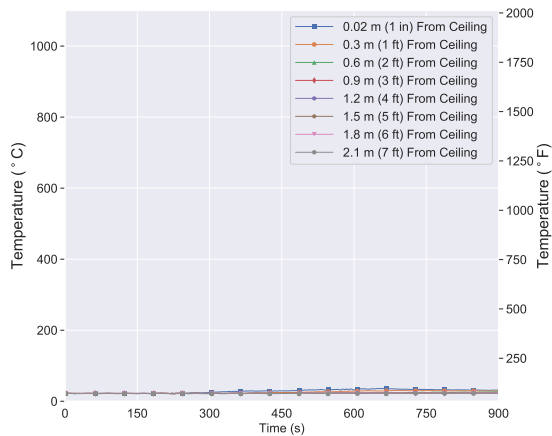
Figure 4.20 shows the temperature histories for the thermocouple array locations inside the single story structure. The dining room, kitchen, hallway, and bedroom 2 areas were open to the living room, and as a result the temperature trends follow those of the living room. The hallway thermocouple array was located the closest to the area of ignition while the bedroom 2, kitchen, and dining room thermocouples were further away. Being remote from the living room resulted in reduced peak temperatures. Only the hallway exceeded 600 °C (1112 °F) from ceiling down to the floor. The other rooms did not transition through flashover. The bedroom furniture in bedroom 2 did not ignite. The temperatures in the bedrooms with closed doors did not increase.

Figure 4.20: Experiment 4, front door open, time-temperature histories for all rooms.

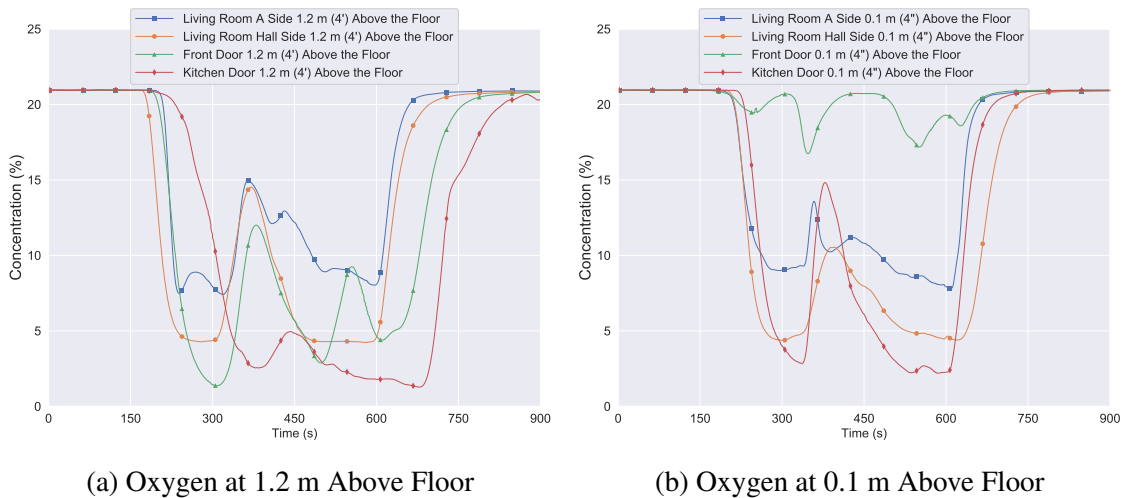
Figure 4.21 includes the time history of the eight oxygen meters. The sampling ports were positioned to surround the point of ignition. Four of the sampling ports were positioned at 1.2 m (4 ft) above the floor (see Figure 4.21a), and the other four were positioned under the upper sampling ports and 100 mm (4 in.) above the floor (see Figure 4.21b): two living room locations, one kitchen location, and a front door location. The four meters sampling from 1.2 m (4 ft) above the floor measured a decrease in oxygen as soon as the hot gas layer covered the sampling port. The oxygen meters measuring conditions to the right of the ignition sofa exhibited the earliest decrease at each level, which started at approximately 180 s and 200 s after ignition for the 1.2 m (4 ft) and the 100 mm (4 in.) sensors, respectively. Similar to Experiment 3 (see Figure 4.14) there was initial drop in oxygen at all sensor locations except for the front door 100 mm sensor. Oxygen within the structure began to rise at approximately 300 s, reaching a local maximum at 360 s. A second drop in oxygen concentration followed, with minimum values reached at approximately 500 s. The first minimum value in oxygen corresponds with the initial drop in temperature. A lack of oxygen in the structure limited combustion, and therefore temperatures decreased. As combustion products exited the structure through the top of open front door, oxygen returned through the bottom portion of the doorway as seen by the rise in oxygen reaching a local peak at approximately 360 s. At this point, oxygen returned to levels to support combustion. The result was a second spike in temperature and subsequent drop in oxygen.

Figure 4.21: Experiment 4, front door open, oxygen concentration versus time.

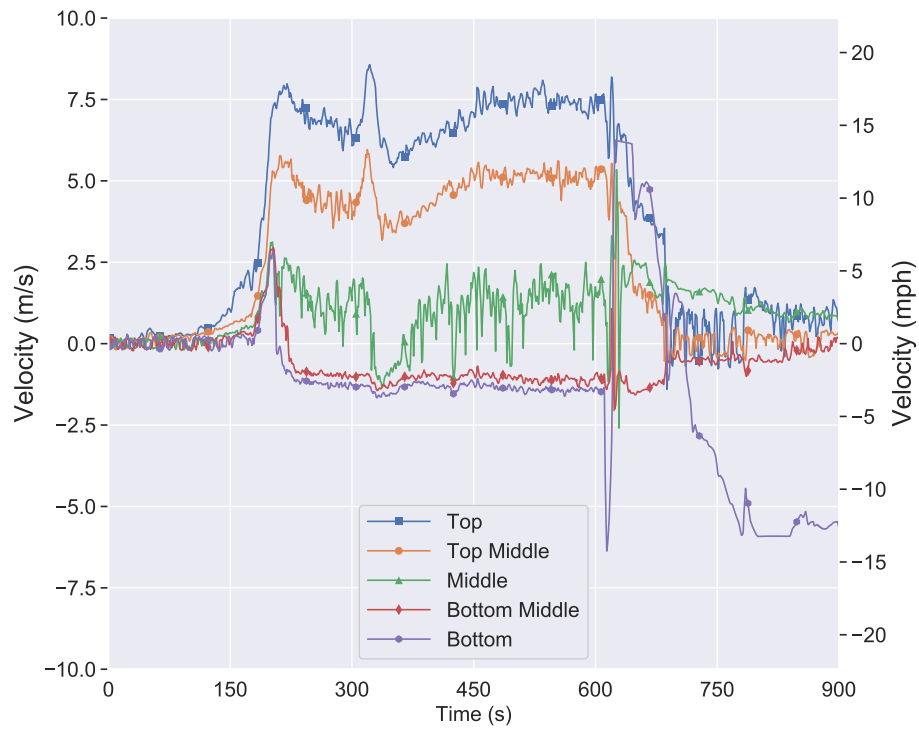
Figure 4.22: Experiment 4, front door open, front door velocity versus time.

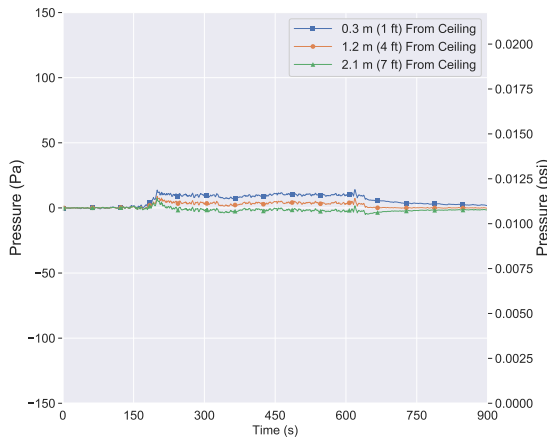
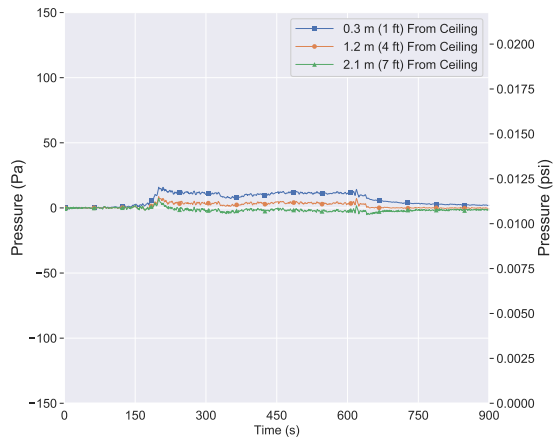
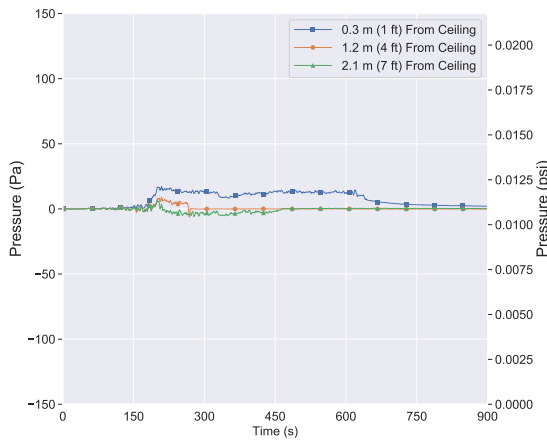
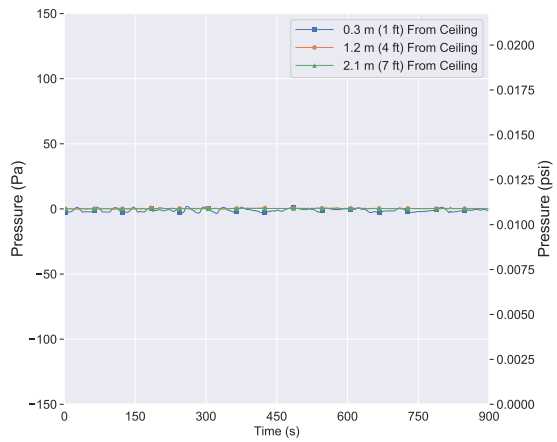
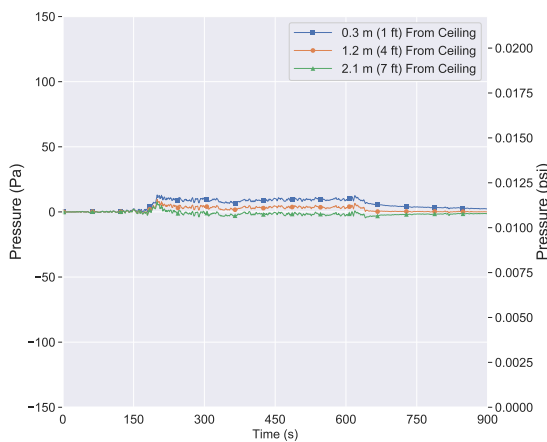
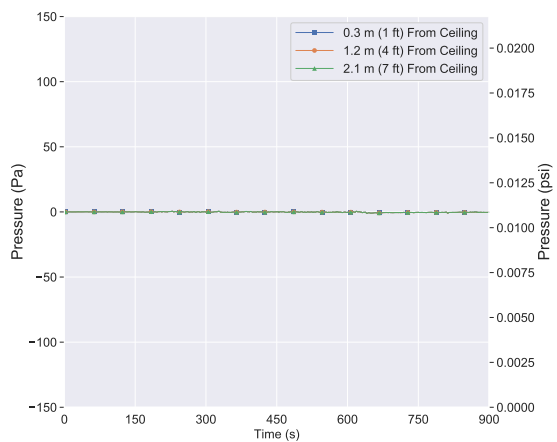
Figure 4.24 provides pressure time histories for all six rooms in the house. As the fire and the hot gas layer grew, the pressure levels throughout the structure increased. Unlike Experiments 1 and 2, pressures within the structure did not exceed 20 Pa because of the open front door. The rooms open to the living room had similar pressures. The two bedrooms with closed doors showed minimal pressure change.

Figure 4.24: Experiment 4, front door open, pressures in all rooms.

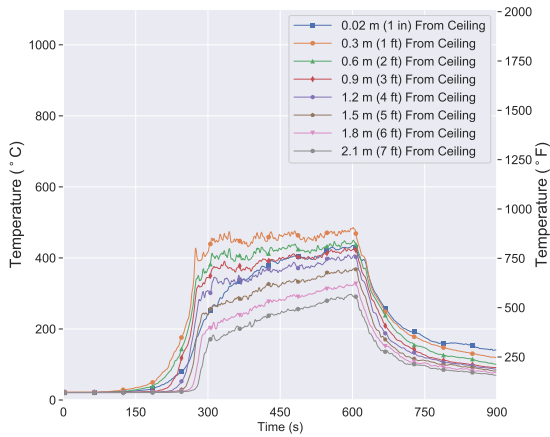
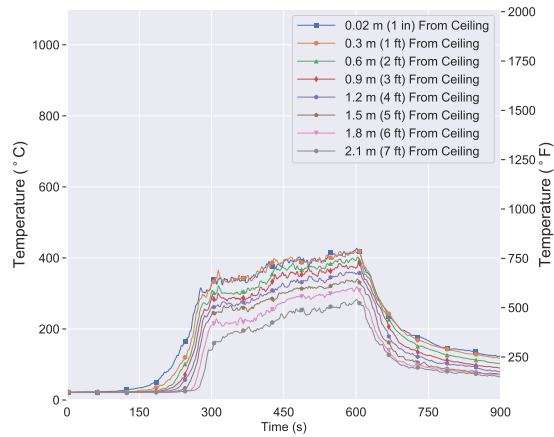
Figure 4.27 shows the temperature histories for the thermocouple array locations inside the single story structure. The dining room, kitchen, hallway, bedroom 2, and bedroom 3 areas were open to the living room, and as a result the temperature trends follow those of the living room. The hallway thermocouple array was located the closest to the area of ignition, while the bedroom 2, kitchen, and dining room thermocouples were further away. The hallway thermocouple array was also in a flow path because of the open bedroom window. Being remote from the living room resulted in reduced peak temperatures. The hallway exceeded 600 °C (1112 °F) from ceiling down to the floor, reflecting the living room. The open window in bedroom 3 eventually led to floor to ceiling temperatures to be 600 °C (1112 °F) as the bedding caught fire and flames exited the window. The other rooms did not transition through flashover. The bedroom furniture in bedroom 2 did not ignite. The temperatures in the bedrooms with closed doors did not increase.

Figure 4.27: Experiment 5, front door and bedroom 3 window open, temperature time histories for all rooms.

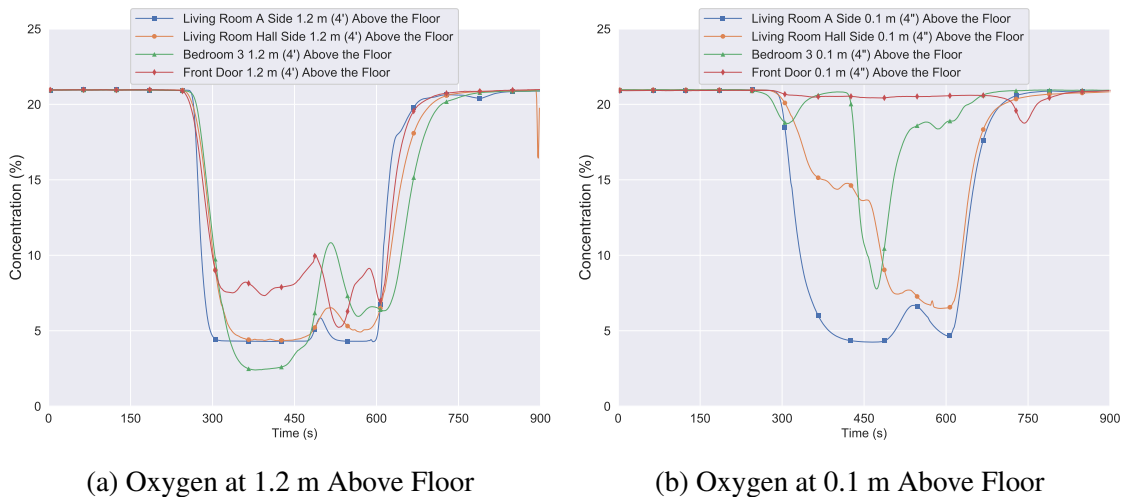
Figure 4.28 includes the time history of the eight oxygen meters. The sampling ports were positioned to surround the point of ignition. Four of the sampling ports were positioned at 1.2 m (4 ft) above the floor (see Figure 4.28a), and the other four were positioned under the upper sampling ports and 100 mm (4 in.) above the floor (see Figure 4.28b): two living room locations, a bedroom 3 location, and a front door location. The four meters sampling from 1.2 m (4 ft) above the floor measured a decrease in oxygen as soon as the hot gas layer covered the sampling port. The oxygen meters measuring conditions to the right of the ignition sofa exhibited the earliest decrease at each level, which started at approximately 260 s–270 s after ignition for the 1.2 m (4 ft) and the 100 mm (4 in.). Similar to Experiments 3 and 4, (see Figures 4.14 and 4.21) there was initial drop in oxygen at all sensor locations except for the front door 100 mm sensor. The oxygen at 100 mm in bedroom 3 had initial drop resulting from the surge of combustion products into the room (see initial spike in temperature in Figure 4.27f), a recovery, followed by a steep decay as a result of the contents igniting. The remainder of the oxygen sensors dropped and remained between 5%–10% until the fire was suppressed.

Figure 4.28: Experiment 5, front door and bedroom 3 window open, oxygen concentration versus time at 1.2 m and 0.1 m above floor.

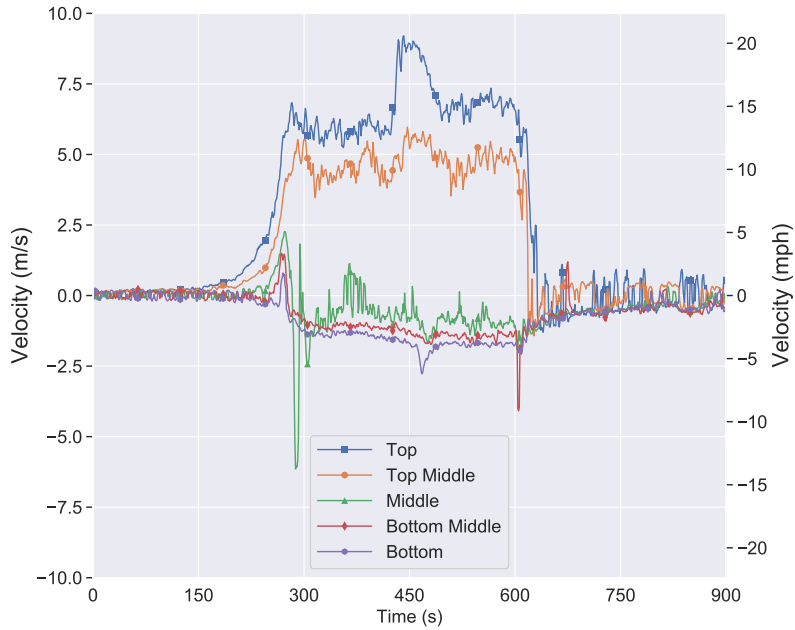
During the initial fire growth and subsequent temperature rise in the living room (see Figure 4.25), the velocity profile at the front door shows that the door was completely an exhaust vent (see 275 s in Figure 4.29). The velocity profile at the interior hallway (see Figure 4.30) at the same time shows the upper portion of the hallway flowing towards the bedrooms while the bottom probe indicates flow towards the fire. As the fire started to decay due to drop in oxygen concentration, the doorway velocity profile changed to a bi-directional flow with the bottom two probes indicating air flowed into the structure. The exhaust flow at the top of the front doorway was steady between 4.5 m/s (10 mph)–6 m/s (13 mph) for the top two probes, respectively.

Figure 4.29: Experiment 5, front door and bedroom 3 window open, front door velocity versus time.

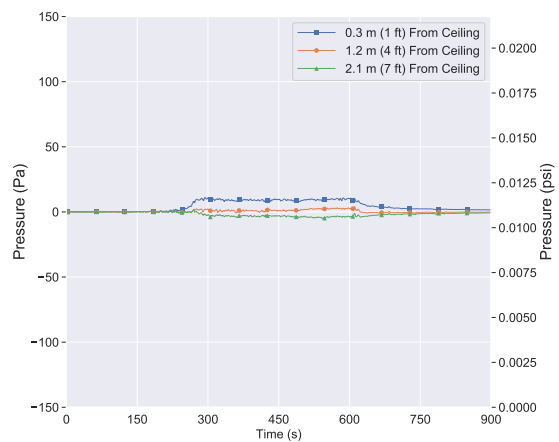
(f) Bedroom 3 Pressure

Figure 4.32 provides pressure time histories for all six rooms in the house. As the fire and the hot gas layer grew, the pressure levels throughout the structure increased. Unlike Experiments 1 and 2, pressures within the structure did not exceed 20 Pa because of the open front door. The rooms open to the living room had similar pressures. The two bedrooms with closed doors showed minimal pressure change.

Figure 4.32: Experiment 5, front door and bedroom 3 window open, pressures in all rooms

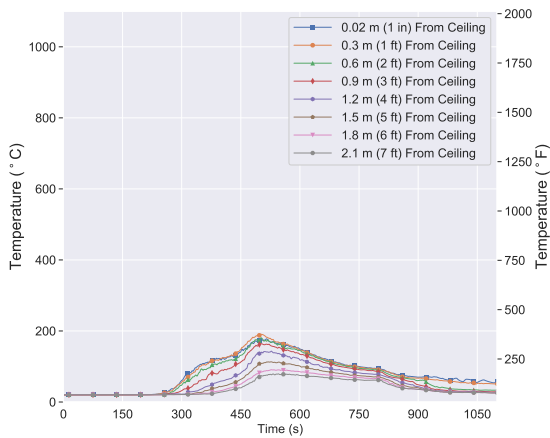
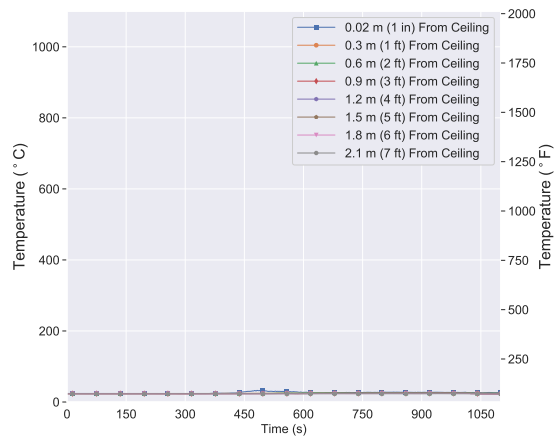
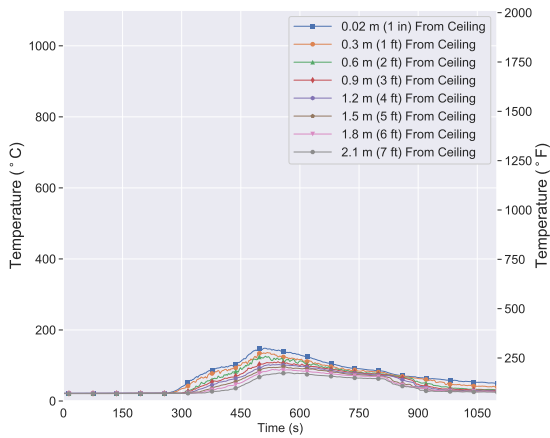
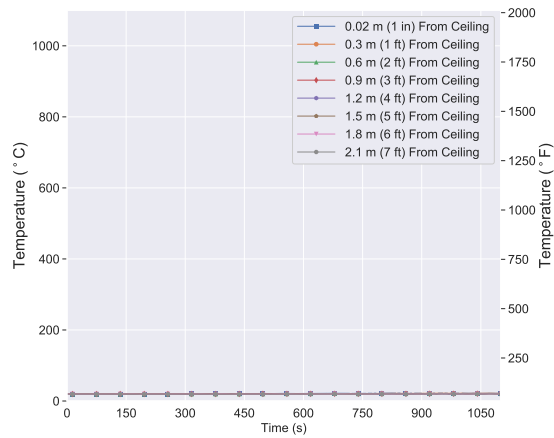
Figure 4.34: Experiment 6, no exterior ventilation openings, temperature time histories for all rooms.

Figure 4.34 shows the temperature histories for the thermocouple array locations inside the single story structure. The dining room, living room, hallway, and bedroom 2 areas were open to the kitchen, and as a result the temperature trends follow those of the kitchen. The breakfast area (see Figure 4.33 bottom) and dining room thermocouple array (see Figure 4.34a) were the two closest arrays to the area of ignition while the bedroom 2, living room, and hallway thermocouples were further away. Being remote from the kitchen resulted in reduced peak temperatures. The breakfast area temperature, which was closest to the kitchen ignition, reached approximately 300 °C (572 °F) at ceiling with cooler temperatures closer to the floor. The temperatures in the bedrooms with closed doors did not increase.
