# Impact of Fixed Ventilation on Fire Damage Patterns in Full-Scale Structures

Daniel Madrzykowski  
Craig Weinschenk

UL Firefighter Safety Research Institute  
Columbia, MD 21045

April 18, 2019

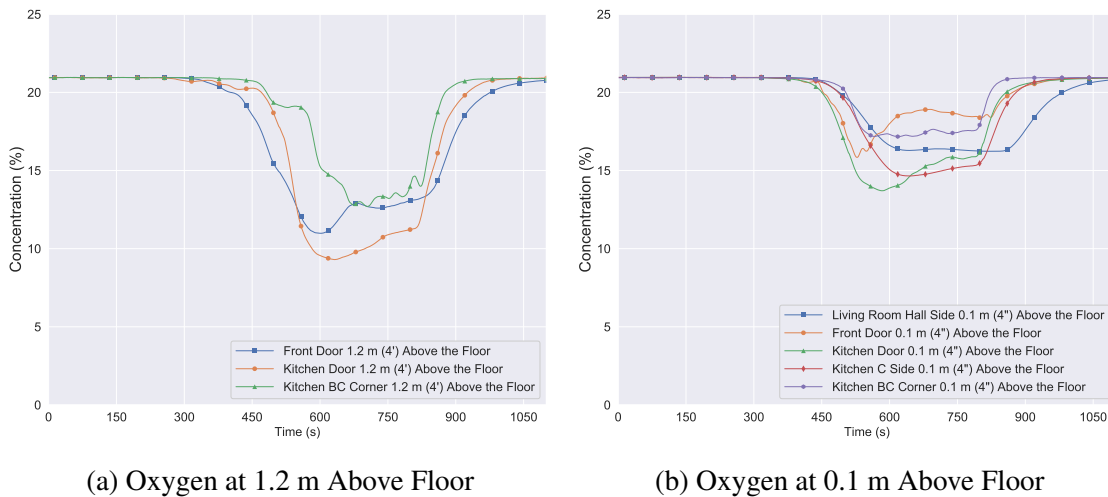
Figure 4.35: Experiment 6, no exterior ventilation openings, oxygen concentration versus time at 1.2 m and 0.1 m above the floor.

Figure 4.35 includes the time history of the eight oxygen meters. The sampling ports were positioned to surround the ignition within the kitchen as well to include locations in the living room and front door. Three of the sampling ports were positioned at 1.2 m (4 ft) above the floor (see Figure 4.35a), and the other five were positioned 100 mm (4 in.) above the floor (see Figure 4.35b). The four meter sampling from 1.2 m (4 ft) above the floor measured a decrease in oxygen as soon as the hot gas layer covered the sampling port.

The oxygen meters measuring conditions at the 1.2 m (4 ft) level started to decrease at 300 s with the most distinct drop in oxygen concentration in the kitchen and at the front door occurring at approximately 450 s. The oxygen meters that measured gases sampled at 1.2 m (4 ft) above the floor had minimum oxygen concentrations between 9.3%–12.7%. The oxygen meters that measured gases sampled at 100 mm (4 in.) had minimum oxygen concentrations of 13.7% or greater. The elevated fuel (0.9 m (3 ft) height) of the kitchen fire and low oxygen concentrations at the 1.2 m (4 ft) level combined with the closed front door closed resulted in a fire that self-extinguished.

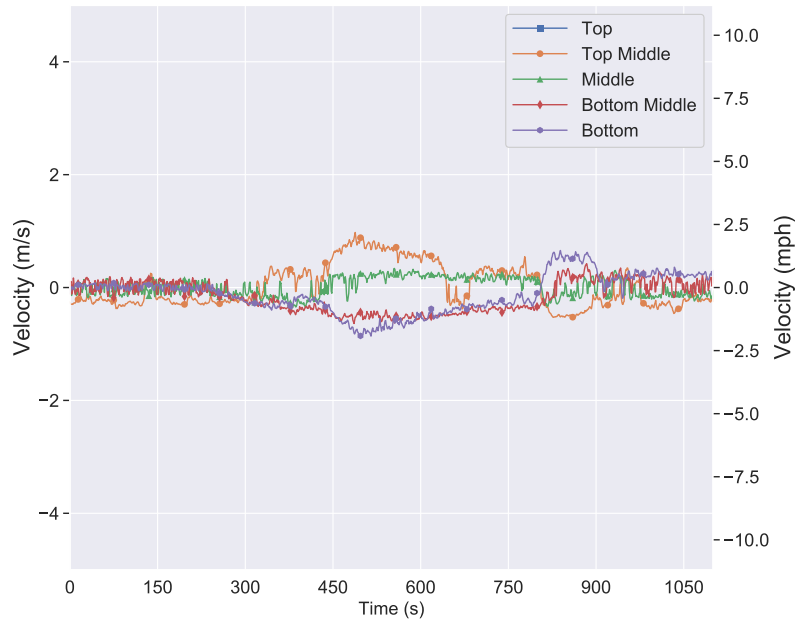
Figure 4.36: Experiment 6, no exterior ventilation openings, hallway velocity versus time. Positive pressure flowing from kitchen/living room to bedroom 2.

Figure 4.36 shows the velocities from the measurement array in the hallway. The velocities provide some insight into the gas flow circulation into and out of bedroom 2. The gases flowing into the bedroom are shown with a positive velocity, and gases out of the bedroom are shown with a negative velocity. When the fire was near its peak burning rate, more than the top half of the hallway had gases exhausting into the bedroom room at velocities of about 1 m/s (2.2 mph). At the same time, denser, cooler, gases were flowing into the bottom of the living room at about 1 m/s (2.2 mph). As the fire decreased in size, the exhaust gases began to slow. The middle of the hallway had a flow of roughly 0.2 m/s (0.5 mph). Note: The top velocity probe failed during this experiment.

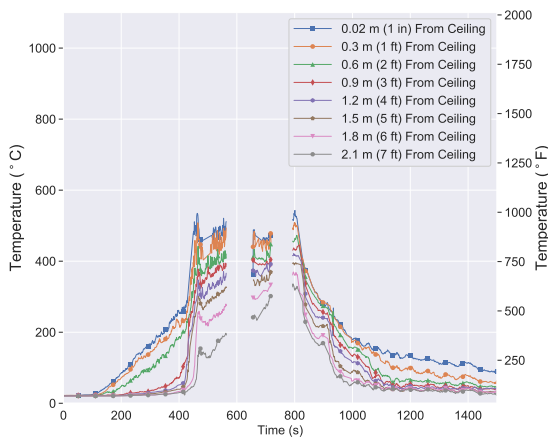
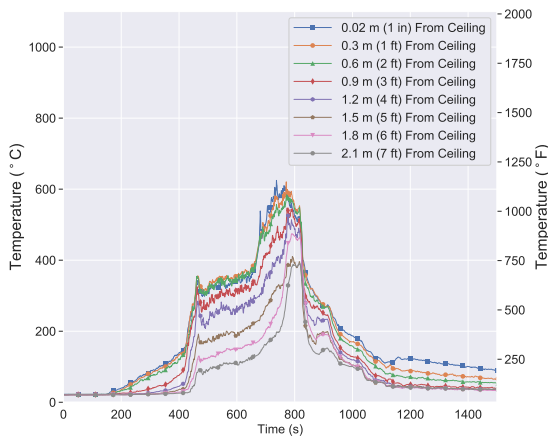
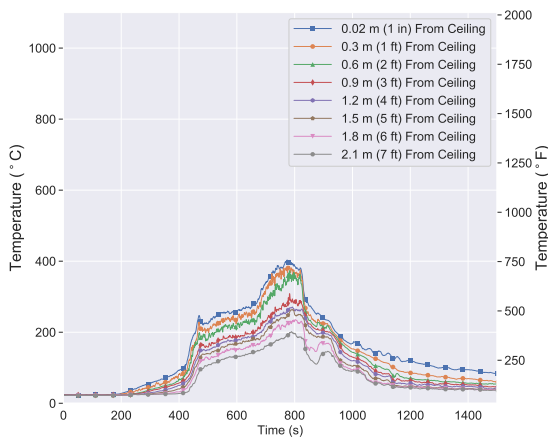
Figure 4.46: Experiment 10, front door open, temperature time histories for all rooms.

Figure 4.46 shows the temperature histories for the thermocouple array locations inside the single story structure. The dining room, living room, hallway, and bedroom 2 areas were open to the kitchen/breakfast area, and as a result the temperature trends follow those of the breakfast area. The living room (see Figure 4.46b) was between the kitchen (ignition) and the open front door (ventilation) and was the only room to have temperatures floor to ceiling in excess of 600 °C (1112 °F).

The remaining rooms open to kitchen (i.e., the dining room, hallway, and bedroom 2) showed similar temperature profiles, with less severe peaks as they were more remote from the ignition room. Note that in the dining room, there were two points in time where the thermocouple data was lost during the experiment. The temperatures in the bedrooms with closed doors did not increase.

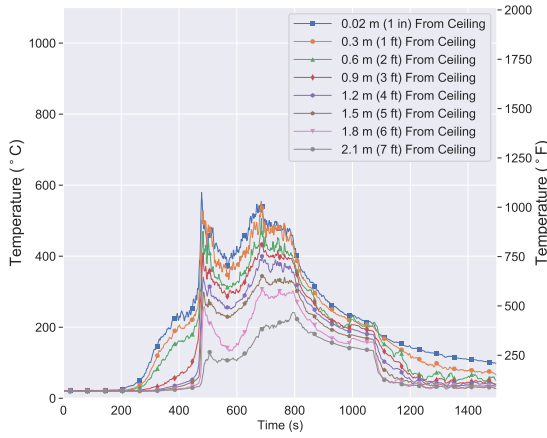
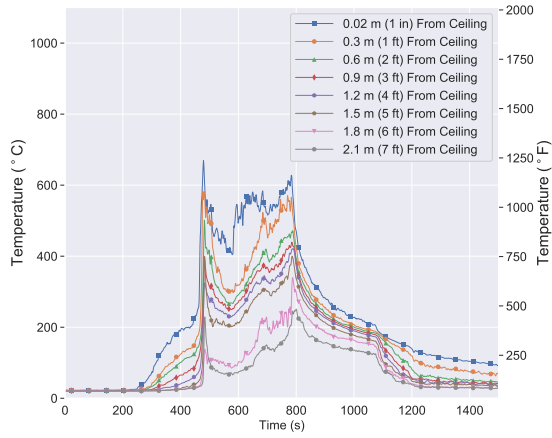
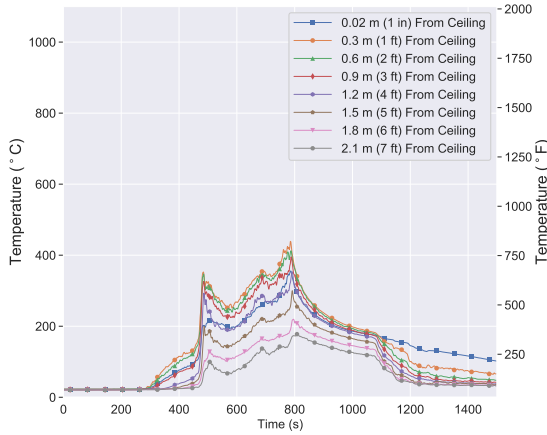
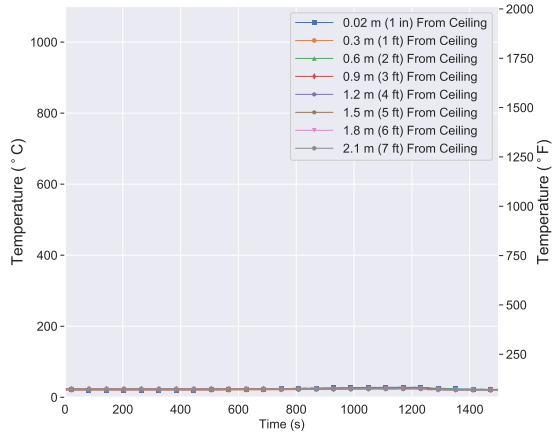
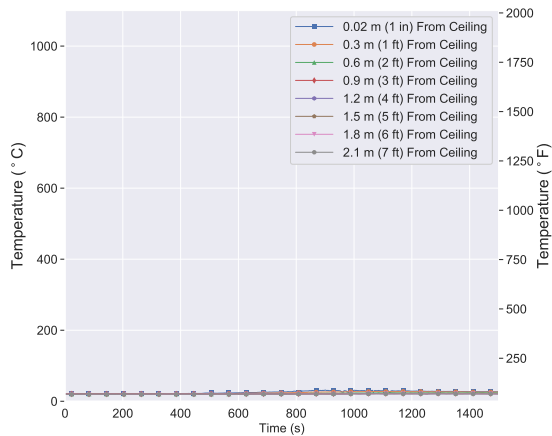
Figure 4.52: Experiment 11, front door open, temperature time histories for all rooms.

Figure 4.52 shows the temperature histories for the thermocouple array locations inside the single story structure. The dining room, living room, hallway, and bedroom 2 areas were open to the kitchen/breakfast area, and as a result the temperature trends follow those of the breakfast area. The living room (Figure 4.52b) was between the kitchen (ignition) and the open front door (ventilation), and while temperatures approached 600 °C (1112 °F) from floor to ceiling (an indication of a transition to flashover), the front door closure at 785 s post ignition resulted in a drop in temperature. The remaining rooms open to kitchen (i.e., the dining room, hallway, and bedroom 2) showed similar temperature profiles, with less severe peaks as they were more remote from the ignition room. The temperatures in the bedrooms with closed doors did not increase.

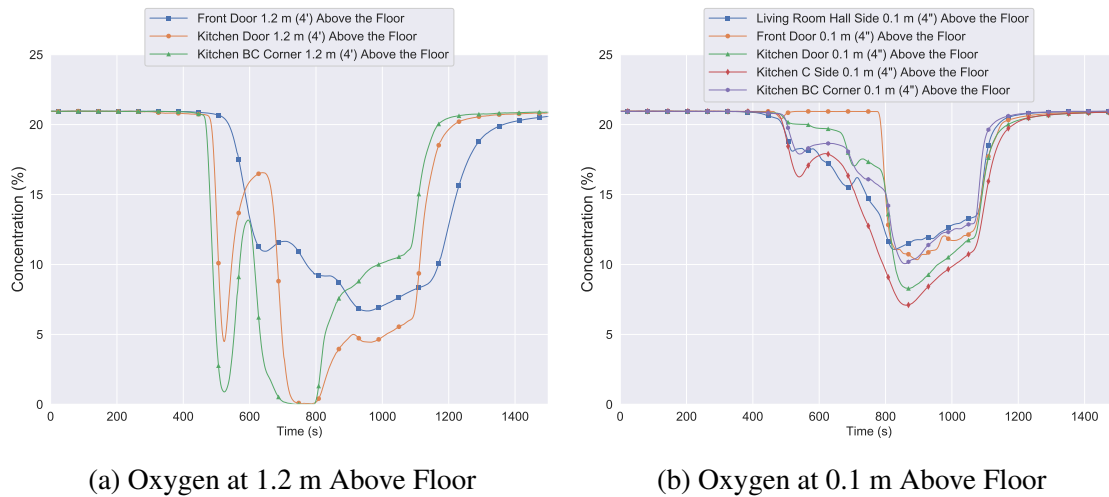
Figure 4.53: Experiment 11, front door open, oxygen concentration versus time at 1.2 m (top) and 0.1 m (bottom) above the floor

Figure 4.53 includes the time history of the eight oxygen meters. The sampling ports were positioned to surround the ignition within the kitchen and to include locations in the living room and front door. Three of the sampling ports were positioned at 1.2 m (4 ft) above the floor (see Figure 4.53a), and the other five were positioned 100 mm (4 in.) above the floor (see Figure 4.53a). The four meter sampling from 1.2 m (4 ft) above the floor measured a decrease in oxygen as soon as the hot gas layer covered the sampling port.

The oxygen meters measuring conditions at the 1.2 m (4 ft) level dropped precipitously at approximately 460 s post ignition. The oxygen concentrations in the kitchen dropped to near 0% oxygen at the 1.2 m level. This confirms the earlier discussion that the smoke layer had dropped to 0.3 m (1 ft off the floor). At approximately 530 s, the oxygen concentrations recovered to between 13% and 16% as the fire decayed in the kitchen. The influx of oxygen led to the fire regrowth, the rise in temperatures through the structure, and subsequent oxygen decay. The 1.2 m (4 ft) sensor at the doorway dropped slower than the kitchen sensors and reflects the observed behavior of the layer height at the doorway. The oxygen eventually dropped as low as 6.6% following the front door closure. The oxygen sensors at the 100 mm (4 in.) height, except for the front door probe, started to decrease at the same time at the 1.2 m (4 ft) level, but decreased at a much slower rate. It was not until the front door closed at 785 s that the sharp drop occurred in all measurements at the 100 m (4 in.) level.

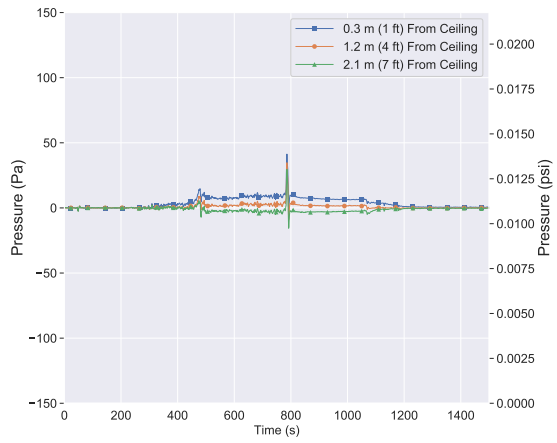
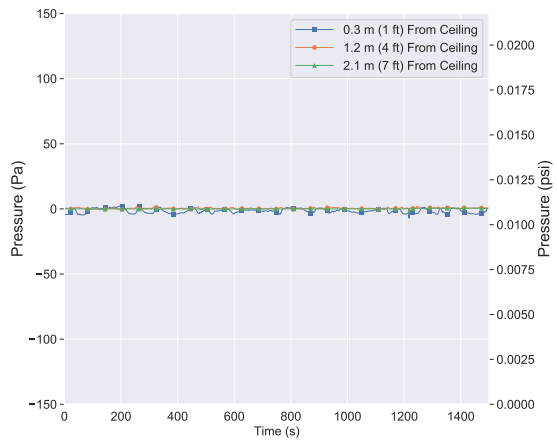
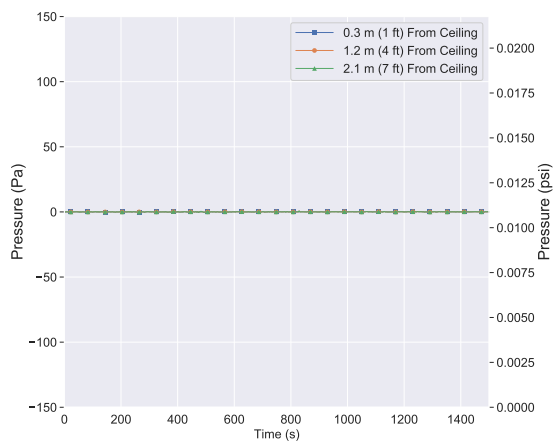
Figure 4.55: Experiment 11, front door open, pressures in all rooms.

Figure 4.55 provides pressure time histories for all six rooms in the house. As the fire and the hot gas layer grew, the pressure levels throughout the structure increased. For the kitchen and rooms open to the kitchen (i.e., the dining room, living room, and bedroom 2), pressures peaked around 10 Pa due to the open front door. The two bedrooms with closed doors showed no noticeable pressure change. The spike in the open rooms occurred as a result of the overpressure due to the front door getting closed.

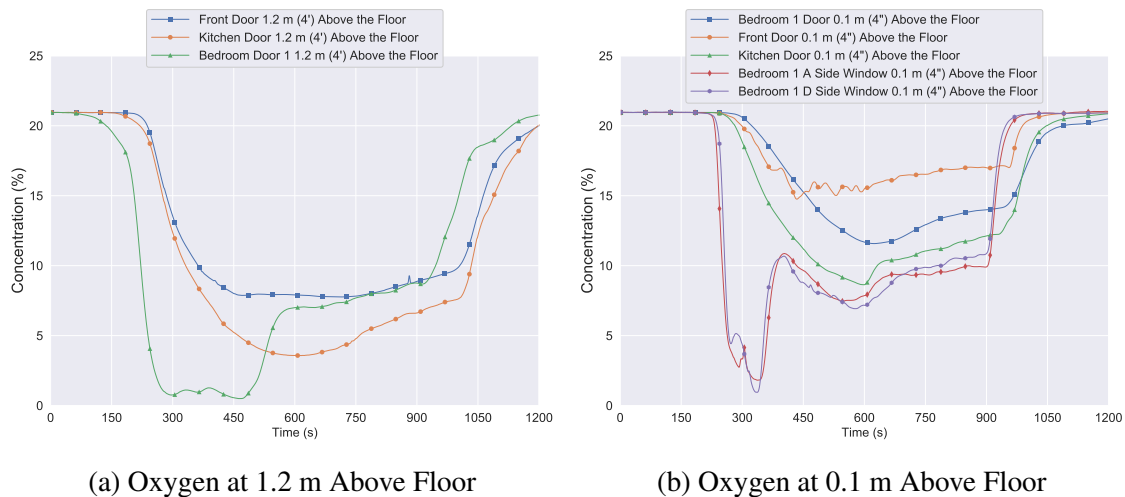
Figure 4.58: Experiment 7, no exterior ventilation openings, oxygen concentration versus time at 1.2 m (top) and 0.1 m (bottom) above the floor.

Figure 4.58 shows the oxygen concentrations at different locations in the structure at two different elevations: 1.2 m (4 ft) above the floor and 0.1 m (4 in) above the floor. The top graph has three 1.2 m (4 ft) positions, one located just inside the bedroom 1 doorway, another in the doorway from the living room to the kitchen, and one adjacent to the closed front door. The oxygen level inside the bedroom decreased to near zero at about the time of peak temperatures. The oxygen concentrations at the other two locations decreased below 15% just as the temperatures in the bedroom had begun to decrease, which correlated with the observation that the fire size had also decreased.

In addition to three locations listed for the 1.2 m (4 ft) positions, five additional sample probes were added at the 0.1 m (4 in) above the floor level. Three oxygen sample probes were located in bedroom 1, one below each window and one at the doorway. The two probes near the floor below the windows in bedroom 1 exhibited the lowest oxygen concentrations. This would denote the area of flaming combustion in the room. The lower oxygen probe near the open bedroom door remained above 20% while the fire in the bedroom was growing and oxygen from the rest of the structure was drawn toward the fire room. As smoke was pushed into the adjoining open areas of the structure, the oxygen concentration in the room decreased faster than the bedroom doorway location. The oxygen levels in the bedroom decreased below 15% and remained there until after ventilation was started. The fire self-extinguished due to a lack of oxygen.

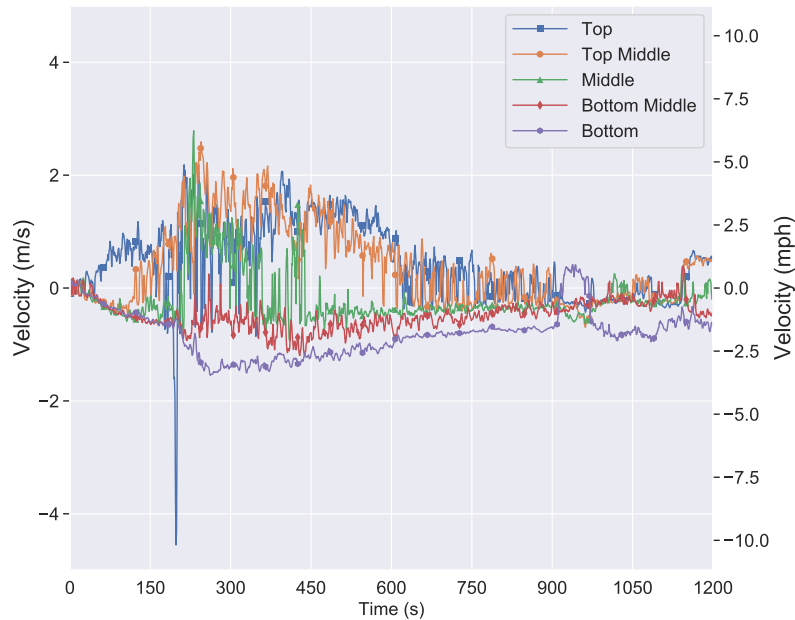
Figure 4.59: Experiment 7, no exterior ventilation openings, hallway velocity versus time. Positive velocity flowing from bedroom to living room.

The velocity array in the hallway provided some insight on the gas flow circulation into and out of bedroom 1. Figure 4.59 shows the gases flowing out of the bedroom with a positive velocity and gases flowing into the bedroom with a negative velocity. When the fire was near its peak burning rate, more than the top half of the doorway had gases exhausting into the hallway at velocities of about 2 m/s (4.4 mph). At the same time, denser, cooler, gases were flowing into the bottom of the doorway at about 1 m/s (2.2 mph). As the fire decreased in size, the exhaust gases began to slow. Exhaust flow was reduced to only the upper third of the hallway. The remainder of the hallway elevation served as a supply of cooler gases. It would appear, based on the hallway velocities, the

oxygen concentrations, and the rate of temperature decrease, that flaming combustion had ceased just prior to 10 min after ignition.

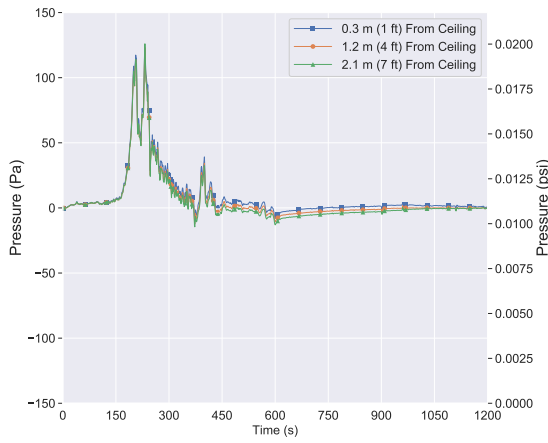
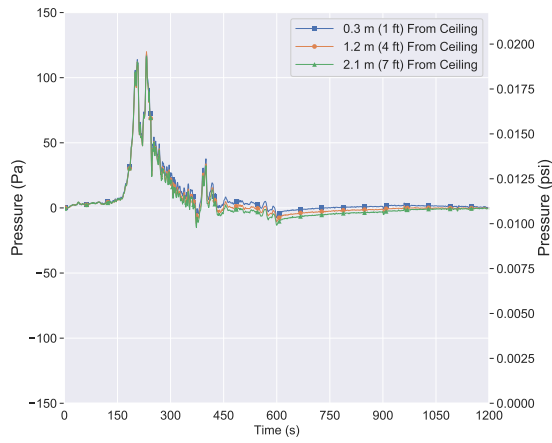
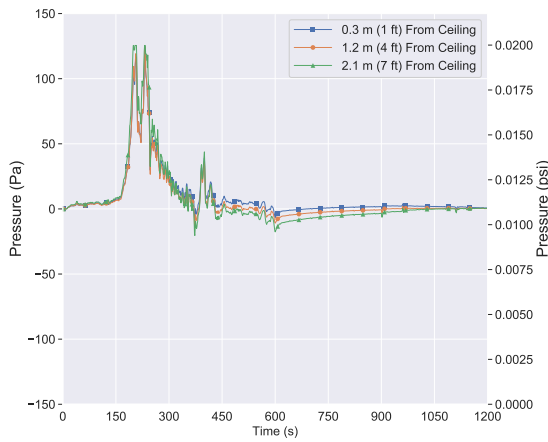
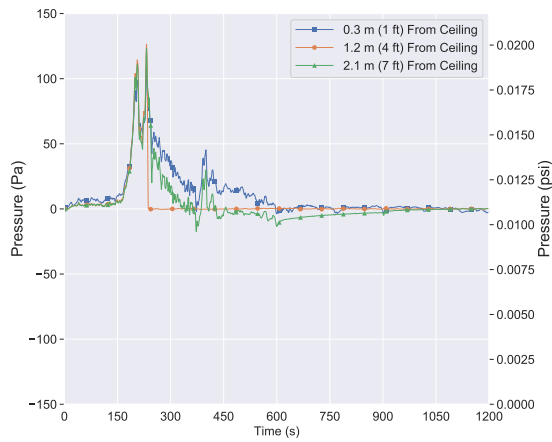
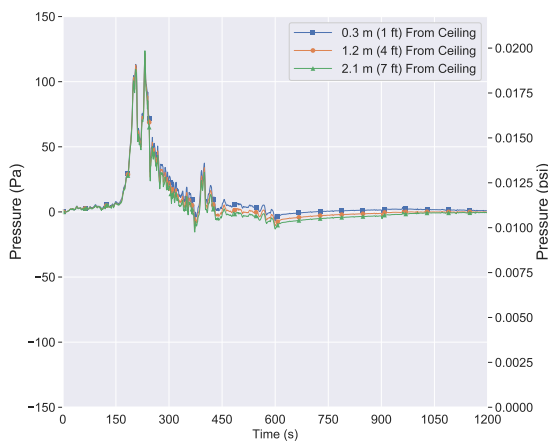
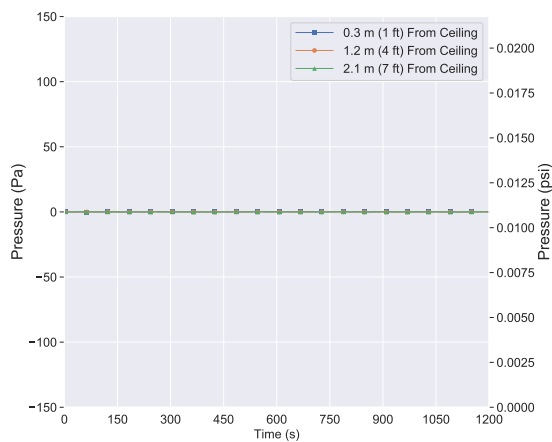
Figure 4.60: Experiment 7, no exterior ventilation openings, pressures versus time in all rooms.

Pressures inside the structure at locations open to the fire room were similar, as shown in Figure 4.60. Pressures near the ceiling were slightly higher than the pressures near the floor, which accounts for the convective circulation in and out of bedroom 1. Bedroom 3, which was closed off from the rest of the structure, did not have a noticeable change in pressure. Note that the 1.2 m (4 ft) below the ceiling pressure sensor in bedroom 1 failed as the fire started to enter the decay stage (Figure 4.60d).

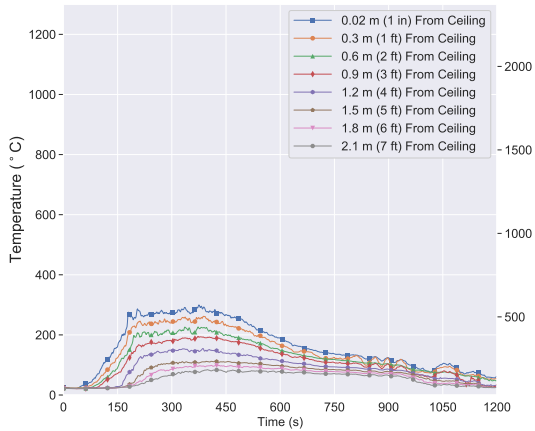
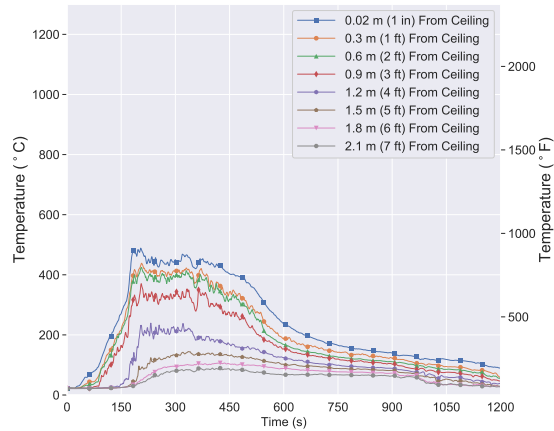
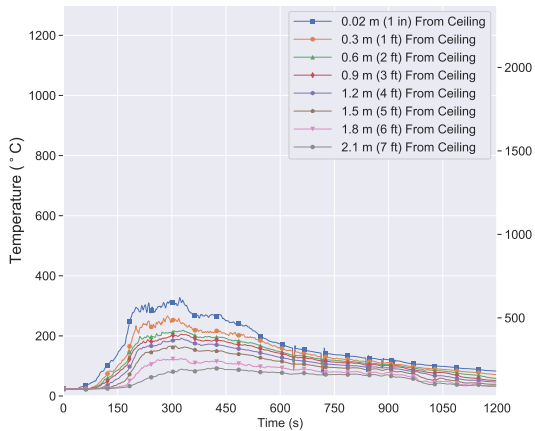
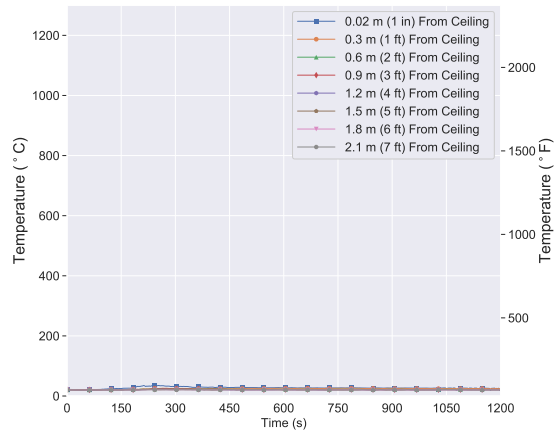
Figure 4.62: Experiment 9, no exterior ventilation openings, temperature time histories for all rooms.

The temperature data from the other thermocouple arrays in the structure appear in Figure 4.62. Again, the thermocouple array (see Figure 4.62c) located closest to bedroom 1 had the highest temperatures, and the temperatures decreased as the distance from bedroom 1 increased. Based on the temperatures, the flames from bedroom 1 did not extend down the hallway to the thermocouple array location. Bedroom 3 was closed, which resulted in a negligible increase in temperature.

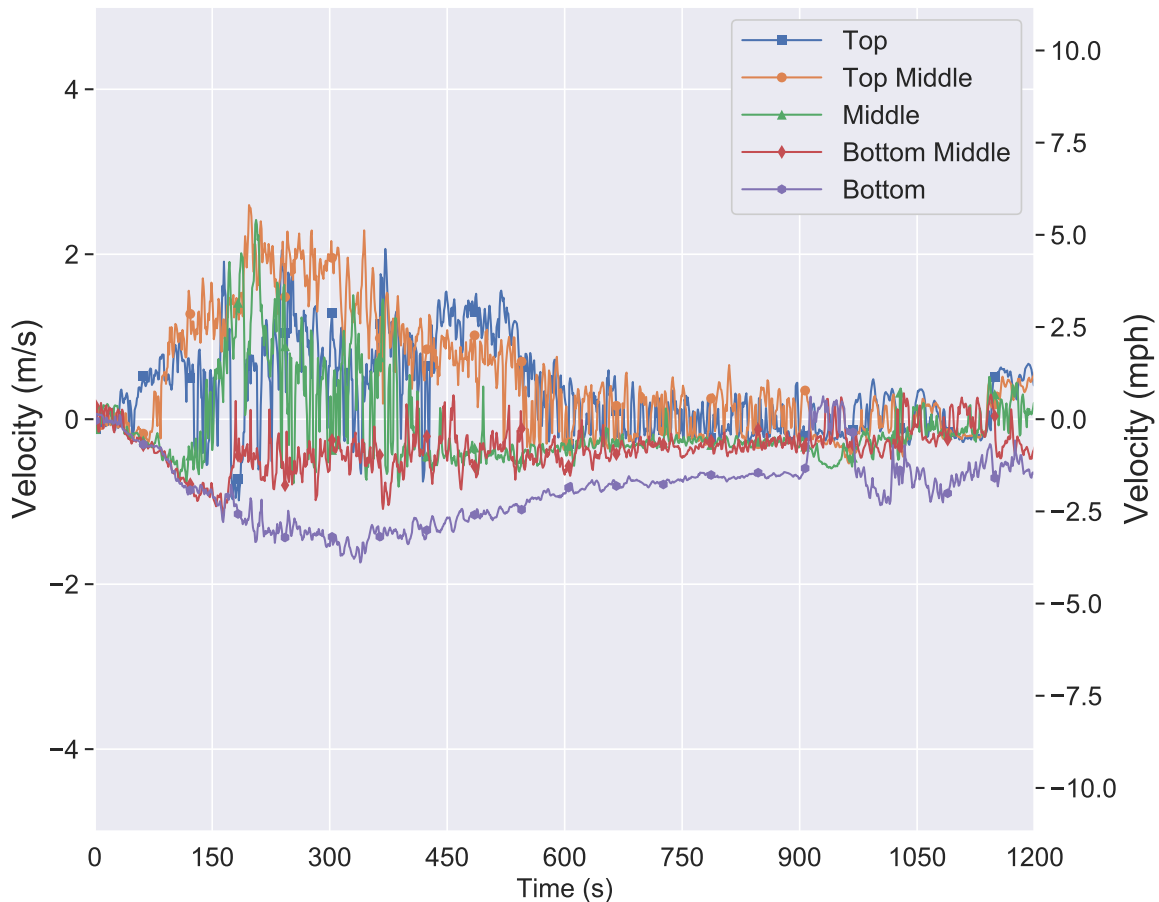
Figure 4.64: Experiment 9, no exterior ventilation openings, hallway velocity versus time. Positive velocity flowing from bedroom to living room.

The hallway velocity array measured the gas circulation into and out of bedroom 1 (Figure 4.64). The gases flowing away from the bedroom show a positive velocity, and gases flowing toward the bedroom show a negative velocity. When the fire was near its peak burning rate, more than the top half of the doorway had gases exhausting into the hallway at velocities of about 2 m/s (4.4 mph). At the same time, denser, cooler, gases were flowing into the bottom of the doorway at about 1.5 m/s (3.3 mph). As the energy generated by the fire decreased, the exhaust gases began to slow, and they only flowed out from the upper third of the hallway. The rest of the hallway cross-section served as an supply of cooler gases to the bedroom. It would appear, based on the hallway velocities, the oxygen concentrations and the rate of temperature decrease, that most of the flaming combustion had stopped around 6 min after ignition.

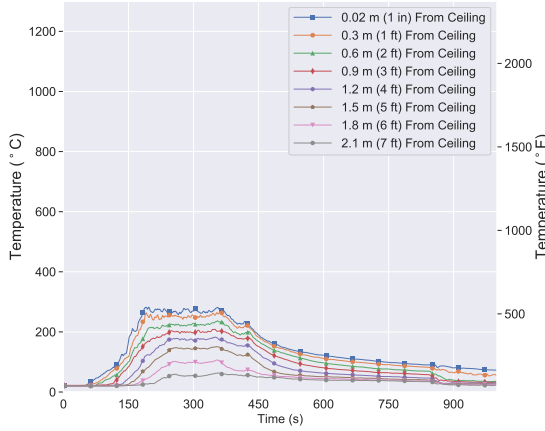
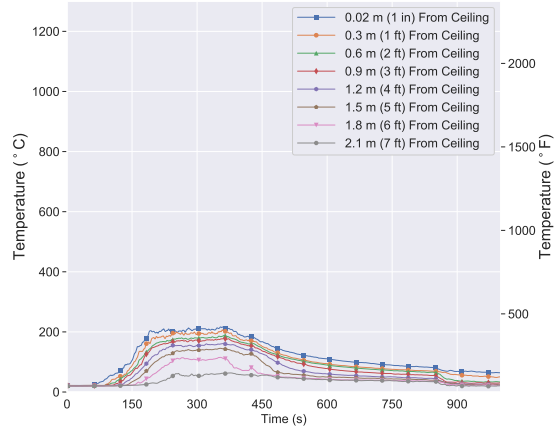
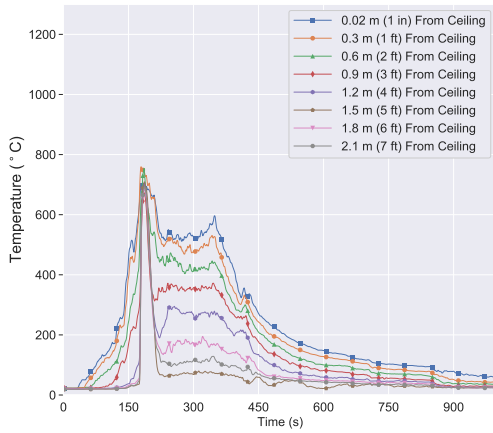
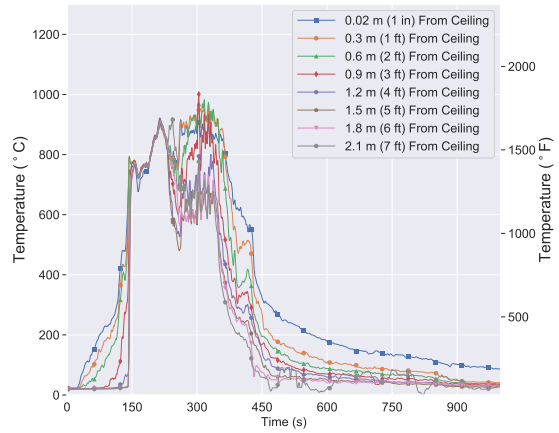
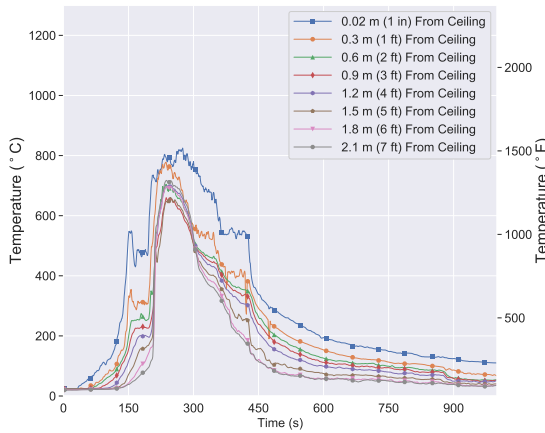
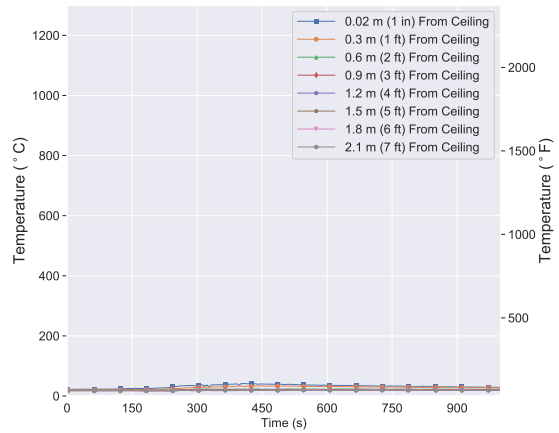
Figure 4.67: Experiment 12, front door and bedroom 1 windows open, temperature time histories for all rooms.

The temperature data from the other thermocouple arrays in the structure are presented in Figure 4.67. The hallway (see Figure 4.67c) and living room (see Figure 4.67b) thermocouple arrays were located in the flow path between bedroom 1 and the front door, and therefore had the highest temperatures of the open adjacent spaces. The hallway area temperatures exceeded 600 °C (1112 °F) from floor to ceiling approximately 150 s after ignition and remained at that level until the temperatures re-stratified 90 s later, an indication of flashover. At approximately 180 s after ignition, the living room temperature rapidly grew to have floor to ceiling temperatures in excess of 600 °C (1112 °F) for about 5 s before rapidly decreasing and stratifying. This corresponds with the video evidence of flames traveling down the hallway toward the front door. As the distance between the fire room and the thermocouple array increased, the peak temperatures decreased. Bedroom 2 also saw a significant rise in temperature due to its open door's proximity to bedroom 1, but not as severe as the hallway because of the lack of oxygen flow to the room. Bedroom 3 was closed, which resulted in a negligible increase in temperature.

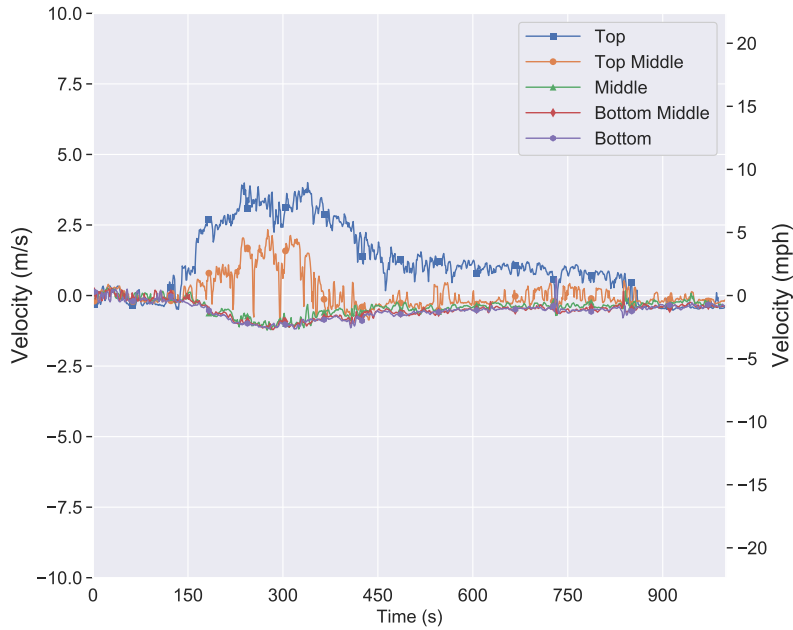
Figure 4.69: Experiment 12, front door and bedroom 1 windows open, front door velocity versus time.

The velocity profile at the front door (see Figure 4.69) confirms the visual observations that the top portion of the doorway was primarily exhaust. The smoke layer did not descend beyond the hallway mark of the doorway as the velocity profile remained an intake from 120 s after ignition until suppression.

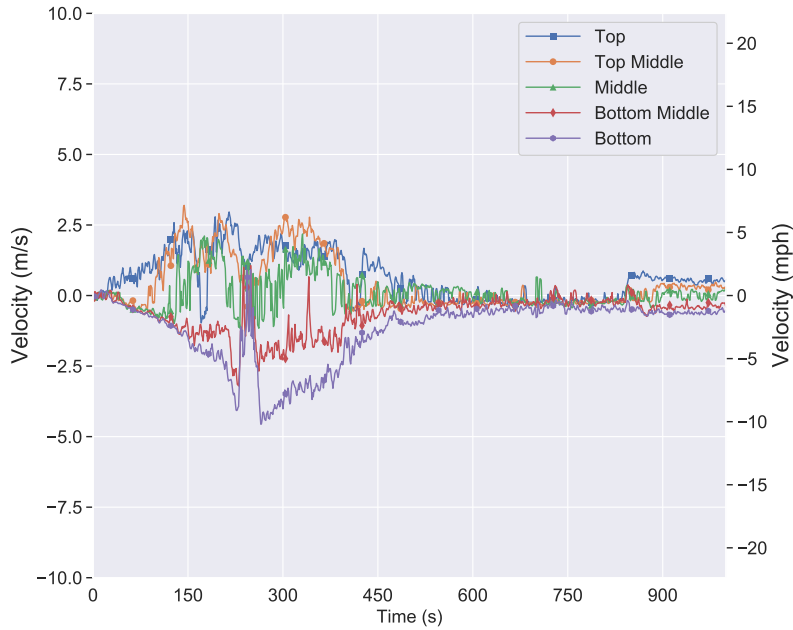
Figure 4.70: Experiment 12, Front door and bedroom 1 windows open, hallway velocity versus time. Positive pressure flowing from bedroom to living room.

The velocity array in the hallway measured the gas flow circulation into and out of bedroom 1. Figure 4.70 shows the gases flowing out of the bedroom with a positive velocity and gases flowing into the bedroom with a negative velocity. When the fire was near its peak burning rate, more than the top half of the doorway had gases exhausting into the hallway at velocities of about 2.5 m/s (5.6 mph). At the same time, denser, cooler gases were flowing into the bottom of the doorway at a peak of about 4.5 m/s (9 mph). After fire suppression, the fire decreased in size and exhaust gases slowed. The short period of time when the entrainment was overcome coincides with the ignition of the hallway carpet.

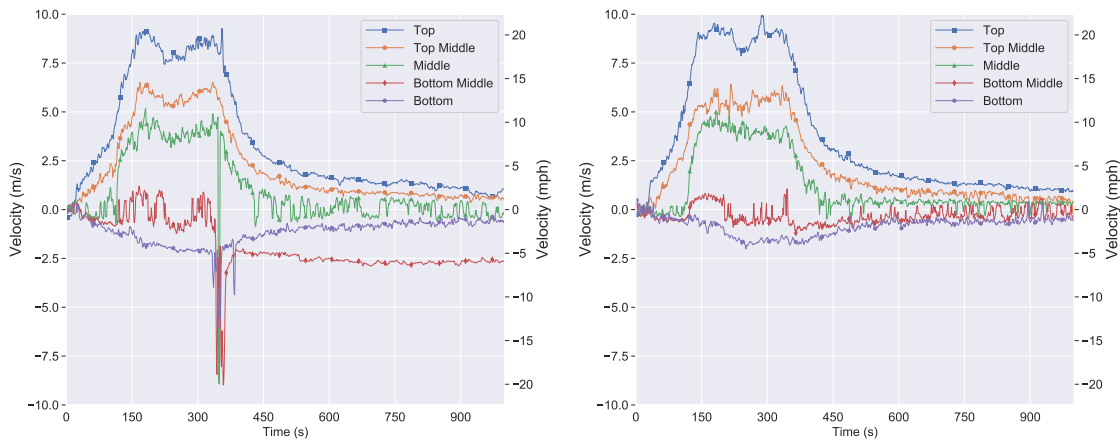
(a) Bedroom 1 Side A Window

(b) Bedroom 1 Side D Window

Figure 4.71: Experiment 12, front door and bedroom 1 windows open, bedroom 1 windows, velocity versus time. Positive velocity is flow leaving the structure.

The open windows in the fire room had similar velocity profiles, as shown in Figure 4.71. The top half of each window was in exhaust with upper probe velocities greater than 9 m/s (20 mph) and middle window velocities of approximately 4.4 m/s (9.8 mph). The bottom probe was the only probe that was an inlet, peaking around 2.3 m/s (5 mph). The probe labeled “middle bottom” in Figure 4.71 was the inflection point that fluctuated between being in inlet or outlet.

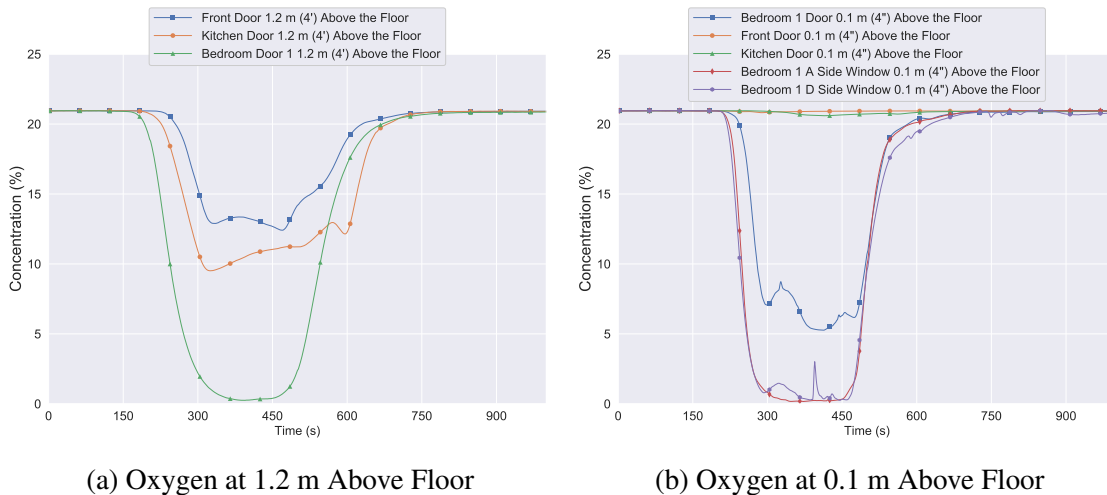
Figure 4.75: Experiment 13, front door and bedroom 1 windows open, oxygen concentration versus time at 1.2 m (top) and 0.1 m (bottom) above the floor.

Figure 4.75 shows the oxygen concentrations at different locations in the structure at two different elevations, 1.2 m (4 ft) above the floor and 0.1 m (4 in) above the floor. The top graph shows three 1.2 m (4 ft) positions, one located just inside the bedroom 1 doorway, another in the doorway from the living room to the kitchen, and one adjacent to the closed front door. The oxygen level inside the bedroom decreased to zero at about the time of peak temperatures. The oxygen concentrations at the other two locations decreased to between 10% to 15% just as the temperatures in the bedroom had begun to decrease, which correlated with the observation that the fire size had also decreased.

In addition to three locations listed for the 1.2 m (4 ft) positions, five additional sample probes were added at the 0.1 m (4 in) above the floor level. Three oxygen sample probes were located in bedroom 1, one below each window and one at the doorway. The two probes near the floor below the windows in bedroom 1 exhibited the lowest oxygen concentrations, dropping to near 0%. The lower oxygen probe near the open bedroom door remained slightly higher, dropping to 5% while the fire in the bedroom was growing and oxygen from the rest of the structure was drawn toward the fire room. As smoke was pushed into the adjoining open areas of the structure, the oxygen concentration in the room decreased more than the bedroom doorway location. The oxygen levels in the kitchen and front door stayed above 20%, indicating the smoke layer did not descend below the 0.1 m (4 in) level in remote rooms within the structure.

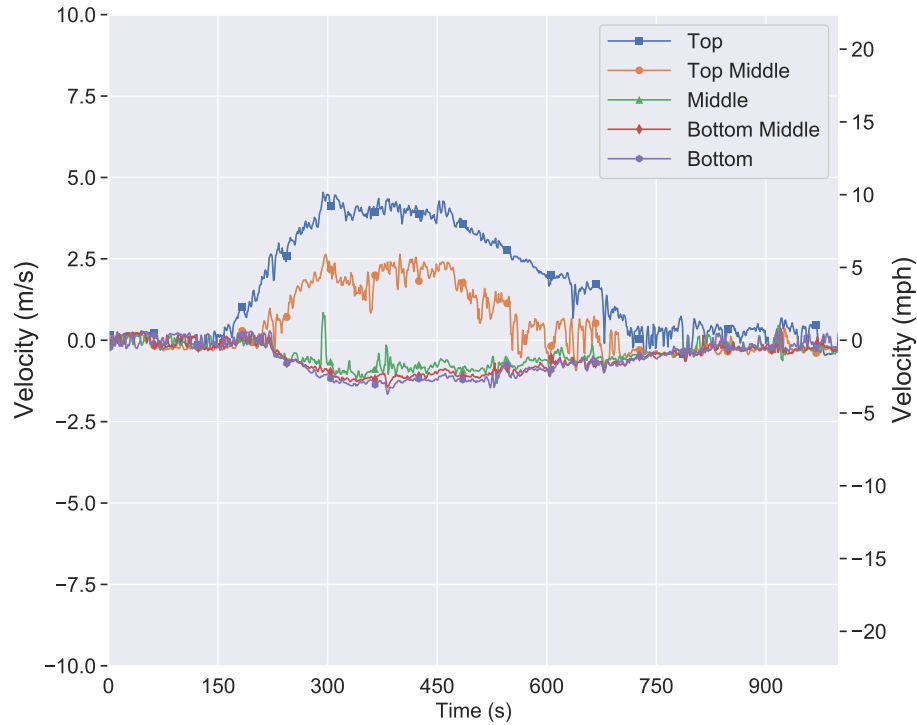
Figure 4.76: Experiment 13, front door and bedroom 1 windows open, front door velocity versus time.

The velocity profile at the front door (Figure 4.76) confirms the visual observations that the top portion of the doorway was primarily exhaust. The smoke layer did not descend below the top half of the doorway because the velocity profile shows the lower half of the doorway served as an air intake from 180 s after ignition until suppression.

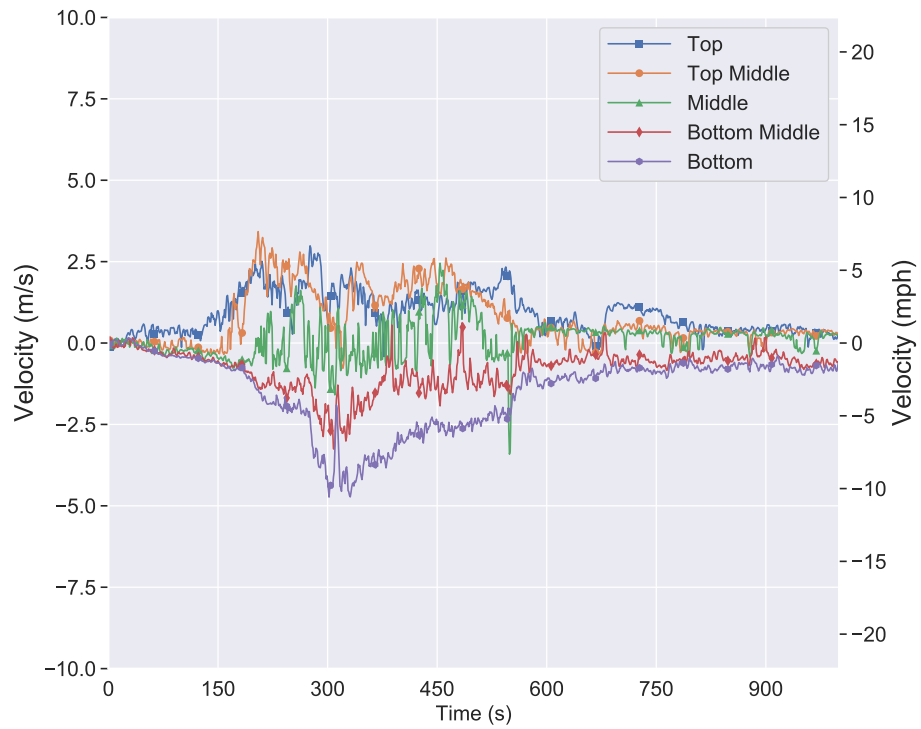
Figure 4.77: Experiment 13, front door and bedroom 1 windows open, hallway velocity versus time.

The velocity array in the hallway, shown in Figure 4.77, measured the gas flow into and out of bedroom 1. The gases flowing out of the bedroom show a positive velocity, and gases flowing into the bedroom show a negative velocity. When the fire was near its peak burning rate, more than the top half of the doorway had gases exhausting into the hallway at velocities of about 2.5 m/s (5.6 mph). At the same time, denser, cooler gases were flowing into the bottom of the doorway at a peak of about 4.5 m/s (9 mph). After fire suppression, the fire decreased in size and exhaust gases slowed. The short period of time when the entrainment was overcome coincides with the ignition of the hallway carpet.

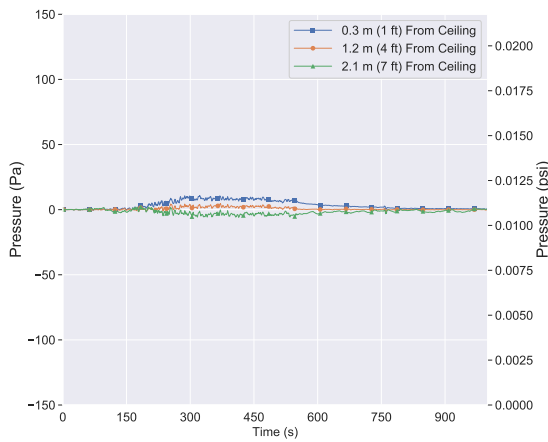
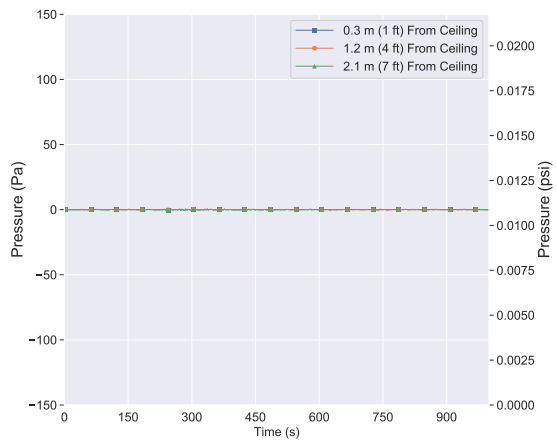
(e) Bedroom 2 Pressure

(f) Bedroom 3 Pressure

Figure 4.79: Experiment 13, front door and bedroom 1 windows open, pressures versus time in all rooms.

Pressures inside the structure at locations open to the fire room were similar, as shown in Figure 4.79. Pressures near the ceiling were slightly higher than the pressures near the floor, which accounts for the convective circulation in and out of bedroom 1. Bedroom 3, closed off from the rest of the structure, did not have a noticeable change in pressure.

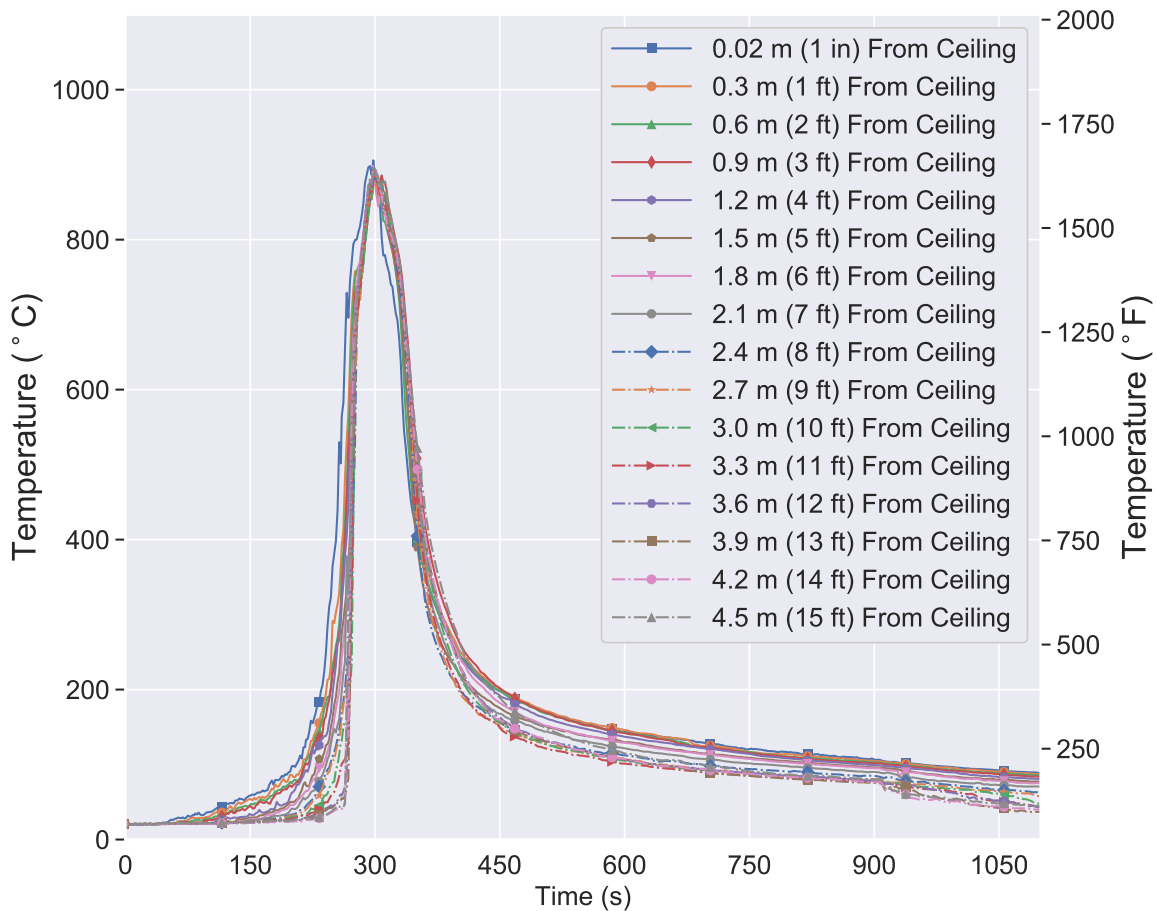
Figure 5.1: Experiment 1, no exterior ventilation openings, family room center temperatures versus time.

Figure 5.1 displays the time history of the temperatures of the thermocouple array positioned in the center of the family room, the closest array to the point of ignition. The graph shows the build up of the hot gas layer from the ceiling down to the floor. Within 300 s after ignition, the temperature neared a peak of 900 °C (1652 °F) followed by a decrease of at least 700 °C (1292 °F) over the next 3 min.

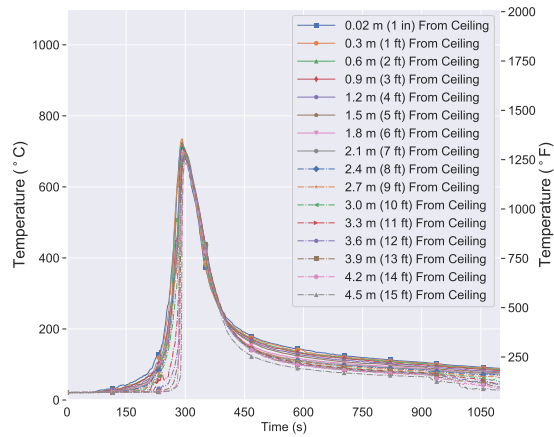
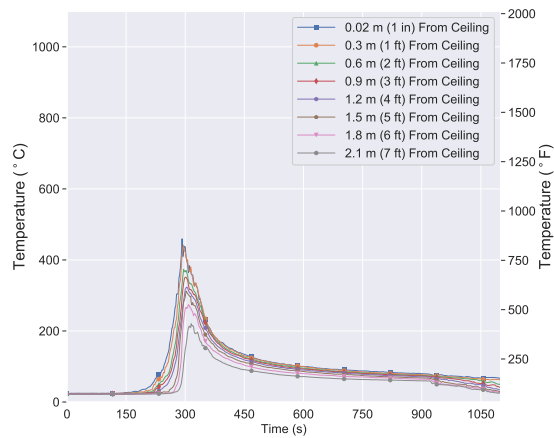
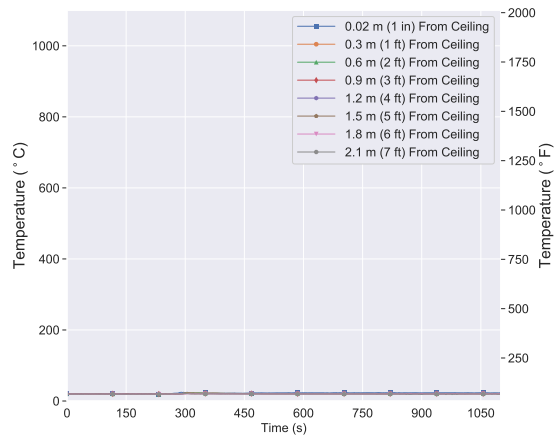
(b) Foyer Temperature

(d) Dining Room Temperature

(f) Den Temperature

Figure 5.2: Experiment 1, no exterior ventilation openings, temperature time histories for family room and other first floor rooms.

The six graphs shown in Figure 5.2 show the temperatures from the other thermocouples arrays positioned on the lower level. The family room corner and kitchen arrays are located across the rear of the structure. The kitchen temperatures not following the trends are believed to have been damaged when the flames pushed out of the bottom of the family room window opening and ignited some instrumentation wire insulation. The den was also located along the rear of the structure, but the doorway was closed. The rooms on the front side of the structure (i.e., the dining room, foyer and living room) had lower peak temperatures than those in the kitchen or family room.
