# Impact of Fixed Ventilation on Fire Damage Patterns in Full-Scale Structures

Daniel Madrzykowski  
Craig Weinschenk

UL Firefighter Safety Research Institute  
Columbia, MD 21045

April 18, 2019

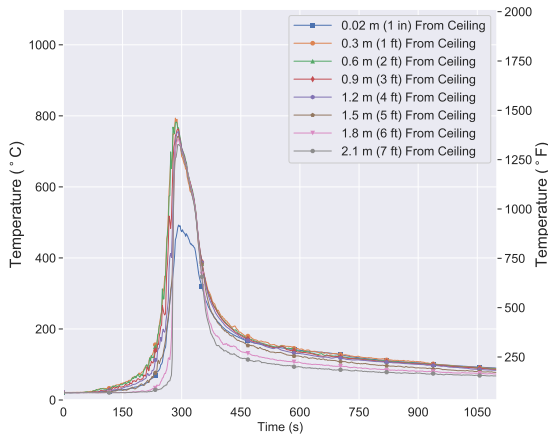
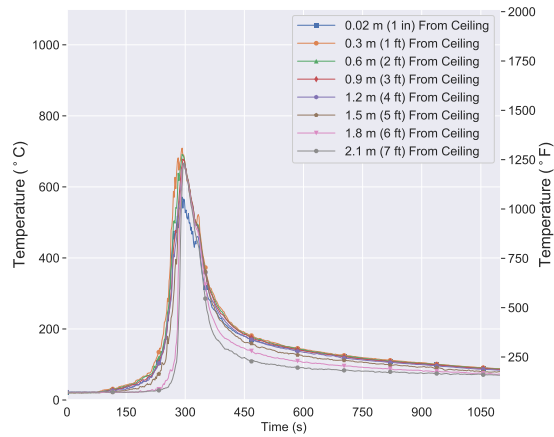
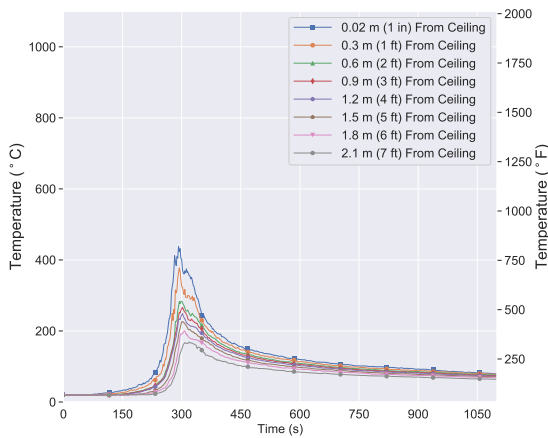
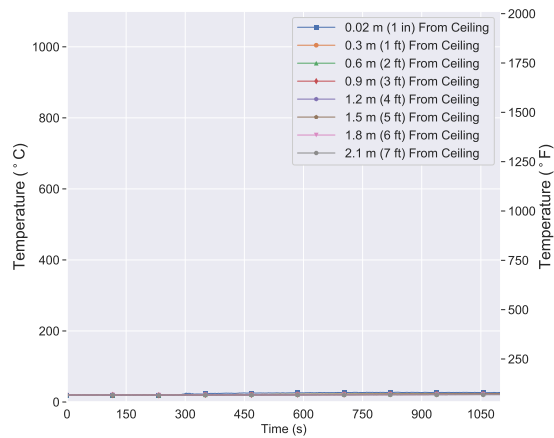
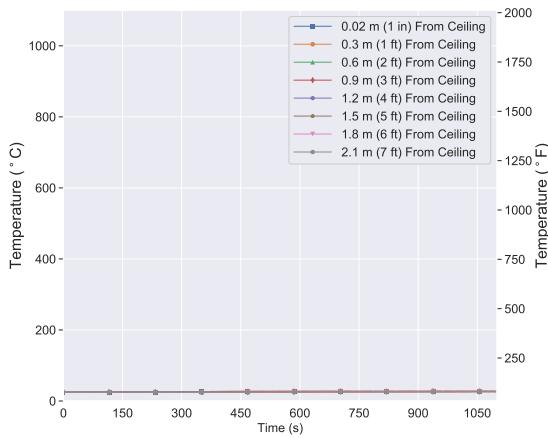
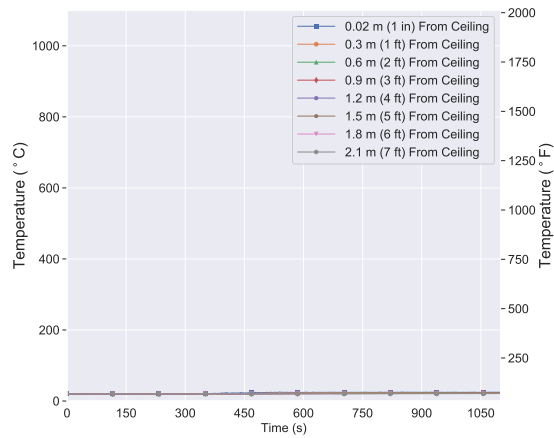
Figure 5.3: Experiment 1, no exterior ventilation openings, temperature time histories for second floor hallway and bedrooms.

Figure 5.3 shows the temperatures recorded by the thermocouple arrays on the upper level. The hallway and bedroom 1 were open to the fire area, and as a result the temperatures follow similar trends in terms of increasing and decreasing with the family room temperatures. In other words, the energy released by the fire in the family room spread throughout all of the open areas of the structure. Bedrooms 1, 2, and 3 were isolated from the fire area by having the doorways closed off, hence there was little to no increase in temperature in the bedrooms.

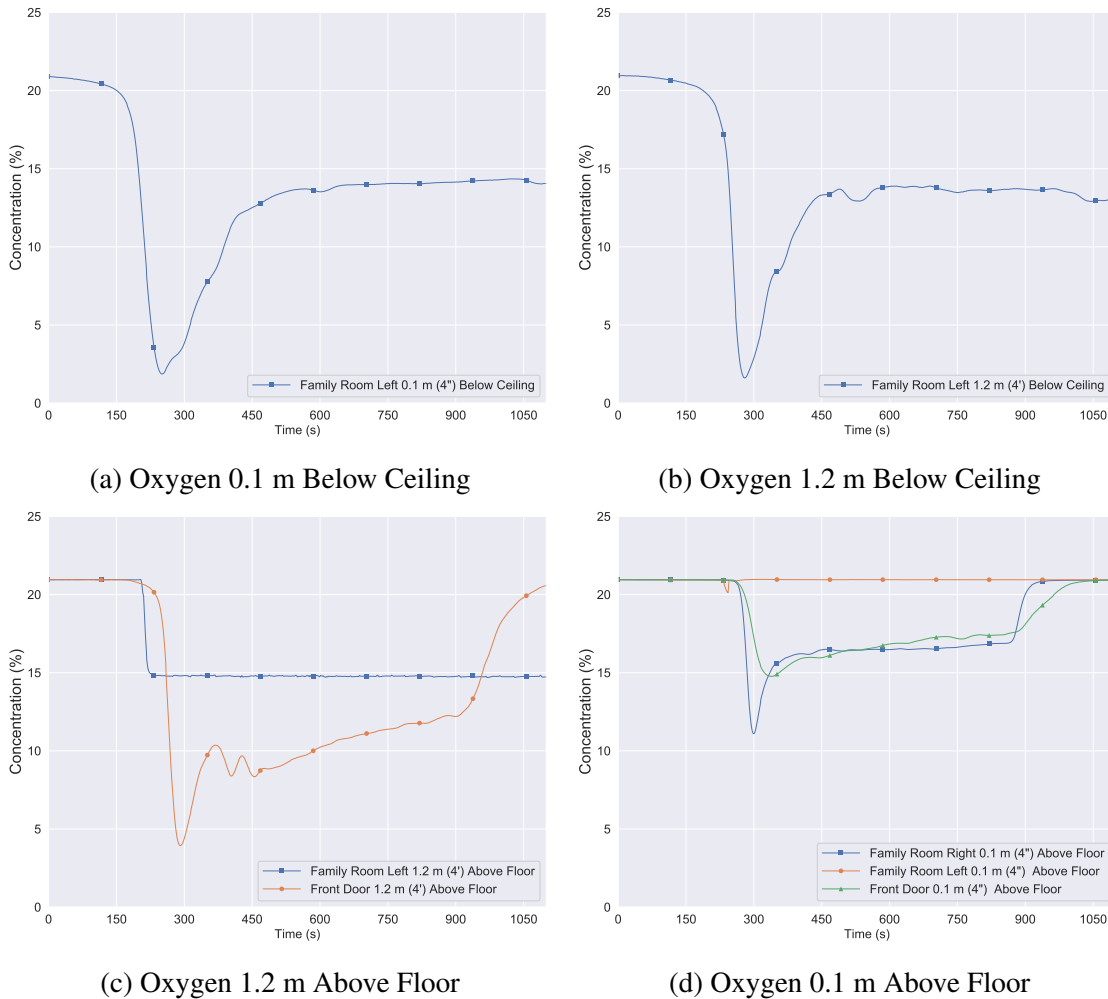
Figure 5.4: Experiment 1, no exterior ventilation openings, oxygen concentrations versus time.

The oxygen concentrations appear in Figure 5.4. The charts shown in Figures 5.4a and 5.4b are from the sampling positions in the family room, located 0.1 m (4 in) and 1.2 m (4 ft) below the ceiling, respectively. As the flames extended to the ceiling, the oxygen levels almost reached zero. The graphs shown in Figures 5.4c and 5.4d are from the sampling positions in the family room, located 1.2 m (4 ft) and 0.1 m (4 in) above the floor, respectively. Once the oxygen levels near the floor reached 15% or lower, the fire started to decrease due to the reduced oxygen level. The oxygen data from the family room left positions were also impacted by the flames burning on the exterior of the structure. After the fire self-extinguished, the oxygen levels began to increase.

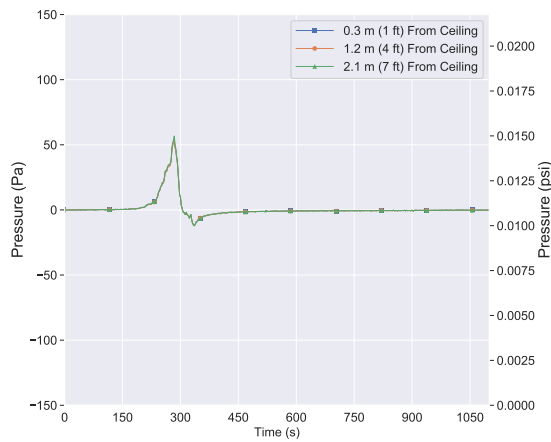
(e) Den Pressure

Figure 5.5: Experiment 1, no exterior ventilation openings, pressures in first floor rooms.

Figure 5.5 shows the pressures from the rooms on the lower level. Notice that as the energy released by the fire increased, the temperature of the gas contained in the structure increased, which caused the gases to expand. This resulted in pressures that exceeded the 125 Pa limit of the pressure transducers. As the heat release rate of the fire decreased, the gas temperatures decreased and the gas contracted, which caused the pressures inside the structure to decrease to at least 100 Pa below atmospheric pressure. In other words, the inside of the structure was essentially under a vacuum relative to the air outside the structure. This pressure difference is the reason fresh air was drawn in

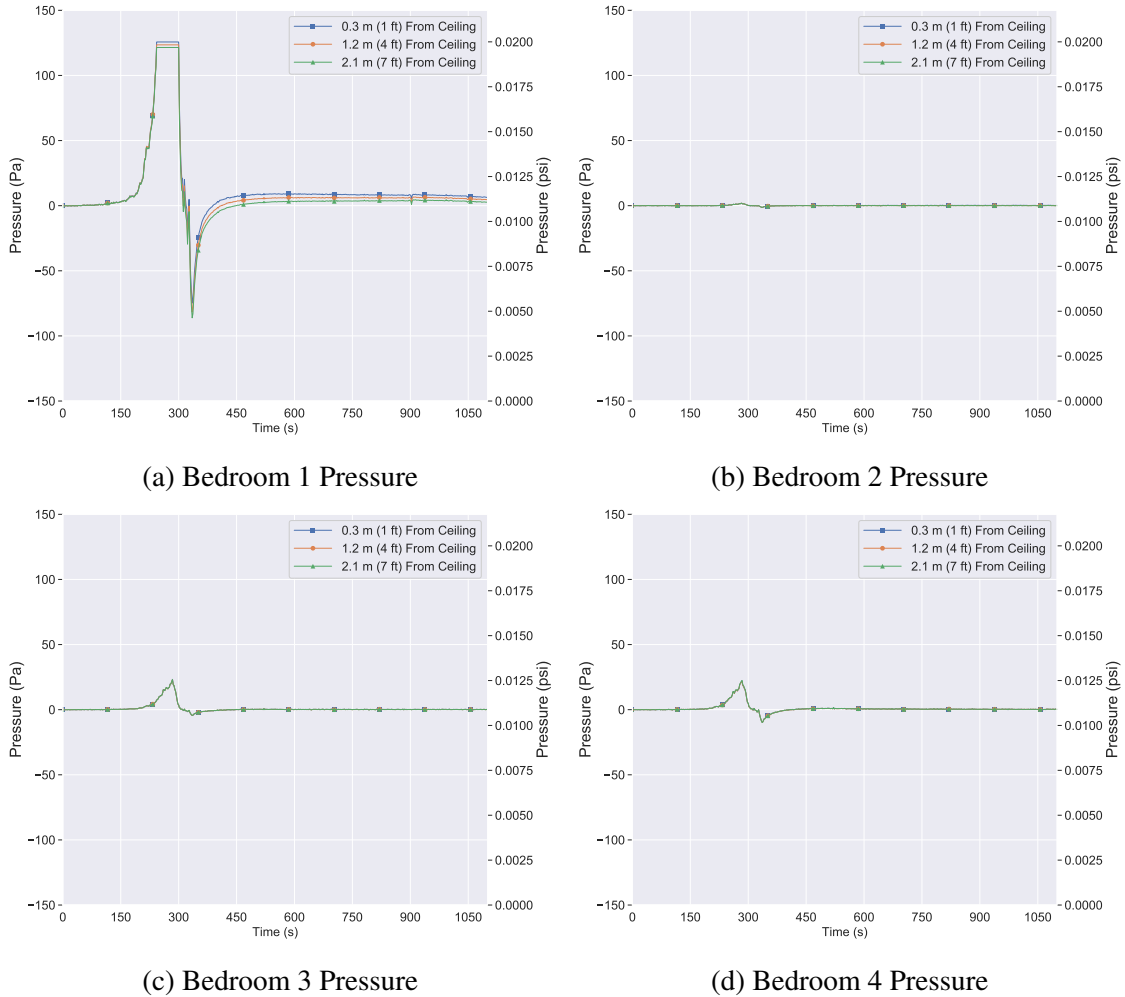
Figure 5.6: Experiment 1, no exterior ventilation openings, pressures in second floor rooms.

The pressures on the upper level appear in Figure 5.6. Bedroom 1 was the only room open to the fire area. The pressure trends in bedroom 1 are the same as those in the open areas on the first floor. Bedrooms 2, 3, and 4 were closed off from the fire area, which limited the amount of pressure change within those rooms.

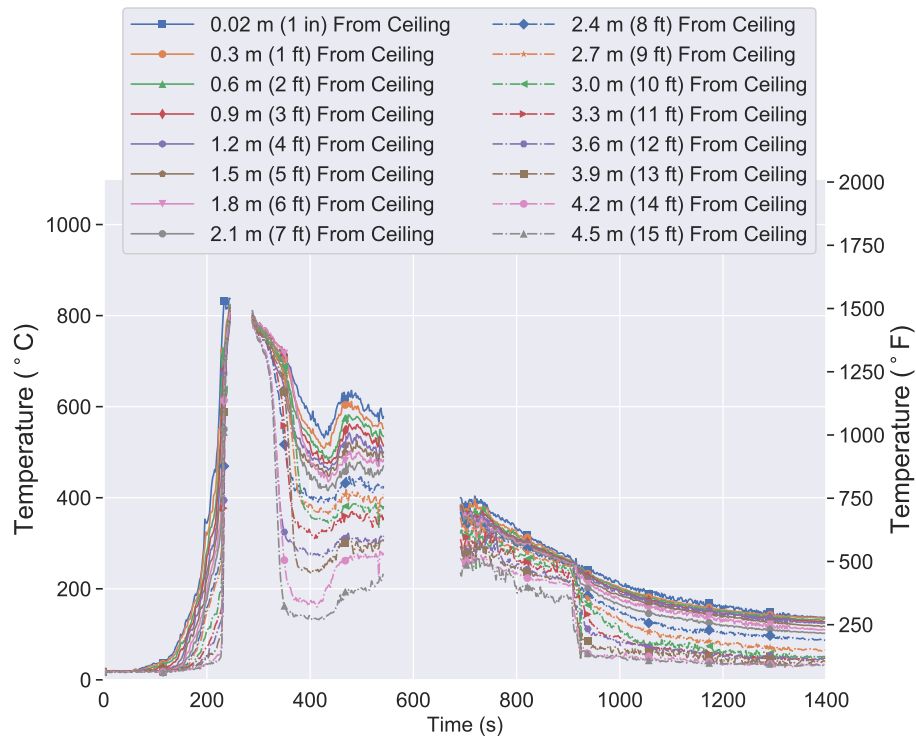
Figure 5.7: Experiment 2, no exterior ventilation openings, family room center temperatures versus time.

Figure 5.7 displays the time history of the temperatures of the thermocouple array positioned in the center of the family room, the array closest to the point of ignition. The graph shows the build up of the hot gas layer from the ceiling down to the floor in the first 225 s after ignition. Seconds later the temperatures in the area of the thermocouple array exceeded 800 °C (1472 °F) and stayed at the level for approximately one minute before decreasing. Approximately 5 min after ignition, the temperatures in the living room began to stratify. Temperatures near the floor decreased by more than 500 °C (932 °F) over a period of less than 30 s. While the rapid decrease in temperature was seen in the previous experiment, this experiment exhibited continued burning that slowed the decrease in the temperatures closer to the ceiling, keeping them above 600 °C (1112 °F) until 500 s

after ignition. The thermal gradient was reduced after this point and continued to get smaller until the firefighters vented the fire room 15 min after ignition. The missing section of the data traces are an artifact of an intermittent data acquisition system malfunction.

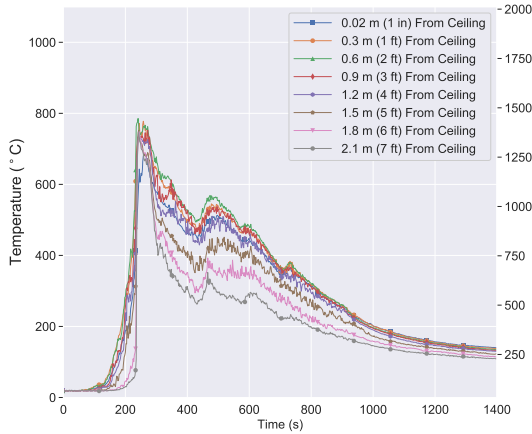
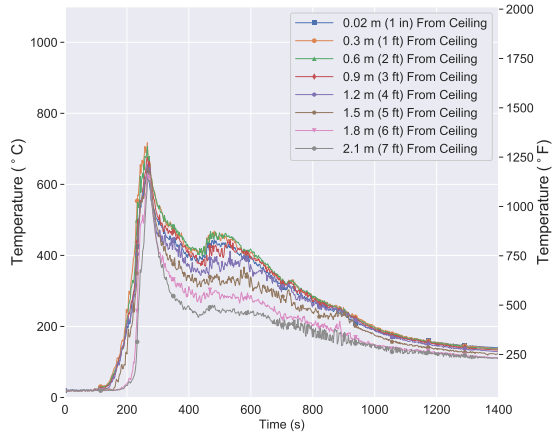
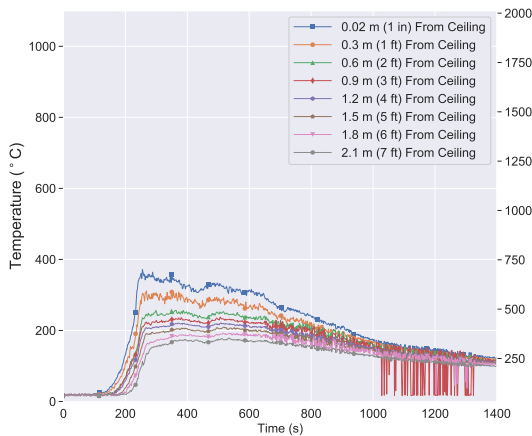
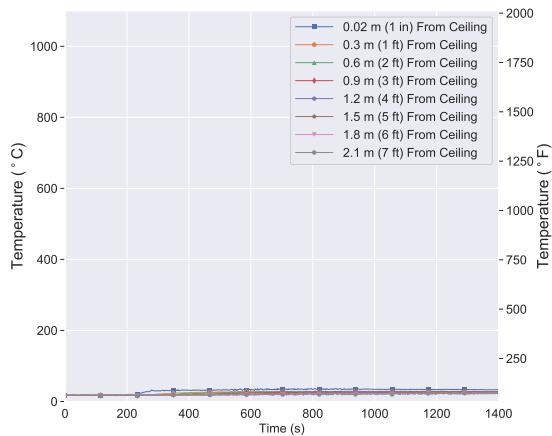
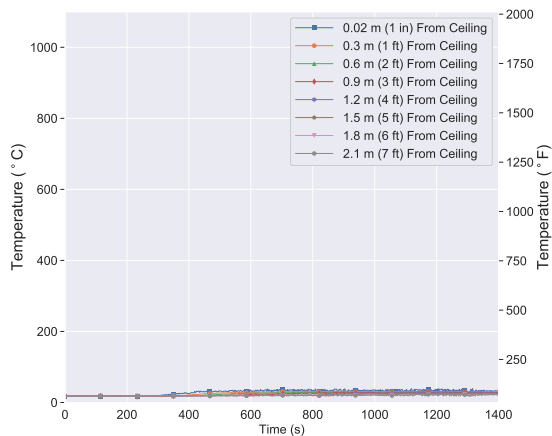
Figure 5.10: Experiment 2, front door open, temperature time histories for second floor hallway and bedrooms.

Figure 5.10 shows the temperatures recorded by the thermocouple arrays on the upper level. The hallway and bedroom 1 were open to the fire area. The mid-hall array temperatures shown in Figure 5.10a had the most similar temperatures and trends as the temperatures in the family room. This array is also in the direct exhaust flow of the hot gases as they flowed from the family room into the foyer and down toward the open front door. As the distance from the mid-hall position increased while moving toward bedroom 1, the temperatures tended to decrease. Bedroom 1, much like the living room, is not part of the main fire flow paths and therefore has lower temperatures than the hallway arrays. Bedrooms 2, 3, and 4 were isolated from the fire area by having the doorways closed off, hence there was little to no increase in temperature in the bedrooms.

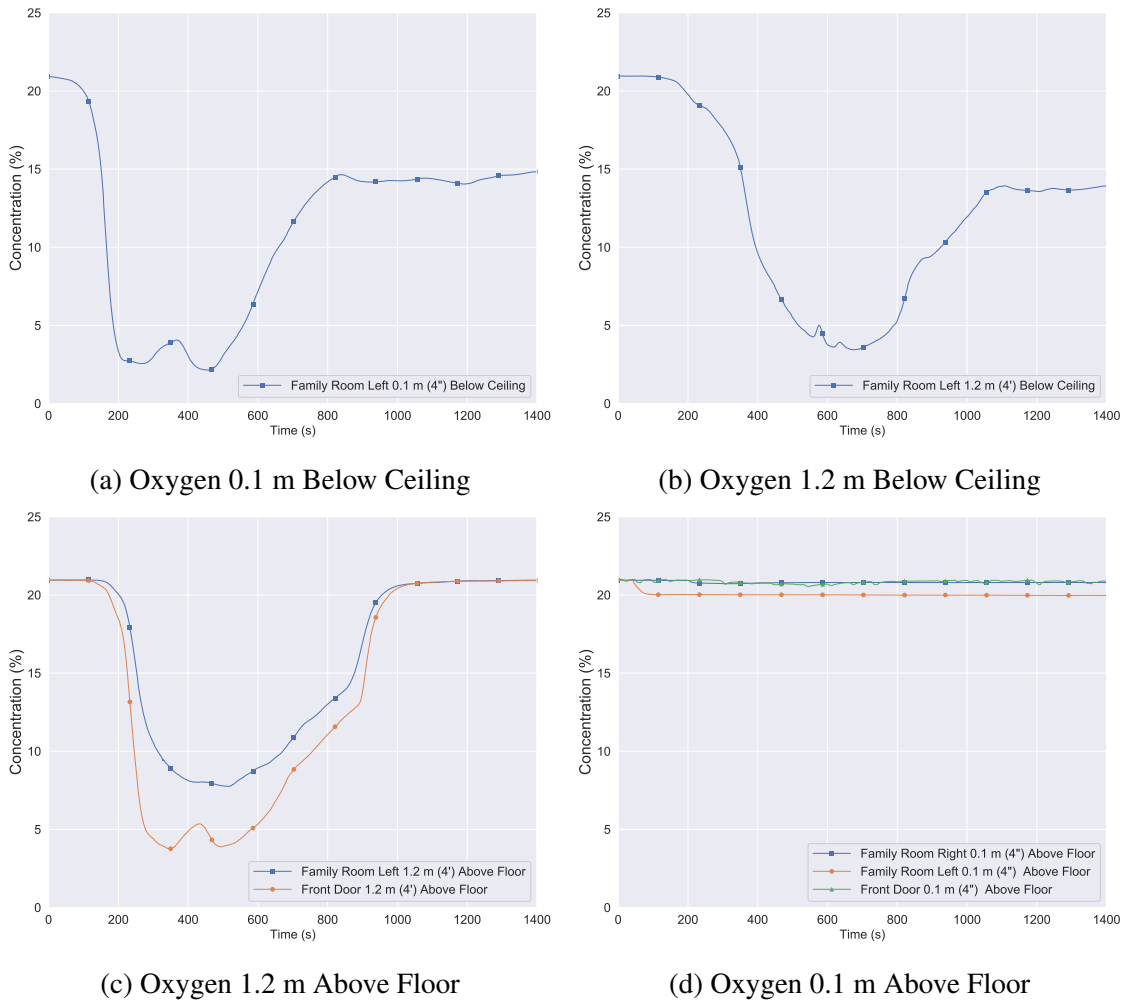
Figure 5.12: Experiment 2, front door open, oxygen concentrations versus time.

The oxygen concentrations appear in Figure 5.12. The charts shown in Figures 5.12a and 5.12b are from the sampling positions in the family room, located 0.1 m (4 in) and 1.2 m (4 ft) below the ceiling, respectively. As the flames extended to the ceiling, the oxygen concentrations decreased below 5%. The oxygen concentrations at these positions remained below 5% post-flashover, for at least 5 min. Perhaps this is due to the continued burning and a lack of exhaust vent on the upper level.

Figures 5.12c and 5.12d are from the sampling positions in the family room, located 1.2 m (4 ft) and 0.1 m (4 in) above the floor, respectively. As the fire was approaching flashover, oxygen-depleted gases were pushed over the oxygen sampling position near the front door and 1.2 m (4 ft) above the floor. The lowest oxygen concentration at this location, below 5%, first occurred about 340 s after ignition, during the fire decay stage. The 1.2 m (4 ft) above the floor oxygen sampling position in the family room trailed the decreases shown at the front door position, indicating that the hot gas layer descended later than the layer elevation near the front door. Further, the oxygen concentration in living room remained higher than in the foyer by the front door. Finally, the oxygen concentrations near the floor, Figure 5.12d, remained at or above 20%. The front door

provided for an exhaust vent, such that the hot gas layer did not fill the lower layer as it did in the previous experiment with no exterior vents, and the front door provided some amount of fresh air to the structure during most of the experiment.

The lowest oxygen concentrations at this height above the floor was approximately 5%. The oxygen concentrations near the floor in the family room (see Figure 5.12d) also decreased to levels between 5% and 14% while the fire was in the post-flashover fully developed stage. The oscillations are believed to be the result of air flowing along the floor from the front door into the fire room. Also in the same graph, the oxygen concentration measured near the floor just inside the front door remained above 20% for the duration of the experiment. With the front door as a bi-directional vent and bedroom window opening serving mainly as an exhaust vent, the hot gas layer did not fill the lower level of the structure as thoroughly as it did in the previous experiments as additional fresh air was admitted into the structure during most of the experiment.

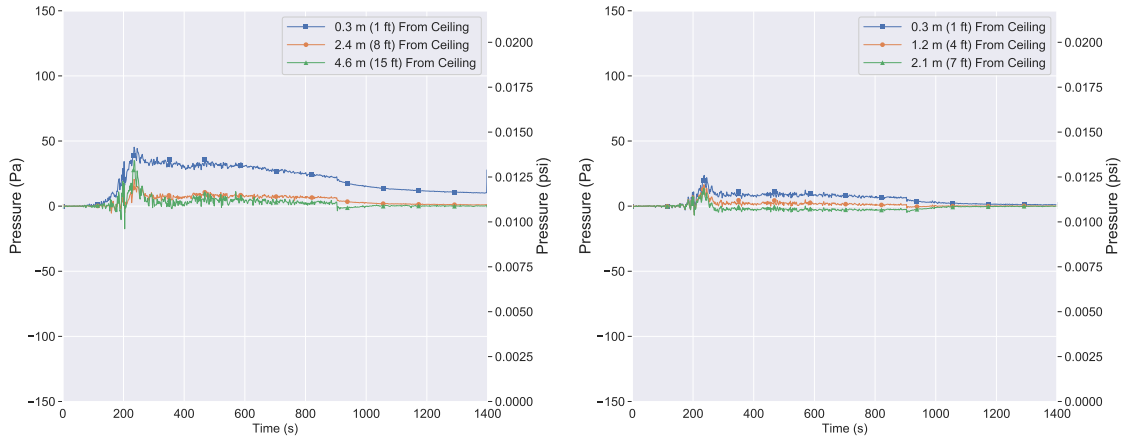
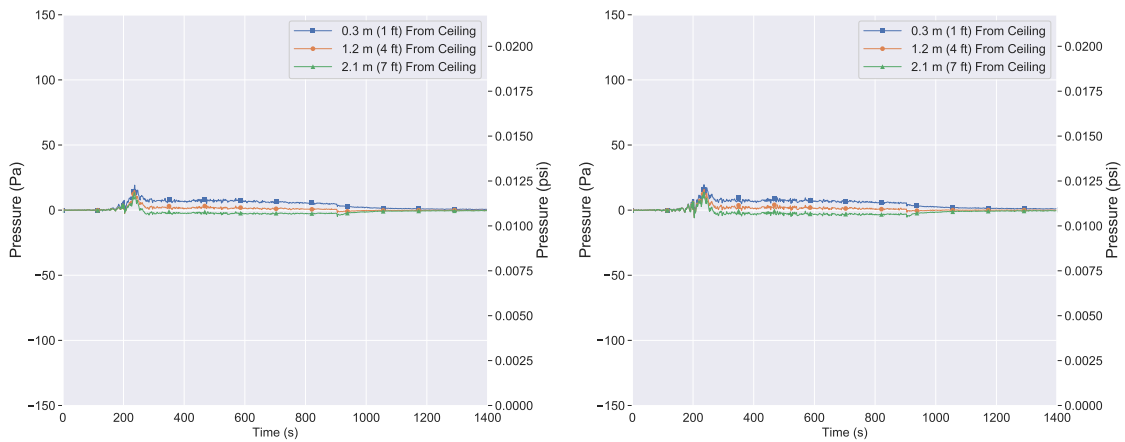
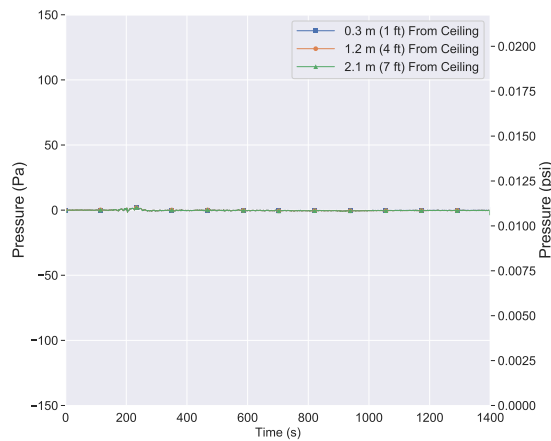
Figure 5.13: Experiment 2, front door open, pressures in first floor rooms.

Figure 5.13 shows the pressures from the rooms on the lower level. The open front door provided not only an exhaust and intake vent, it also served as a pressure-relief vent. The peak pressure in the family room was less than 50 Pa. The family room pressures were also the peak pressures in the structure. The pressure gradient with the higher pressures near the ceiling and the lower pressures near the floor was more pronounced than in the closed door experiment. The gas pressures increased as the gas temperatures increased (gas expansion) and decreased as the gas temperatures decreased (gas contraction). The pressure difference between the ceiling and floor and between different areas of the structure resulted in gas movement from areas of higher pressure to areas of lower pressure via flow paths. The slightly negative pressure post-flashover in the kitchen, living room, and front door positions near the floor allowed for the higher pressure outside air to flow into the structure. In this experiment, the den was closed off from the fire area, so the pressure in the den did not change.

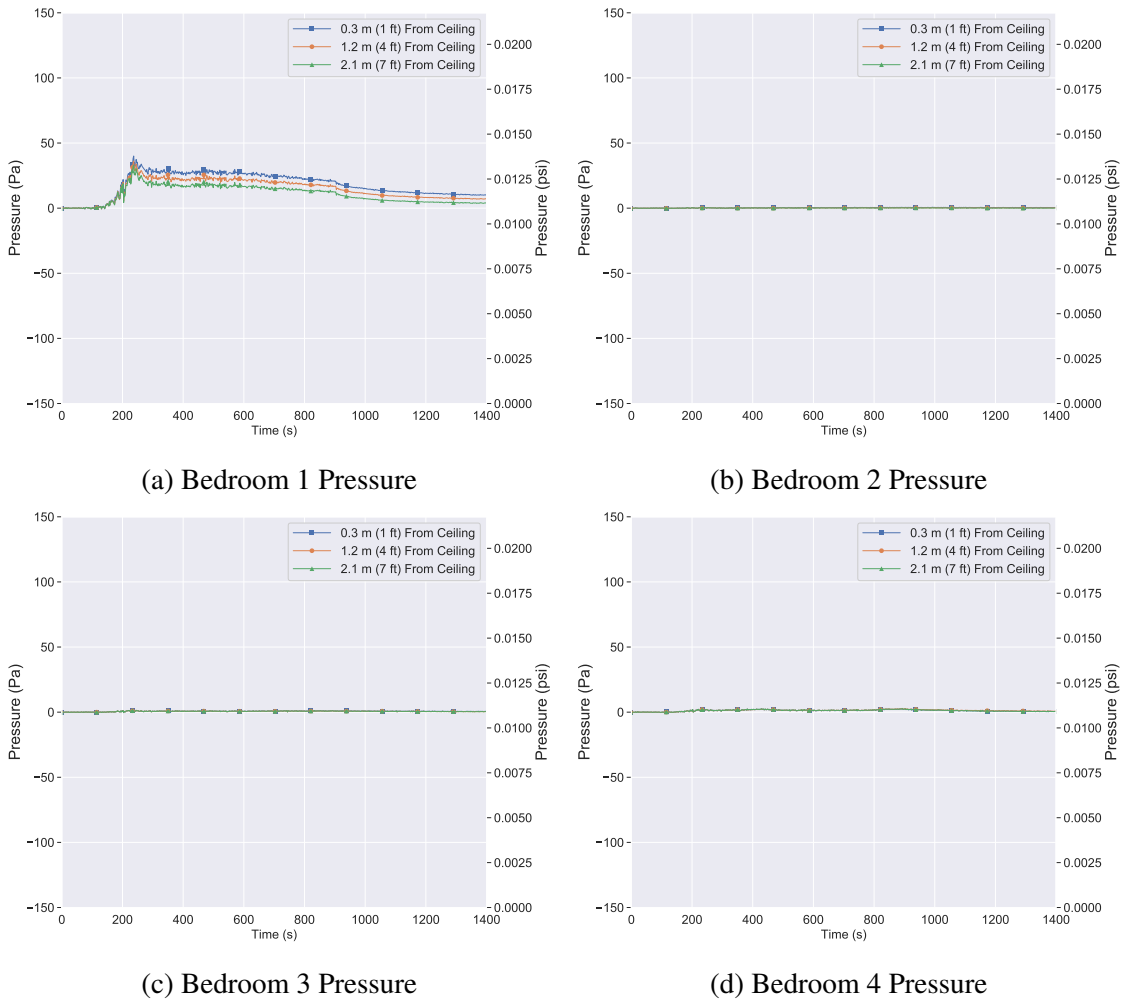
Figure 5.14: Experiment 2, front door open, pressures in second floor rooms.

The pressures on the upper level appear in Figure 5.14. Bedroom 1 was the only room open to the fire area. The pressure trends in bedroom 1 were similar to the pressure in the upper portion of the

family room. Bedroom 1 had a positive pressure from fire growth through firefighter intervention. Bedrooms 2, 3, and 4 were closed off from the fire area, which resulted in little to no pressure change within those bedrooms.

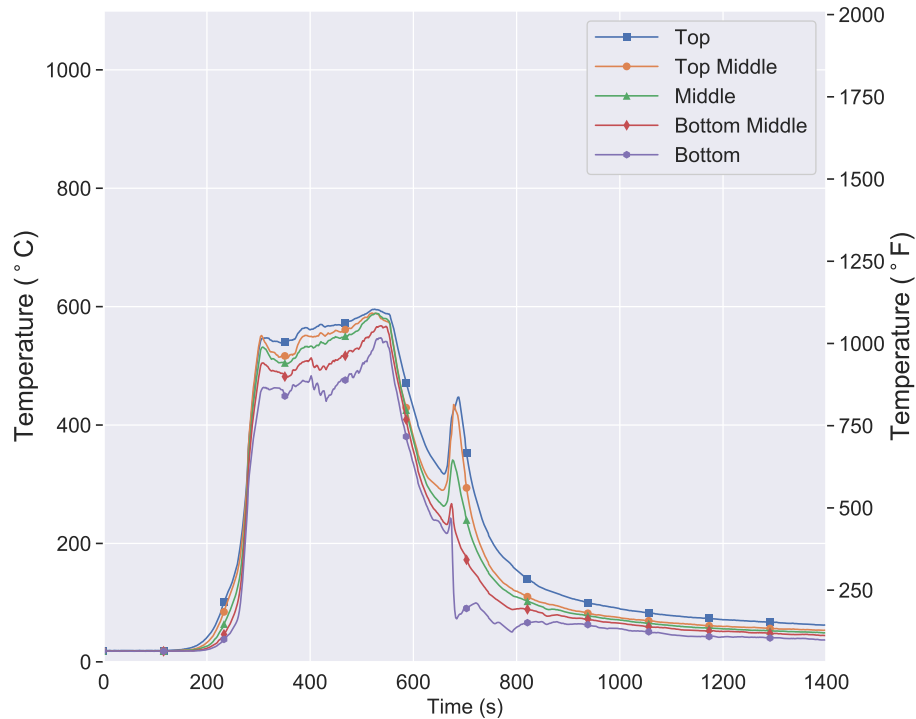
Figure 5.17: Experiment 3, front door, bedroom 3 door and window open, bedroom 3 window temperatures versus time.

The bedroom 3 window temperatures for Experiment 3 appear in Figure 5.17. The peak temperature in the upper portion of the window was approximately 600 °C (1112 °F). The minimum temperature of gas that flowed out of the window during the fully developed fire stage was in the lower portion of the window, 440 °C (824 °F). The trends of the temperature increases and decreases track along with the temperatures of the source fire up to the time of initial fire suppression in the family room, which occurred between 540 s and 580 s after ignition. After this point, the fire in Bedroom 3 re-grew. This caused the late increase in temperatures at the bedroom window that is inconsistent with the temperature trends of the family room source fire.

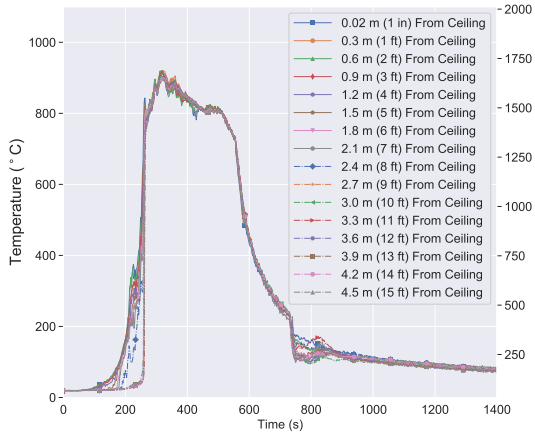
(a) Family Room Corner Temperature

Figure 5.18: Experiment 3, front door, bedroom 3 door and window open, temperature time histories for family room and other first floor rooms.

The six graphs in Figure 5.18 show the temperatures from the other thermocouple arrays positioned on the lower level. All of the temperature graphs show evidence of a longer burn time (compared to the two previous experiments) at conditions that were in excess of 600 °C (1112 °F) from the ceiling down to near floor level in the family room. The family room corner and foyer arrays are both 4.88 m (16 ft) high and have the best agreement with the temperatures from the center of the family room.

The other three rooms open to the family room have 2.44 m (8 ft) ceilings. The kitchen, dining room, and living room (see Figures 5.18c, 5.18d, and 5.18e) have similar temperature ranges and trends. The den had no temperature increase as a result of being closed off from the fire area.

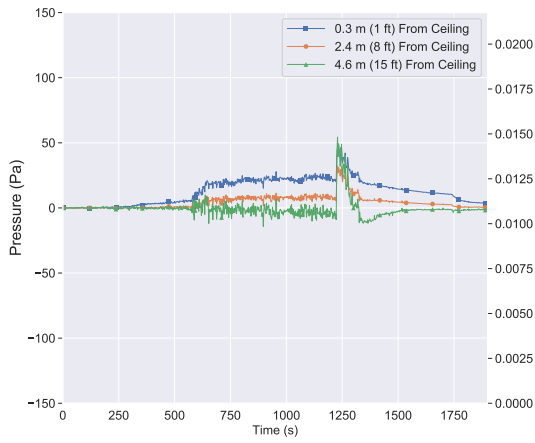
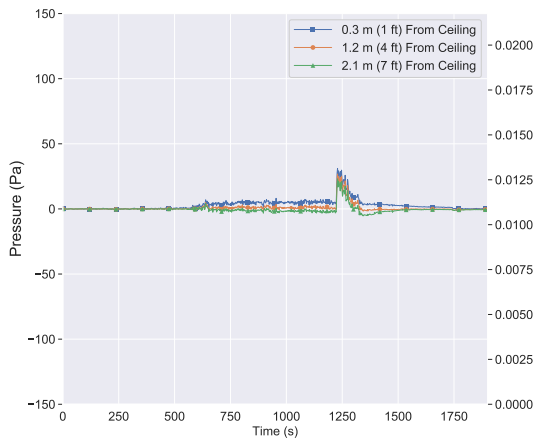
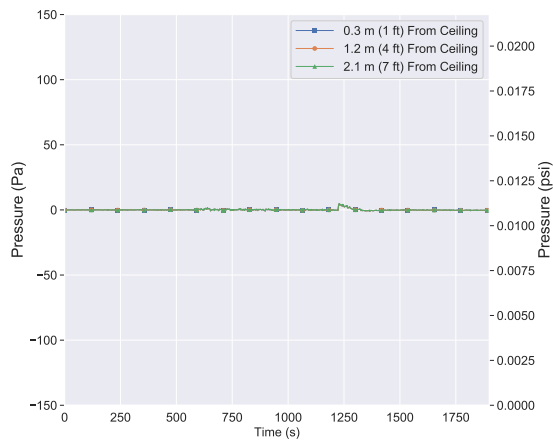
Figure 5.59: Experiment 6, front door open pressures in first floor rooms.

Figure 5.59 shows the pressures from the rooms on the lower level outside of the laundry room. The open front door acted as an exhaust (pressure relief) and intake vent. From the time of ignition, until the closure of the front door at 1200 s after ignition, the trends of the pressures in the open lower level rooms are the same. The pressure gradient in each room had positive pressures near the ceiling and negative pressures near the floor. As noted before, this pressure difference accounted for the circulation of hot gases out of the structure and air flow into the structure through the open front door.

The pressure location near the ceiling in the family room had measurements of approximately 25 Pa, which were the highest pressure measurements in the structure during post-flashover burning stage of the fire. The pressures in the upper level portion of the family room collected hot gases with no exhaust vent on the upper level, which in turn resulted in higher pressures on the lower level.

Closing the door at 1200 s after ignition generated a pressure increase, floor to ceiling, throughout the structure. The peak pressure in the family room was just over 50 Pa, while the peak pressure in the other rooms ranged from about 30 Pa to 35 Pa. When the door was closed, the increased pressure inside the structure forced hot gases through the gaps around the laundry room window shutter. The gases burned on the exterior of the structure and ignited the exterior of the shutters. In this experiment, the den was closed off from the fire area, so the pressure in the den did not change.

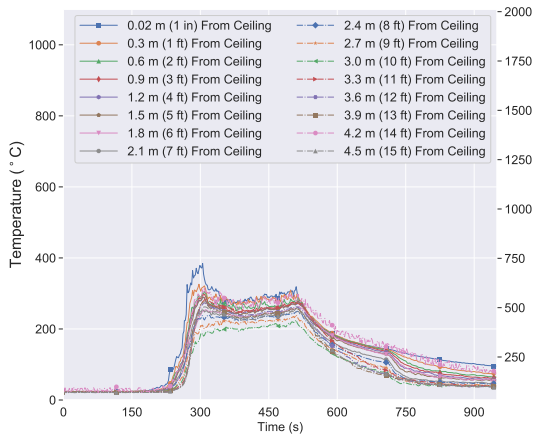
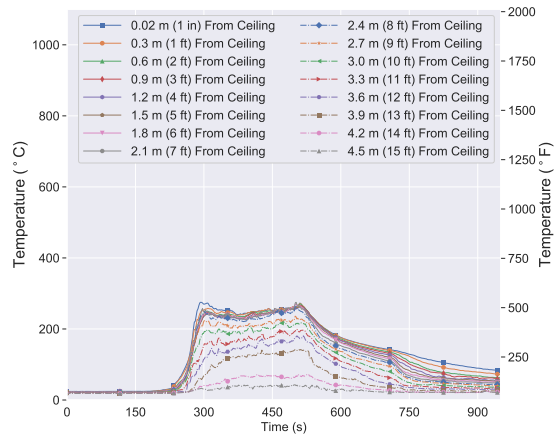
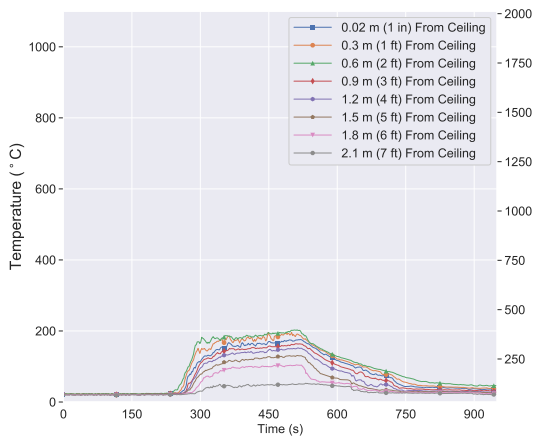
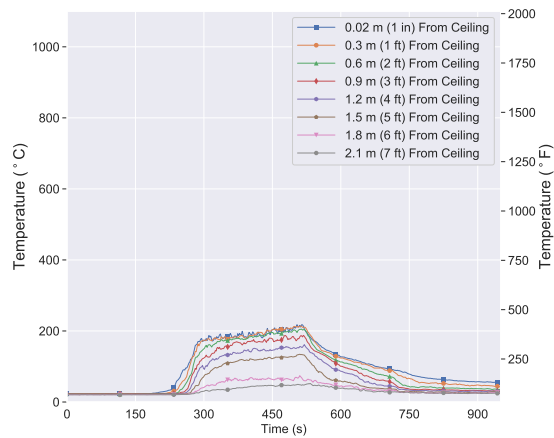
Figure 5.64: Experiment 7, front door and den window open, temperature time histories for first floor rooms

Figure 5.64 contains six graphs with the temperatures from the thermocouple arrays that were located on the lower level. The five rooms open to fire room included from the closest to the den to the furthest: family room, dining room, foyer, and living room, and kitchen. The rooms in the flow path between the den and the front door were the kitchen, the family room, and the foyer. These three rooms had the highest peak temperatures outside of the laundry room.

Along the flow path, the closer room (i.e., the family room) had the higher temperatures, while the further room (i.e. the foyer) had the lower temperatures. The dining room and kitchen room were outside of the flow path and had the lowest temperatures on the lower level. The living room, while not in the flow path, had elevated temperatures because of proximity to the den. Due to the open den window, the temperatures were not as high as compared to similar flow path arrays from the laundry room experiments, which did not have an open window.

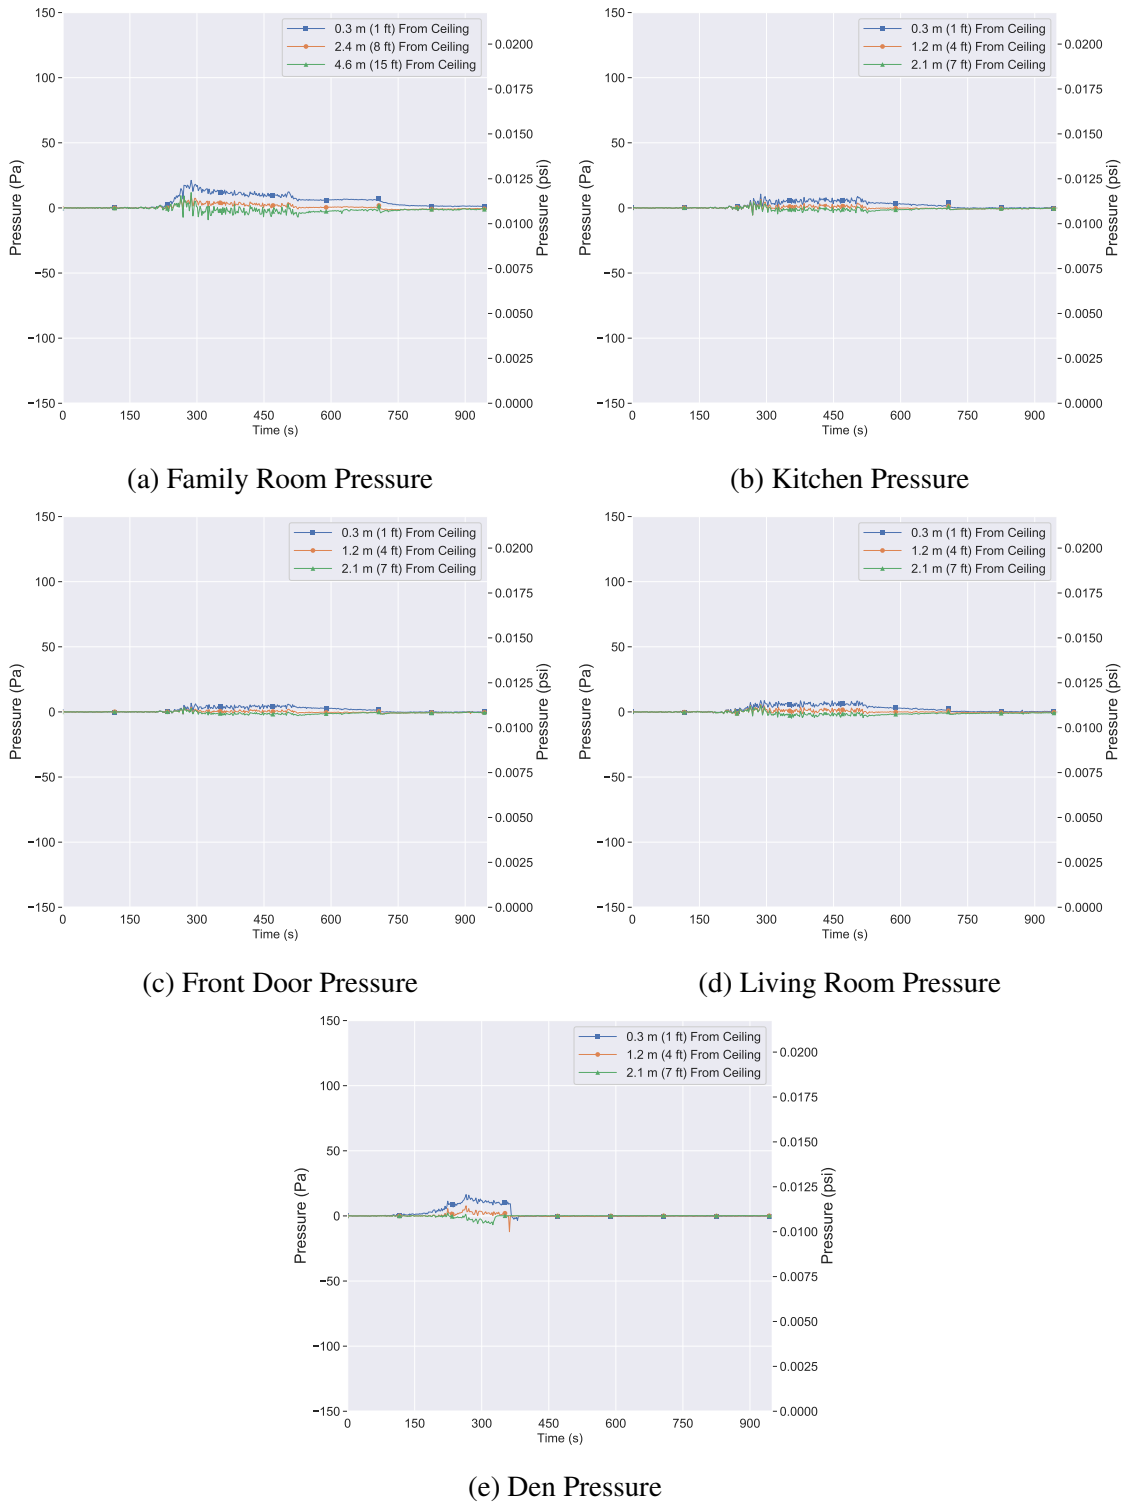
Figure 5.68: Experiment 7, front door and den window open, pressures in first floor rooms.

Figure 5.68 shows the pressures from the rooms on the lower level outside of the den. The open front door acted as an exhaust (pressure relief) and intake vent. From the time of ignition, the trends of the pressures in the open lower level rooms were the same, with the den and family room (closest to the den) showing the highest pressure gradients. The pressure gradient in each room had the positive pressures near the ceiling and the negative pressures near the floor. As noted before, this pressure difference accounted for the circulation of hot gases out of the structure and air flow into the structure through the open front door.

The pressure location near the ceiling in the family room had measurements of approximately 20 Pa, which were the highest pressure measurements in the structure during the post-flashover burning stage of the fire. The pressures in the upper level portion of the family room collected hot gases with no exhaust vent on the upper level, which in turn resulted in higher pressures than on the lower level of the structure.

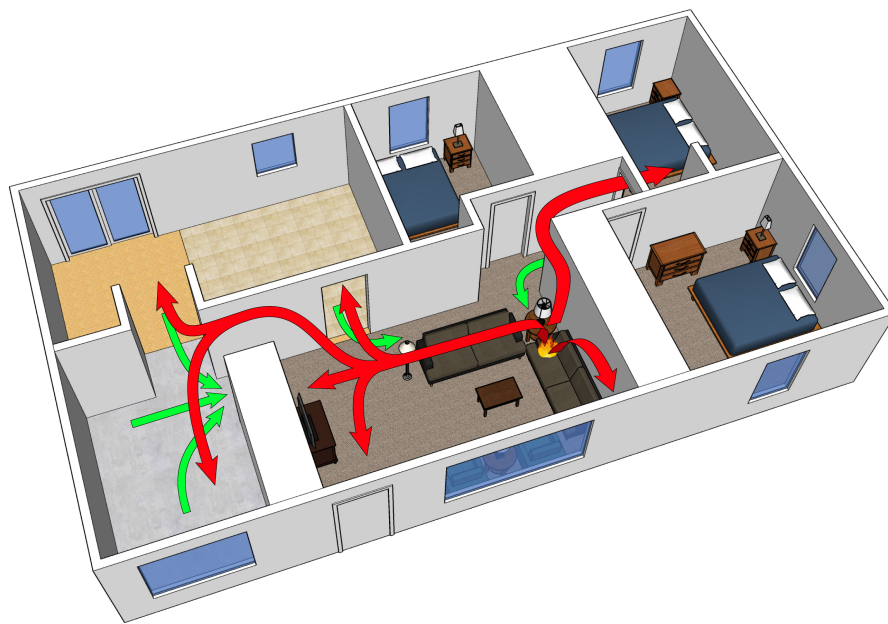
Figure 6.1: Drawing of the pre-flashover flows within the closed ranch structure, living room fire.

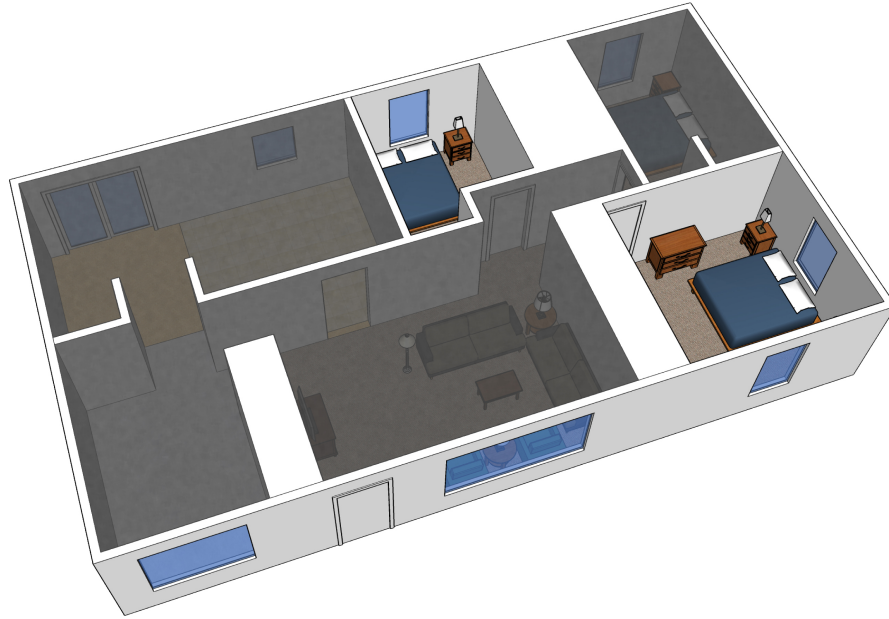
Figure 6.2: Drawing of the post-flashover conditions within the closed ranch structure, living room fire.

Figures 6.1 and 6.2 provide a graphic representation of the flow paths within the ranch structure. Figure 6.1 shows the flow of hot gases (red arrows) beginning at the area of fire origin and flowing throughout the adjoining rooms in the structure that are open to the living room. As the hotter, higher pressure fire gases flow into other rooms, such as the kitchen, dining room, or bedroom 2, the fresh air (green arrows) in those rooms was displaced toward the area of origin. This delivered oxygen needed for combustion. As combustion within the structure ceased due to a lack of oxygen, the measurable flows also stopped, as represented by the smoke-filled areas in Figure 6.2. Bedrooms 1 and 3 are closed and are not part of the flow paths.

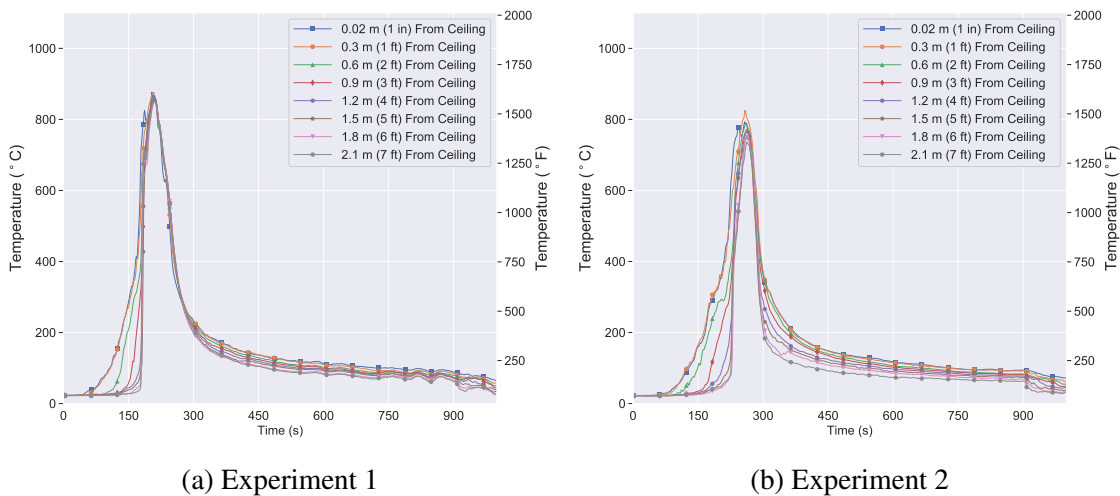
Figure 6.3: Comparison of closed door living room fire temperatures.

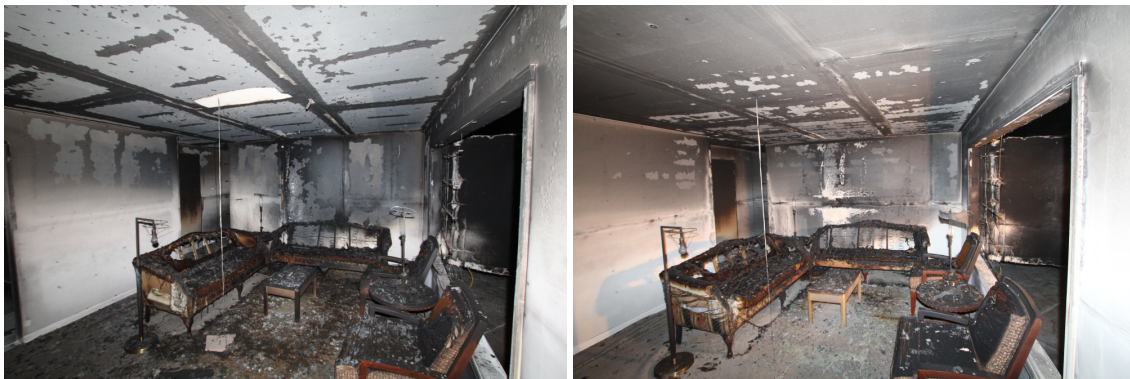
Figure 6.6: Post-suppression comparison of living room area of origin, with closed door.

The post fire suppression photographs of the living room looking toward the area of origin (see Figures 6.6 and 6.7) have many similarities. The wall behind the ignition sofa and the floor area under the sofa have fire damage patterns that frame the point of origin. Both walls have a vertical damage pattern starting above the back of the sofa and continuing toward the ceiling. The line of demarcation on the left wall was horizontal and approximately 1.5 m (5 ft) above the floor in both experiments.

Examining the furniture, the ignition sofa has the most fire damage. Moving away from the point of ignition toward the front door, the thermal damage to the furniture decreased. The wood moulding surrounding the living room window opening sustained the most fire damage on the vertical piece on the side of the window closest to ignition. The top piece of moulding above the window was charred close to the point of origin, and the damage decreased moving away from the origin. The vertical wood moulding closest to the front door had no thermal damage. The baseboard moulding along the floor was undamaged with the exception of the moulding behind the ignition sofa. The extent of the damage to the moulding behind sofa was similar.

Figures 6.6 through 6.9 compare similar photographs of the two living room fires conducted with no open exterior vents.

Key differences between the two experiments included the damage to the ceiling, damage to the moulding on the bottom of the window, and damage to the carpeting. The damage to the ceiling was more extensive in Experiment 1 than Experiment 2, although the thermal damage did not extend all the way across the ceiling. In Experiment 1, the piece of moulding on the bottom of the window had burn damage that extended behind the chair closest to the point of ignition before it stopped. In Experiment 2, there was no fire damage on this piece of moulding. In Experiment 1, there was more fire damage to the carpeting in the area between the chairs and the sofas than in Experiment 2. This larger area of damage on the floor is consistent with the larger area of damage on the ceiling in Experiment 1.

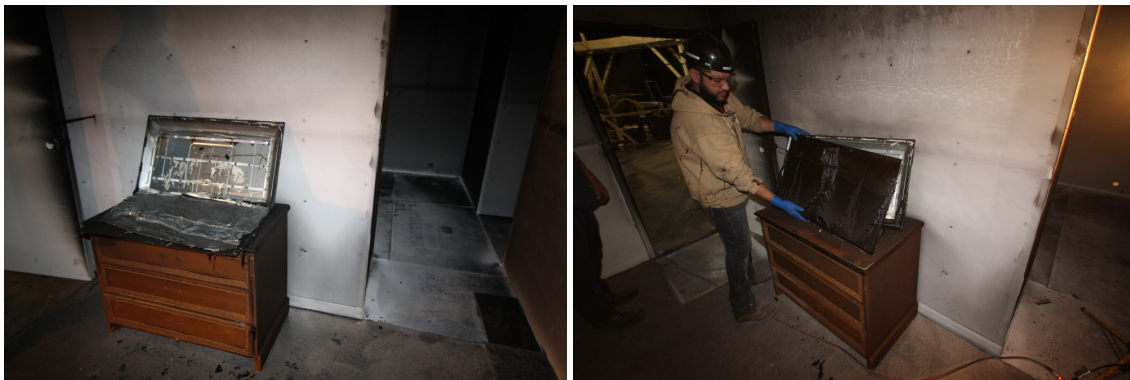
Figure 6.8: Post-suppression comparison of living room wall opposite the area of origin and adjacent to front door with closed door.

Figures 6.8 and 6.9 show the area adjacent to the front door. There is limited soot damage on the wall. It would appear that the exposed portion of the wall was heated enough that only a limited amount of soot condensed on the exposed portion of the wall. The portion of the wall behind the TV stand was shielded from the radiant heat from the fire and was at a lower temperature than the rest of the wall. The smoke convected behind the TV stand came in contact with the cool portion of the wall, and some of the soot condensed out on the wall behind the TV stand. Also note that the carpeting on this side of the room sustained no thermal damage in both cases.

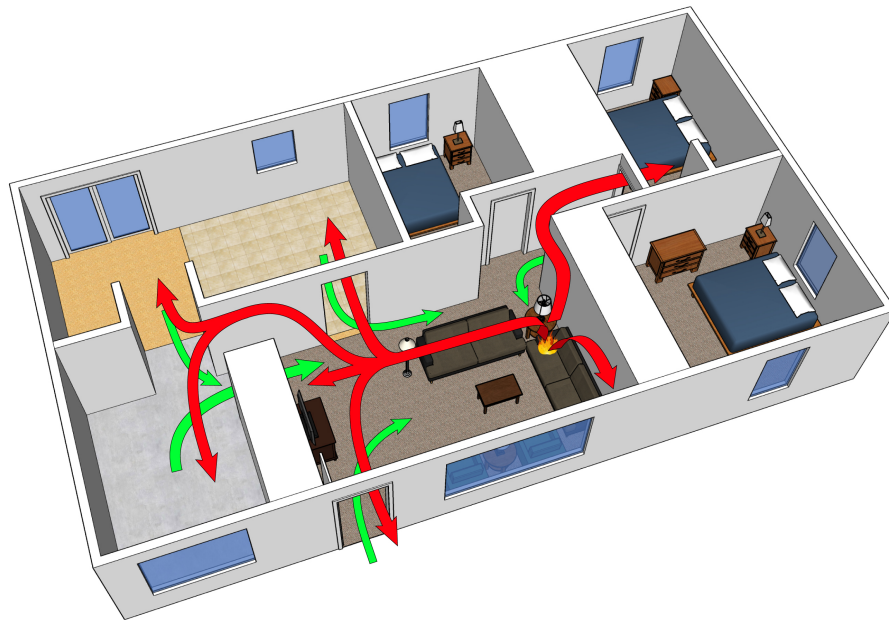
Figure 6.10: Drawing of the pre-flashover flows within the ranch structure, living room fire with open front door.

Figures 6.10 and 6.11 provide a graphic representation of the flow paths within the ranch structure. Figure 6.10 shows the flow of hot gases (red arrows) beginning at the area of fire origin and flowing throughout the adjoining rooms in the structure that are open to the living room. As the hotter, higher pressure fire gases flow into other rooms, such as the kitchen, dining room, bedroom 2, or out of the front door, the fresh air (green arrows) in those rooms was displaced toward the area of origin. This represents the availability of oxygen needed for flashover. Post-flashover, the measurable air flow within the structure was minimal. Post-flashover the air was supplied primarily through the front door and flowed to the area of combustion which had moved from the area of origin toward the doorway. The remainder of flow movement within the structure was the circulation of combustion products, as represented by the predominant red arrows in Figure 6.11. Bedrooms 1 and 3 are closed and are not part of the flow paths.

Figures 4 and 5 provide a graphic representation of the flow paths within the ranch structure. Figure 6.10 shows the flow of hot gases (see red arrows) beginning at the area of fire origin and flowing throughout the adjoining rooms in the structure open to the living room. As the hotter, higher pressure fire gases flowed into other rooms, like the kitchen, dining room, bedroom 2, or out the front door, the fresh air (see green arrows) in those rooms was displaced toward the area of origin. This represents the availability of oxygen needed for flashover. Post-flashover, the measurable air flow within the structure was minimal. The air entering through the front door flowed toward the seat of the fire which had moved from the area of origin toward the front door. The remainder of flow movement within the structure was the circulation of combustion products, as represented by the predominant red arrows in Figure 5. Bedrooms 1 and 3 were closed and were not part of the flow paths.
