# Impact of Fixed Ventilation on Fire Damage Patterns in Full-Scale Structures

Daniel Madrzykowski  
Craig Weinschenk

UL Firefighter Safety Research Institute  
Columbia, MD 21045

April 18, 2019

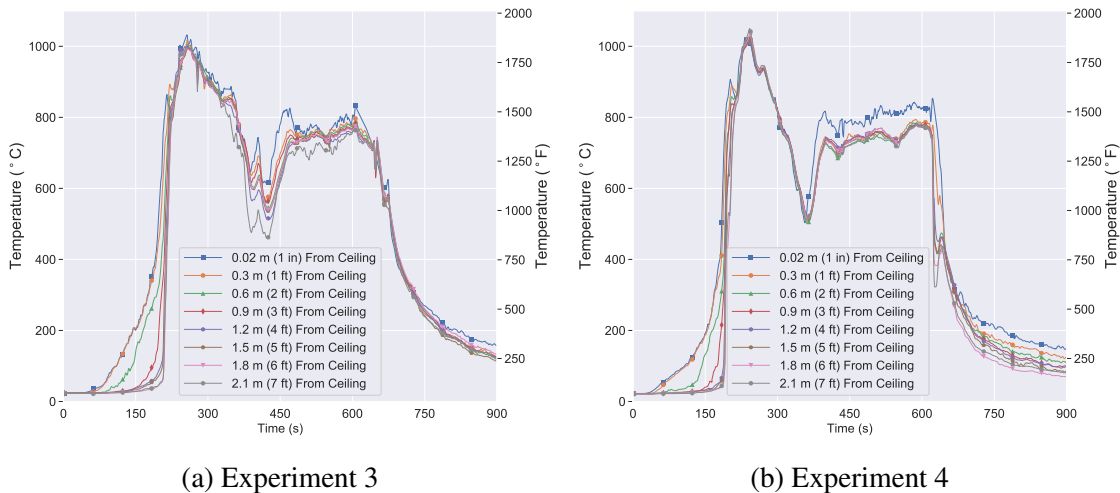
Figure 6.12: Comparison of open door living room fire temperatures.

The temperature time histories of the living room fires were similar in magnitude as shown in Figure 6. The growth rate, time to flashover, and post-flashover behavior were similar for both experiments. Experiment 4 showed a sharper decay, due to more efficient suppression actions.

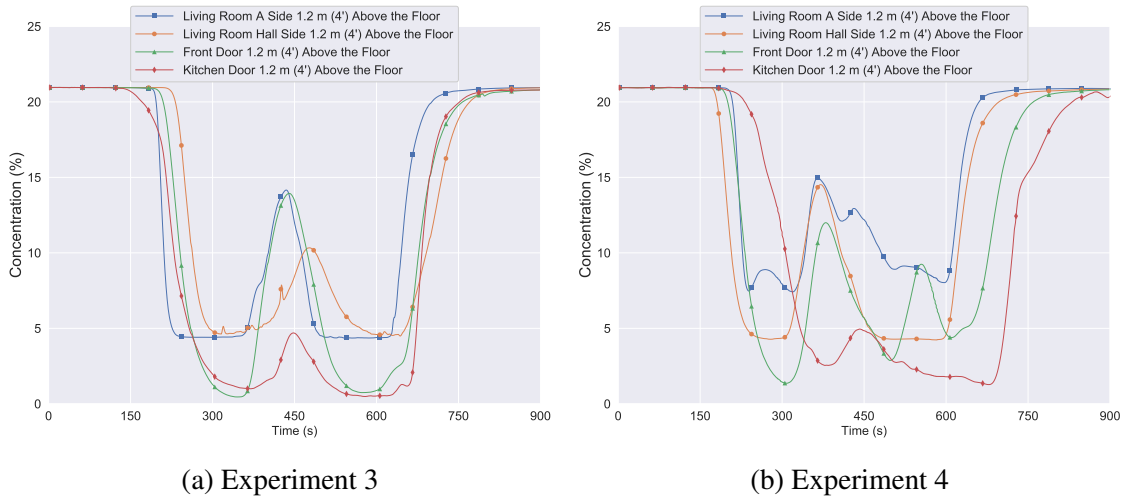
Figure 6.13: Comparison of open door oxygen concentrations at 1.2 m above the floor.

In both experiments, post-flashover, the oxygen levels measured at 1.2 m above the floor at locations bounding the living room decreased to 5%–8% as shown in Figure 7, recovered to approximately 15% as the fire decayed, and again dropped to 5%–8% as the fire recovered. The oxygen levels measured at 0.1 m above the floor in similar locations, Figure 8, showed a similar trend for the living room and kitchen: There was a decay to between 5%–10%, a recovery, and then a second decay before a full recovery to ambient levels following suppression. The oxygen sampling position near the floor by the front door did not see as significant of decay in either experiment as the door fluctuated between exhaust and intake. Although each of the oxygen concentration values between are not exact matches, the trends are similar, and the relationship between oxygen values and the increase and decrease in temperatures in the living room are consistent.

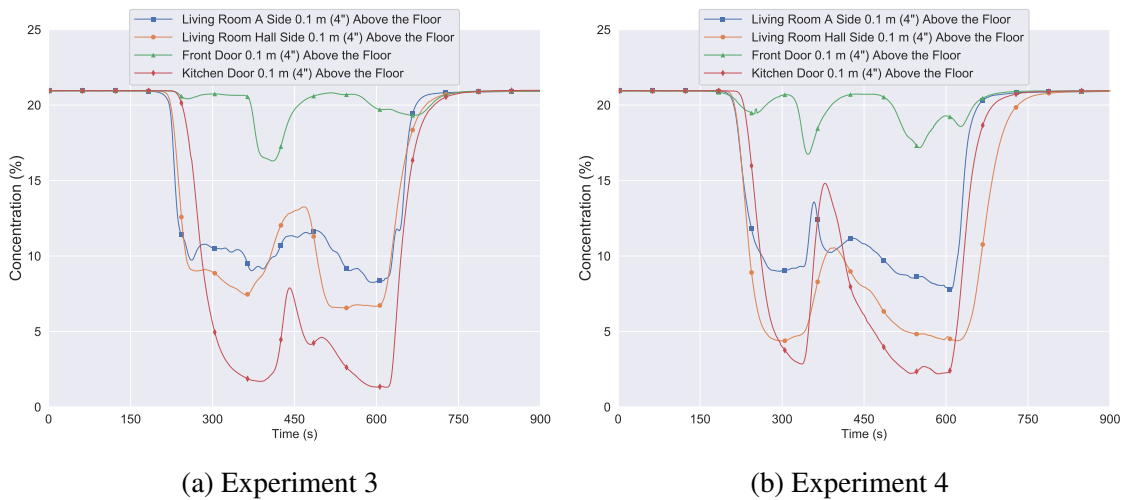
Figure 6.14: Comparison of open door oxygen concentrations at 0.1 m above the floor.

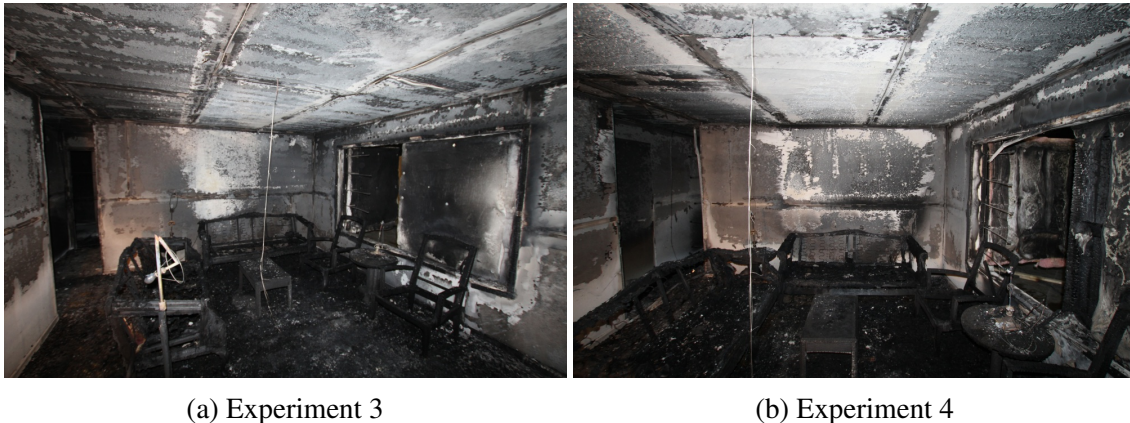
Figure 6.15: Post-suppression comparison of living room area of origin, with open door.

The first two sets of photographs are of the area of origin (see Figures 6.15 and 6.16). These two living rooms have many similarities. The wall behind the ignition sofa and the floor area under

the sofa have fire damage patterns above and below the outline of the sofa that frame the point of origin. Both walls have a vertical damage pattern starting above the back of the sofa and continuing toward the ceiling.

Both of the ceilings have had most of face paper of the gypsum board burned off over the full length and width of the living room. The carpet and padding burned with the exception of some small protected areas, such as areas under a solid object like the base of the floor lamp or the TV stand. The sub-floor was charred from the ignition wall to the front door, and from the second sofa to the front wall. The horizontal line of demarcation on the left wall was approximately 0.75 m (2.5 ft) above the floor in both experiments.

Figures 6.15 and 6.18 show the post fire suppression photographs of the living rooms that burned with the front door open. Both rooms burned for approximately 7 min post-flashover.

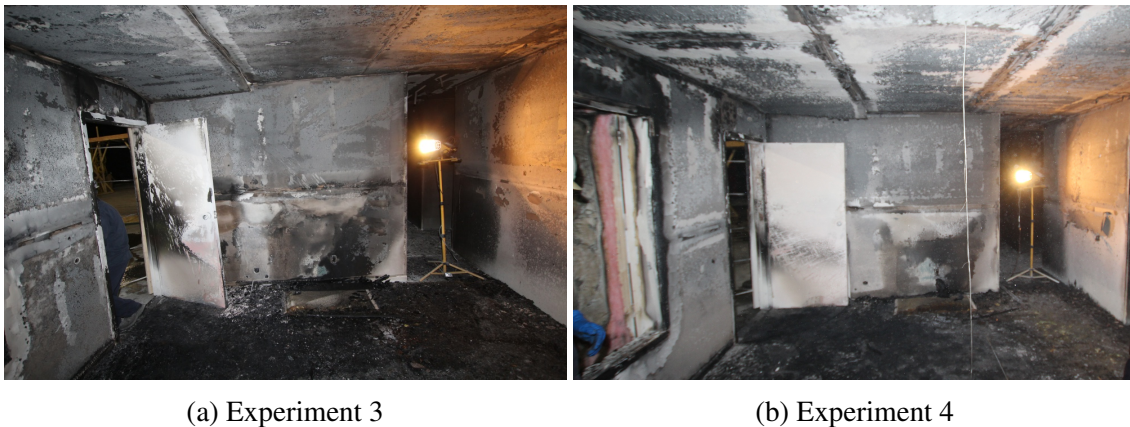
Figure 6.18: Post-overhaul comparison of living room wall opposite the area of origin and adjacent to front door with open door.

Figures 6.17 and 6.18 show the area adjacent to the front door. Both of the walls show a dark pattern on the wall in the area of the TV stand. There is an area in the center of each pattern that has additional burn damage, some portions of it clean burned. On the right side of each of the patterns is a dark plume mark that sweeps over and up the right side. This collection of damage was likely caused by the intake air from the door, which enabled the TV stand to burn later into the fire event, resulting in a clean burn in the middle of a pre-flashover soot pattern. The flow of the intake air caused the combustion products from the burning TV stand to flow toward the inside of the house. If the outward plume pattern was caused by an obstruction and not impacted by the ventilation, two equal plumes on both sides of the TV stand would be expected.

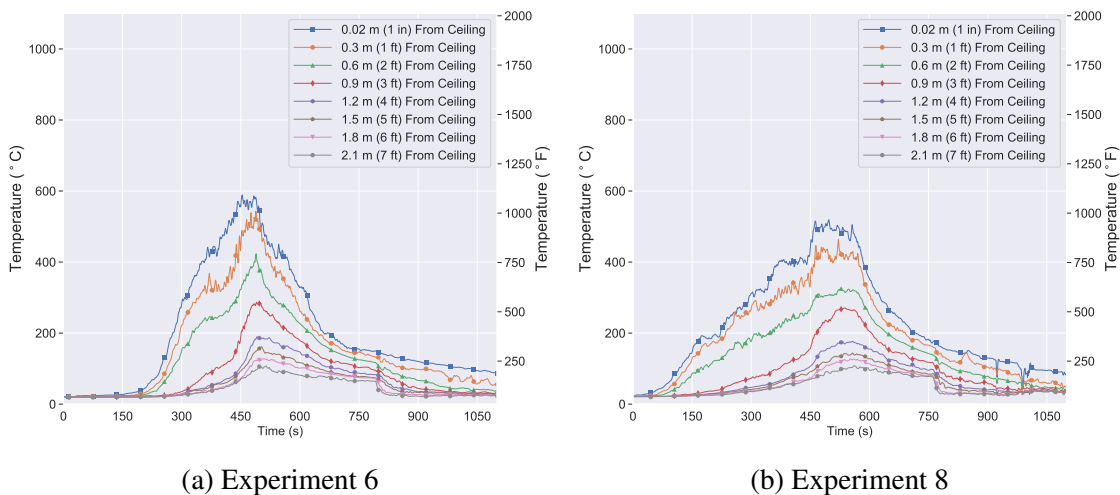
Figure 6.21: Comparison of closed door breakfast area temperatures.

For the closed door kitchen fires, the thermocouple array in the kitchen for Experiment 8 failed during the experiment. To compare these experiments, the breakfast area temperatures are used because the breakfast area is the next closest measurement array to the kitchen. The temperature time histories of the kitchen fires were similar in magnitude as shown in Figure 6.21, but lower in overall magnitude compared to the kitchen.

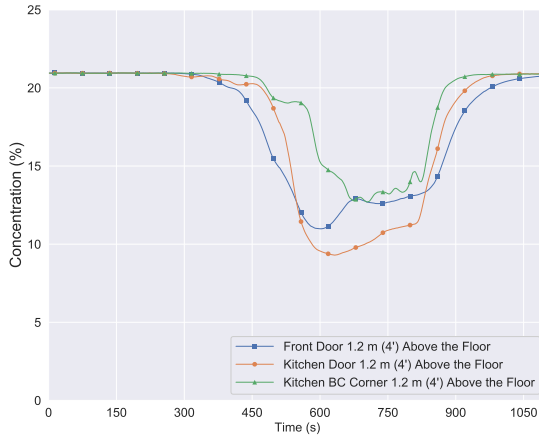
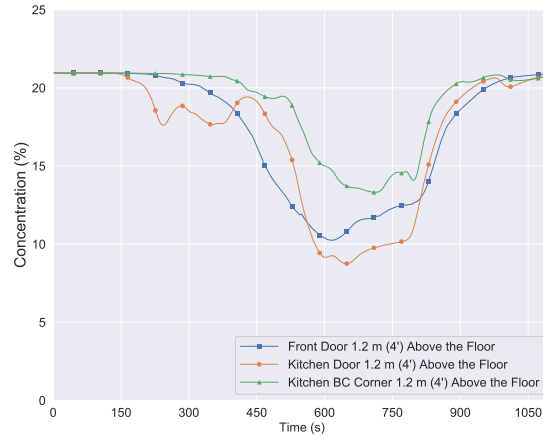
Figure 6.22: Comparison of closed door oxygen concentrations at 1.2 m above the floor for kitchen fire.

In both experiments post-flashover, the oxygen concentrations measured at three locations 1.2 m above the floor in the kitchen and the front door decreased to a range of 9%–13% as shown Figure 6.22. The oxygen concentrations measured at five locations 0.1 m above the floor decreased

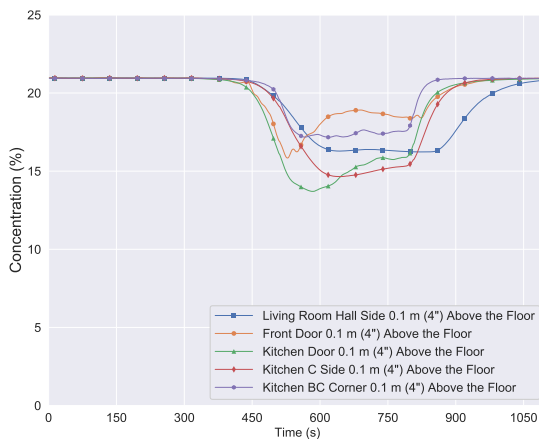
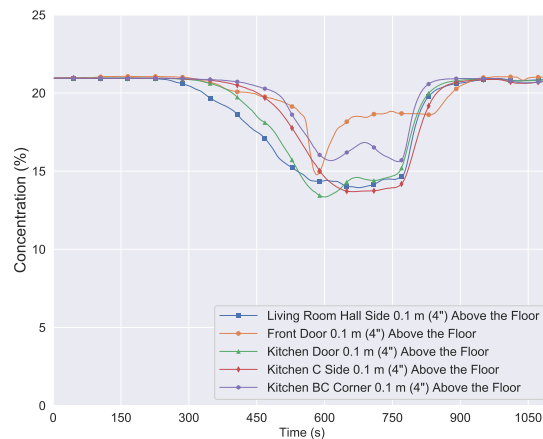
Figure 6.23: Comparison of closed door oxygen concentrations at 0.1 m above the floor for kitchen fire.

to between 14%–18% as shown for both experiments in Figure 6.23. While each of the oxygen concentration values between the experiments are not exact matches, the trends are similar, and the relationship between oxygen values and the increase and decrease in temperatures in the living room were consistent.

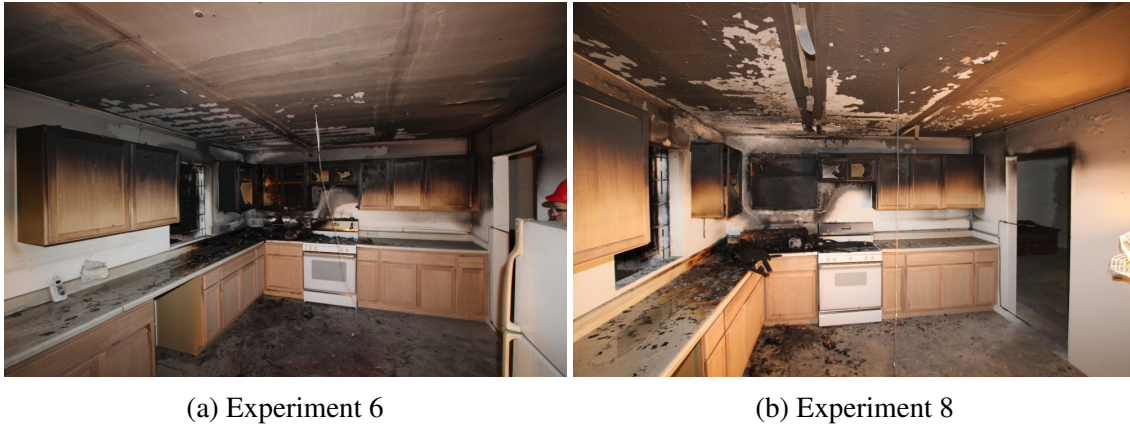
Figure 6.24: Post-suppression comparison of kitchen room area of origin with a closed door.

Figures 6.24 and 6.25 show the post fire suppression photographs of the kitchen fire experiments that burned with no exterior vents open. Both rooms burned until they self-extinguished. The fire in Experiment 6 appeared to self extinguish about 8 min and 30 s after flaming ignition of the coffee maker. The fire in Experiment 8 appeared to self-extinguish at 10 min and 45 s after ignition of the coffee maker. In both experiments, firefighters entered the structure approximately 13 min after ignition and extinguished hot spots with a handheld fire extinguisher.

The wall cabinets above ignition have different levels of damage. Both were fully involved in the fire and the cabinet doors burned away, as did the fuel load inside the cabinet. However, in Experiment 6, the outer box of the cabinet was still on the wall, while in Experiment 8, only the back board of the cabinet was attached to the wall. When the wall cabinet collapsed, that removed an obstruction to the fire burning up from the counter. Without the cabinet in the way, the flames extended toward the ceiling, which resulted in the ceiling damage aligned with the point of origin and toward the center of the room. Since much of the heat went up and away from the countertop area of origin, the damage to the cabinet on the left wall adjacent to the fire origin was reduced when compared to Experiment 6. In Experiment 6, the bottom of the wall cabinet over the coffee maker remained in place, which directed flames toward the bottom of the cabinet on the left wall. This resulted in additional burning of the wall cabinet on the left wall, which in turn caused more thermal damage to the ceiling toward the left wall.

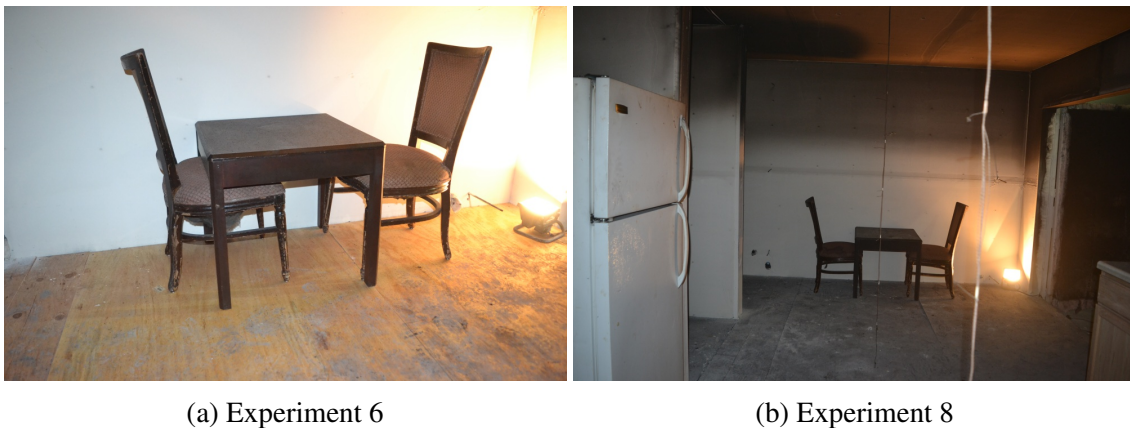
Figure 6.25: Post-suppression comparison of kitchen dining area opposite area of origin with closed door.

Moving past the window on the left wall, the damage of both experiments becomes more alike. There was no thermal damage on either dinette set. Further, the plywood floor was undamaged in both experiments.

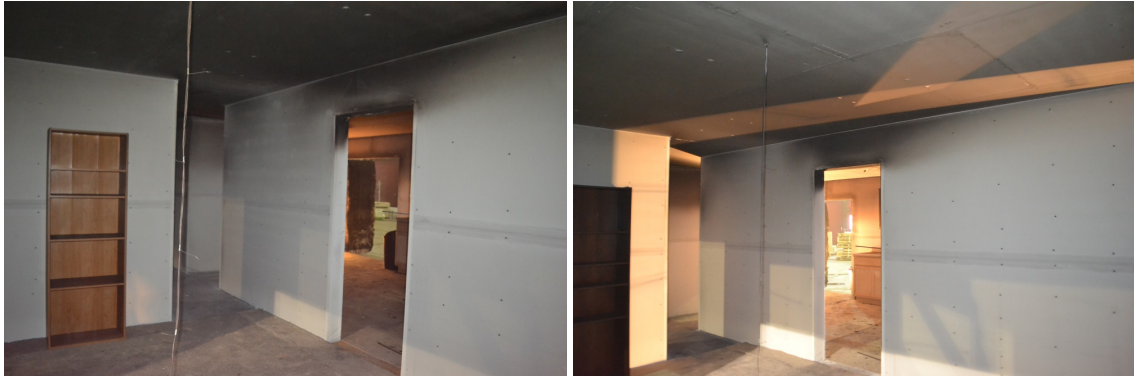
Figure 6.26: Post-suppression comparison of kitchen room area of origin and closed door.

The next pairs of figures show the post fire conditions in the living room. Figure 6.26 shows the area between the closed front door on the left and the open doorway to the kitchen on the right. In both experiments, there is evidence of smoke flow through the upper portion of the kitchen doorway with soot deposited above the doorway, on both sides of the door, and spread over the living room ceiling. The photos in Figure 6.27 show the sofa located on the wall opposite the wall with the bookcase. There was no thermal damage to that wall or the sofa in either experiment.

There were differences within the pre-flashover damage zone due to the timing of the cabinet collapse. Considering the fires from the aspect of ventilation and available oxygen for combustion, these fires and the resulting damage were very similar. The fire damage was limited to the corner of the kitchen near the fire origin, and then the flaming combustion self-extinguished and did not re-kindle.

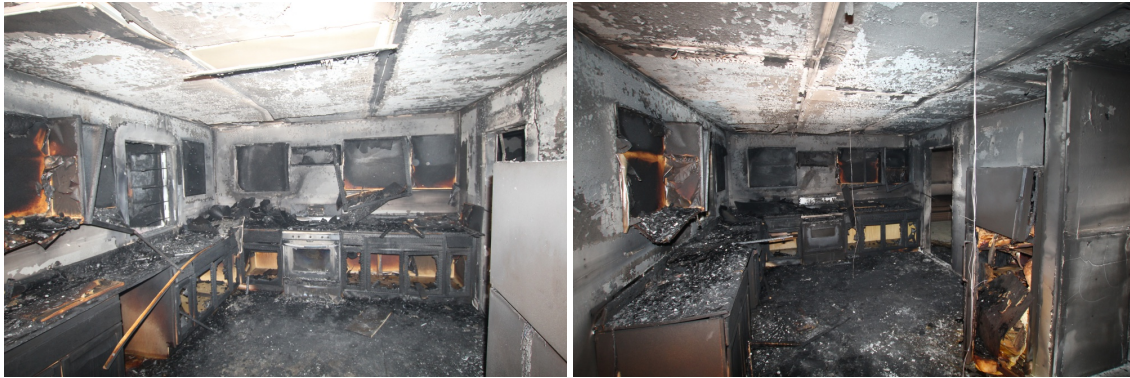
Figure 6.33: Post-suppression comparison of kitchen room area of origin with a open door.

Figures 6.33 and 6.34 show the post fire suppression photographs of the kitchen fire experiments that burned with an open front door. Both fires flashed over the kitchen. Both fires went into decay in 75 s or less post-flashover. For Experiment 10, the heat release from the fire in the kitchen increased to the point that fire spread into the living room and the living room flashed over. Within one minute post-flashover in the living room, the fire extinguishment started. In Experiment 11, the heat release rate rebounded just like in the previous experiment, and the living room carpet near the kitchen door ignited. The temperatures in the living room increased on a similar trend to Experiment 10. The front door was closed to examine the impact on the fire due to stopping the flow of fresh air into the structure.

In both experiments, the damage to the wall cabinets was similar. Even the remains of the cabinets on the wall were similar. In both fires, the doors of the base cabinets burned through, with the exception of the base cabinet most remote from the fire origin.

The ceiling and floor damage in the area bounded by the kitchen cabinets was consistent with post-flashover damage. In both experiments, the table and chairs in the breakfast area of the kitchen ignited. On the wall behind the table and chairs, soot deposits formed a line of demarcation 0.6 m (2 ft) or less above the floor. Another line of demarcation on the wall formed by thermal damage was located approximately 1.5 m (5 ft above the floor).

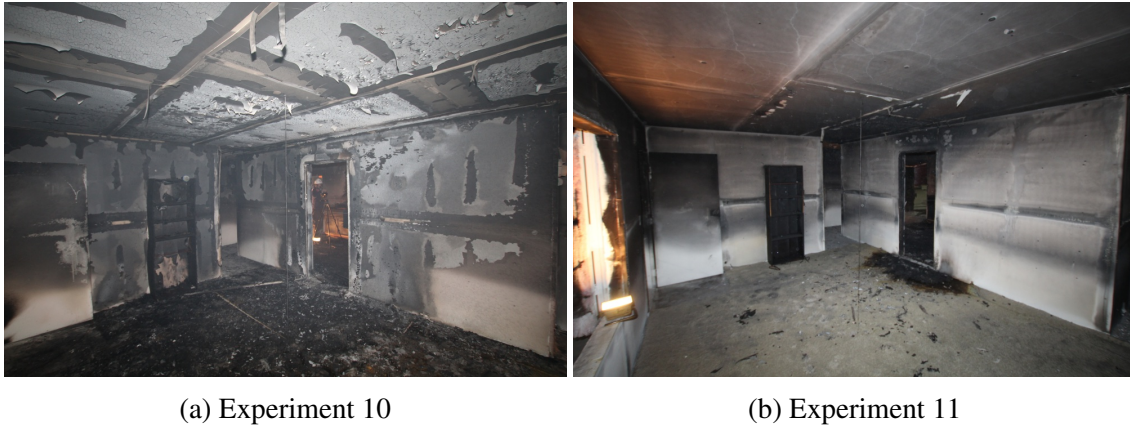
Figure 6.35: Post-suppression comparison of living room between kitchen room area of origin and open door.

The next two figures show the post fire conditions in the living room. Figure 6.35 shows the area between the open front door on the left and the open doorway to the kitchen on the right. In other words, this shows the living room portion of the flow path. Figure 6.36 show the sofas located on the wall opposite the wall with the bookcase. In the images from Experiment 10, area between the two doors had fire damage from the ceiling down to the floor, consistent with a post-flashover fire environment. On the other side of the living room, there was fire damage across the ceiling and down the walls to within 0.9 m (3 ft) of the floor. The sofa also ignited.

The kitchen fires in both cases transitioned through flashover and then decreased due to a reduction in oxygen. As the fires cycled and the additional oxygen could flow into the kitchen, the heat release of the fires increased, perhaps due to the continued oxygen limit or the reduced amount of fuel in the upper portion of the kitchen, neither kitchen flashed over again. The fire damage patterns in both kitchens are similar, indicating that the flashed over living room or lack thereof had little influence on the fire damage in the kitchen in this set of experiments.

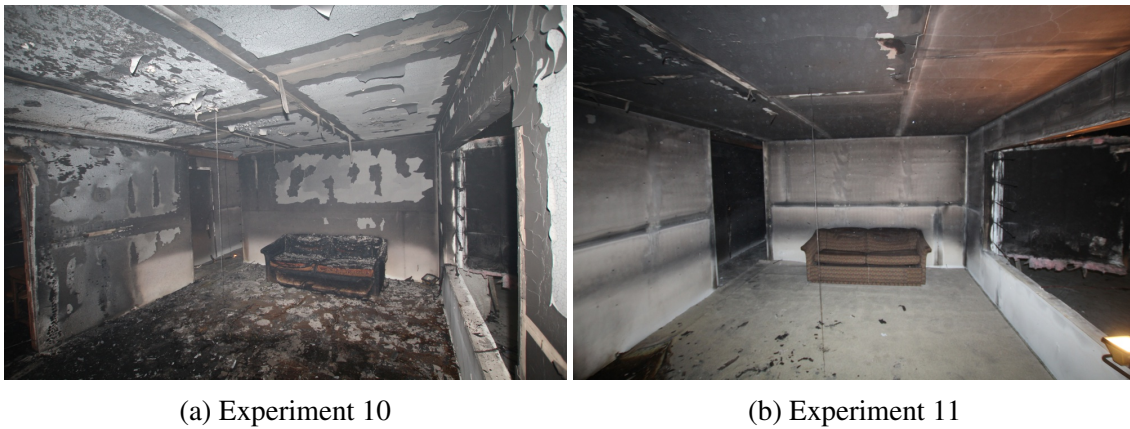
Figure 6.36: Post-suppression comparison of living room wall remote from kitchen with open door.

was limited to soot condensed on the ceiling and walls. Neither the sofa nor the bookcase ignited.

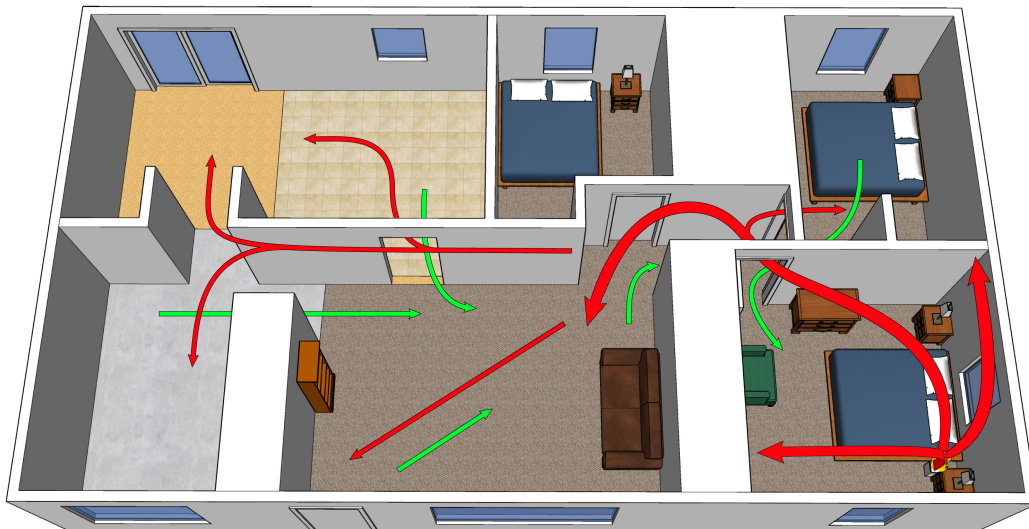
Figure 6.37: Drawing of the pre-flashover flows within the closed ranch structure bedroom fire.

Figures 6.37 and 6.38 provide a graphic representation of the flow paths within the ranch structure. Figure 6.37 shows the flow of hot gases (red arrows) beginning at the area of fire origin and flowing throughout the adjoining rooms in the structure that are open to the bedroom. As the hotter, higher pressure fire gases flowed into other rooms such as the living room or bedroom 2, the fresh air (green arrows) in those rooms was displaced toward the area of origin. This delivered the supply of oxygen needed for combustion. As combustion within the structure ceased due to a lack of oxygen, the measurable flows also stopped, as represented by the smoke-filled areas in Figure 6.38. Bedroom 3 was closed and was not part of the flow path.

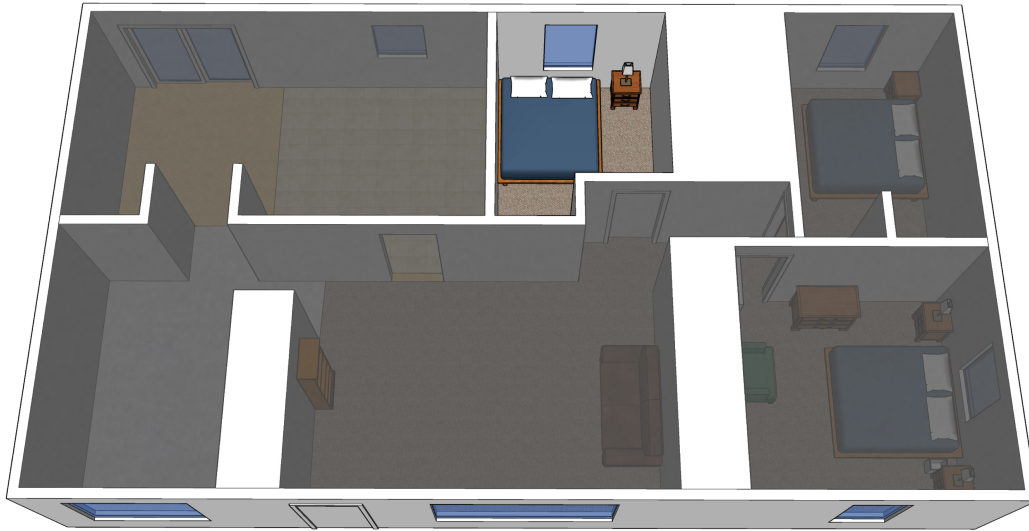
Figure 6.38: Drawing of the post-flashover condition within the closed ranch structure bedroom fire.

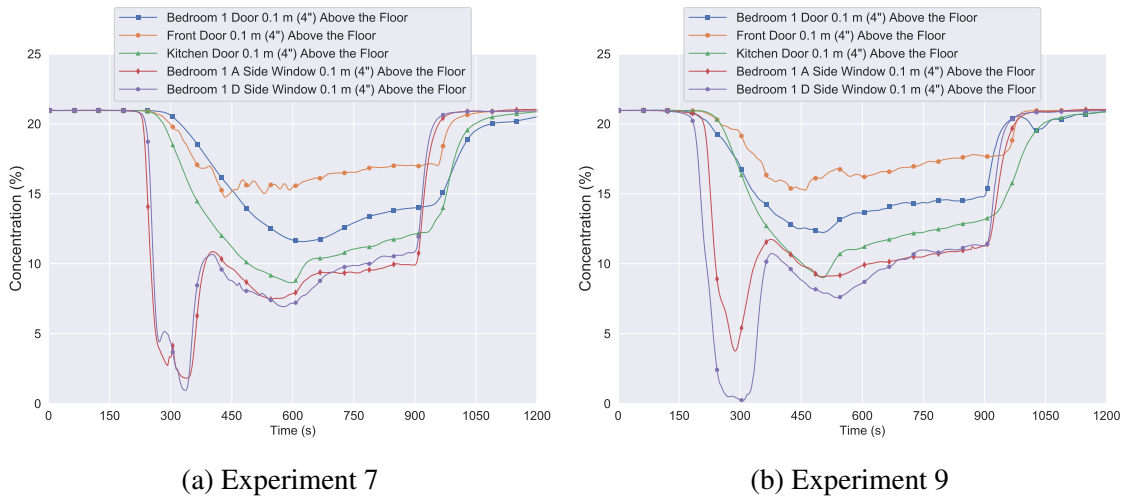
Figure 6.41: Comparison of closed door oxygen concentrations at 0.1 m above the floor for bedroom fire.

5% in both experiments. Figure 6.41 shows the oxygen concentrations at 0.1 m. While each of the oxygen concentration values between are not exact matches, the trends are similar, and the relationship between oxygen values and the increase and decrease in temperatures in the living room were consistent.

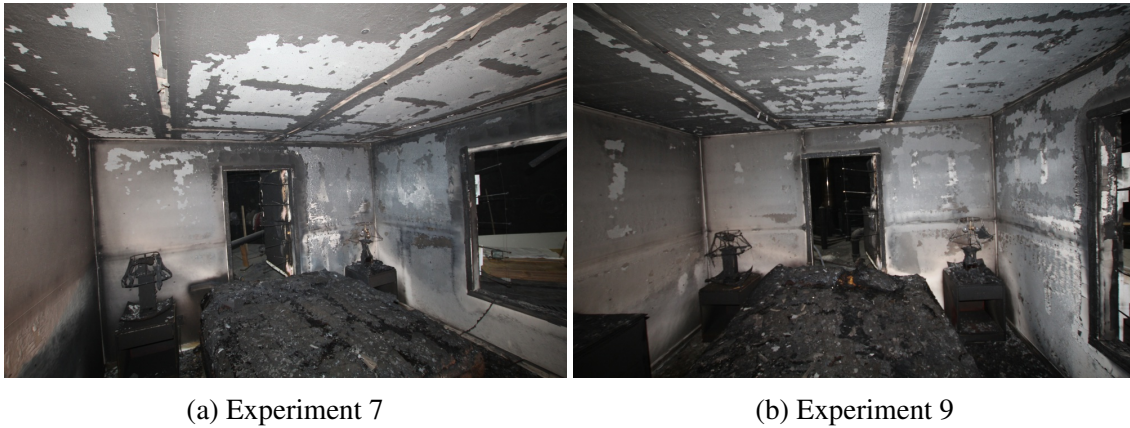
The first pair of images, Figures 6.42 and 6.43, show the areas of origin with the furnishings still in place. The bed, nightstands, dresser, and chair had damage consistent with being ignited and burned over their exposed surfaces. Heat damage to the upholstered chair was similar in both experiments and seemed to start from the top down.

Figure 6.42: Post-suppression comparison of bedroom 1 area of origin with a closed door.

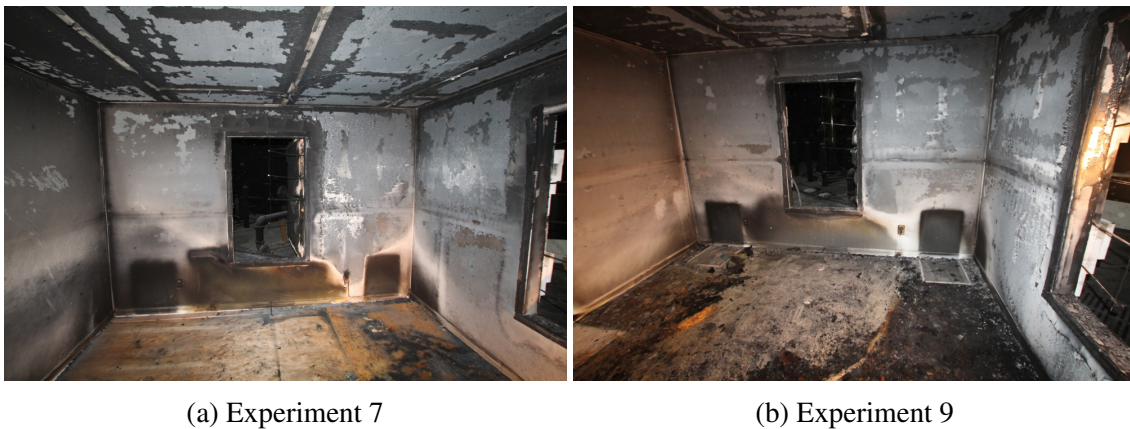
Figure 6.43: Post-furniture removal comparison of bedroom 1 area of origin with closed door and windows.

The next sets of images have the furniture removed. Looking at the area of origin photographs, both ceilings had the paper burned off of the gypsum board from the area over the bed to the front wall, and the wall with the chair against it. The walls have similar damage in both experiments, in part because of the soot patterns formed in the shielded areas behind the furniture and the large window openings in two of the walls. In both experiments, the front wall received thermal damage across the upper half of the wall that was across from the bedroom door. The lack of damage on the lower portion of the wall may be a result of the chair obstructing the air flow into the bedroom. Approximately 0.3 m to the side of the front window, the thermal damage demarcation line moved toward the floor. The thermal damage continued across the front walls above and

below the window. Continuing across the front wall to the corner near the point of ignition, the thermal damage extended over the height of the wall. The doorway walls opposite the front walls had limited thermal damage with discrete areas in the upper half of the walls where the paper was burned off of the gypsum wallboard. The wall adjacent to the doorway in both experiments had a protected area pattern behind the upholstered chair. The walls had a light coating of soot and some discrete thermal damage areas in the upper left half of the wall. On the downstream side of the chair there was a clear area on the wall. Also in both fires, portions of the bedroom door from the door knob up were burned away.

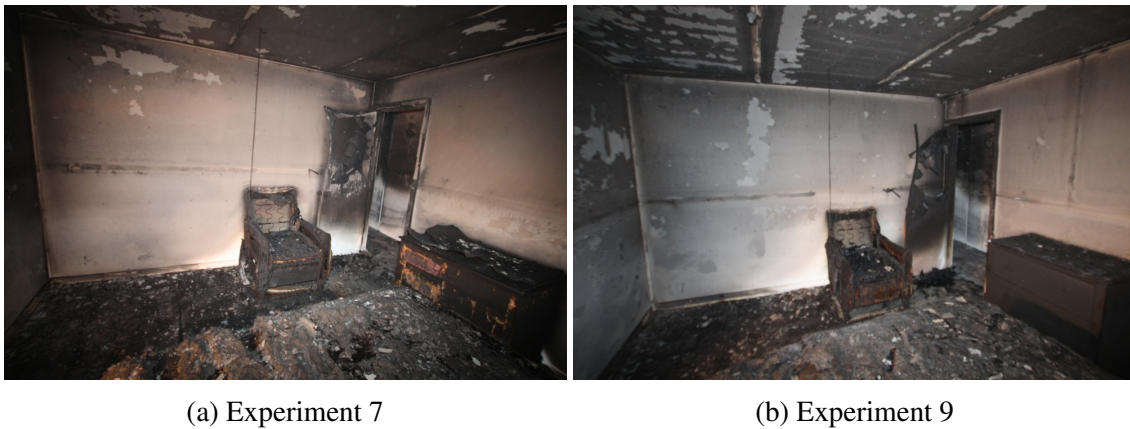
Most of the fire damage to the carpet and sub-floor occurred along the air intake path from the bedroom door, starting just past the chair, past the foot of the bed, and around the side of the bed between the bed and the front wall. This was due not only to the air flow there, but also because the carpet was pre-heated and pyrolyzed due to radiation from the fire burning from the night stand and side of the bed.

Figure 6.44: Post-suppression comparison of bedroom 1 opposite the area of origin with closed door.

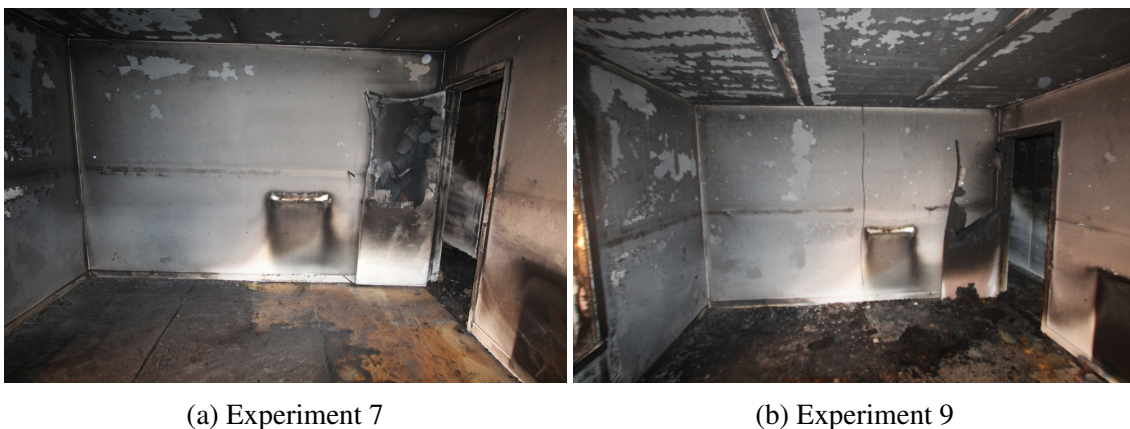
Figure 6.45: Post-furniture comparison of bedroom 1 wall opposite area of origin with closed door and windows.

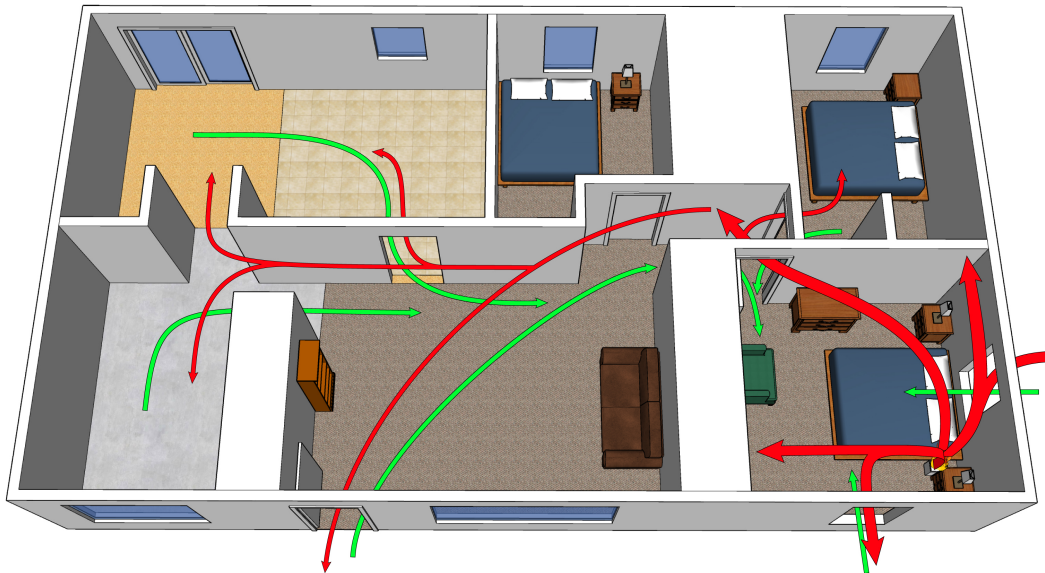
Figure 6.46: Drawing of the pre-flashover flows within the ranch structure bedroom fire with open front door and bedroom windows.

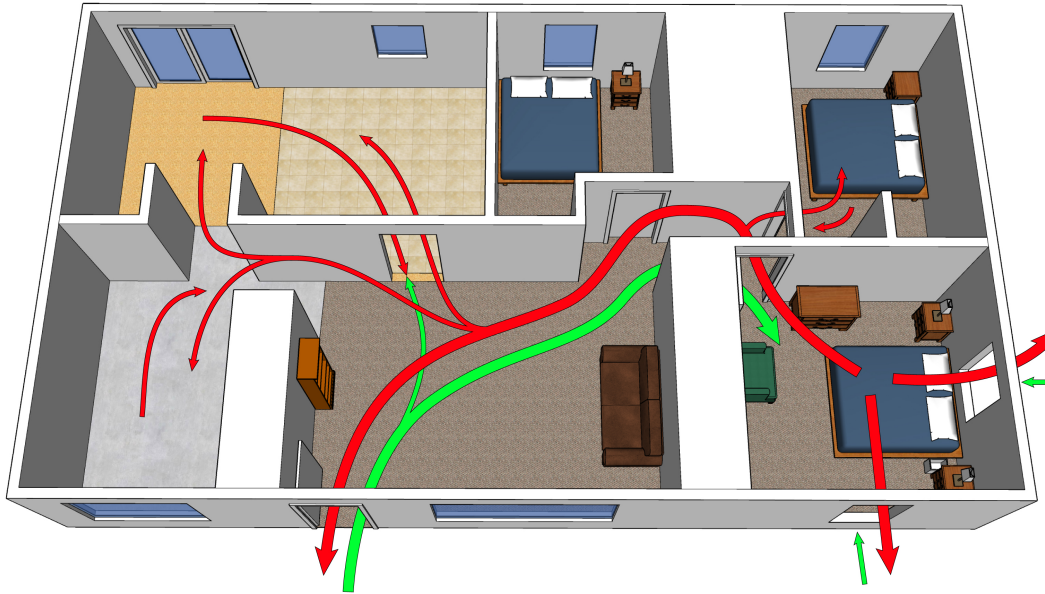
Figure 6.47: Drawing of the post-flashover flows within the ranch structure bedroom fire with open front door and bedroom windows.

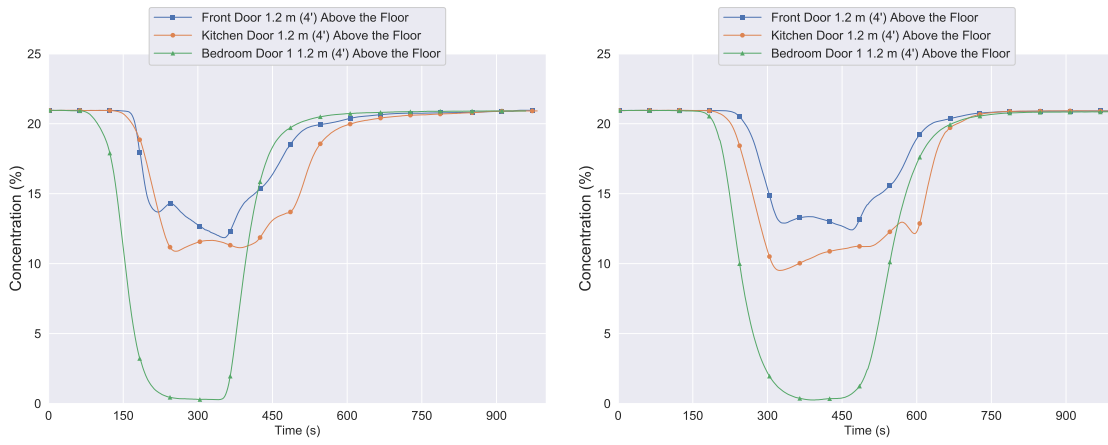
In both experiments, the oxygen levels measured at the bedroom doorway at 1.2 m above the floor dropped to near 0%, while the front door and kitchen doorway (both further from the fire room) had oxygen concentrations between 10% and 15% as shown in Figure 6.49. All five oxygen sensors

Figure 6.49: Comparison of open door and windows oxygen concentrations at 1.2 m above the floor for bedroom fire.

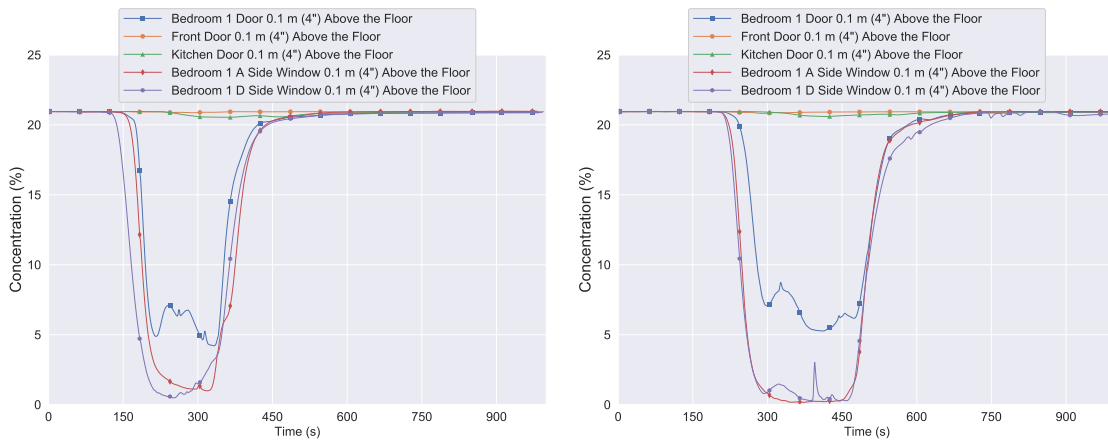
at the 0.1 m elevation had similar responses: The sensors closest to the front door had the highest oxygen concentrations, while the two sensors in the bedroom below the open windows had the lowest values, as Figure 6.50 shows.

Figure 6.50: Comparison of open door and windows oxygen concentrations at 0.1 m above the floor for bedroom fire.

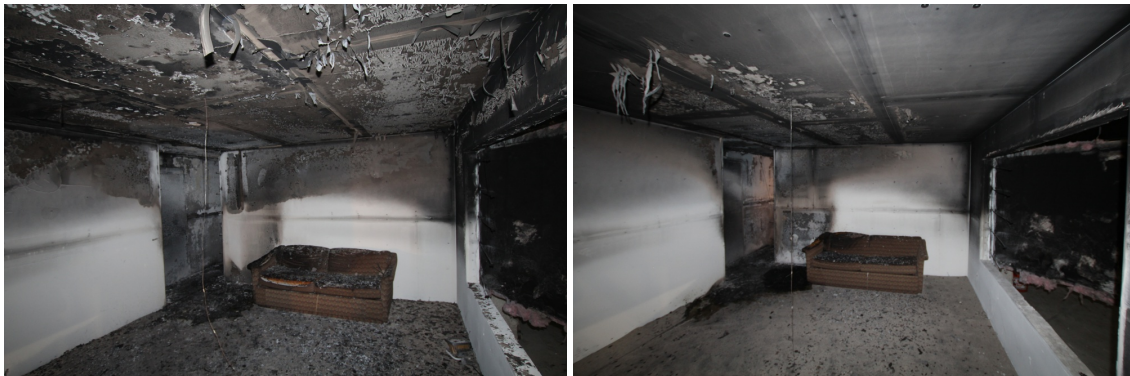
The last set of photographs for these two experiments show the conditions in the living room, which served as one of the flow paths for gases to exit the structure and fresh air to enter the structure. Figure 6.55 shows the living room from the front door, looking toward the hall leading to the fire room. In both experiments, flames exited the bedroom and flowed into the hall. The carpeting in the hall burned and spread to the living room to the point of igniting the left side of the sofa. The

arched line of demarcation over the sofa was similar in both experiments. The soot patterns and their lines of demarcation on the walls in the living room were similar in height above the floor, and by observation, in amount. In Experiment 12, more than half of the ceiling had thermal damage. In Experiment 13, less than half of the ceiling had thermal damage. Figure 6.56 shows the portion of the living room toward the open front door. It shows that the damage was reduced as the distance increased from the fire room. The bookcases did not ignite in either experiment.

Figure 6.55: Post-furniture comparison of living room area adjacent to bedroom hall, open front door and bedroom windows.

No clear fire pattern identifying an area of origin appeared on the walls. There are several reasons for this: The ventilation points near the point of ignition, the increased post-flashover heat release rate in the room, and the ignition fire, which did not contact the wall early in the early stage of the fire.

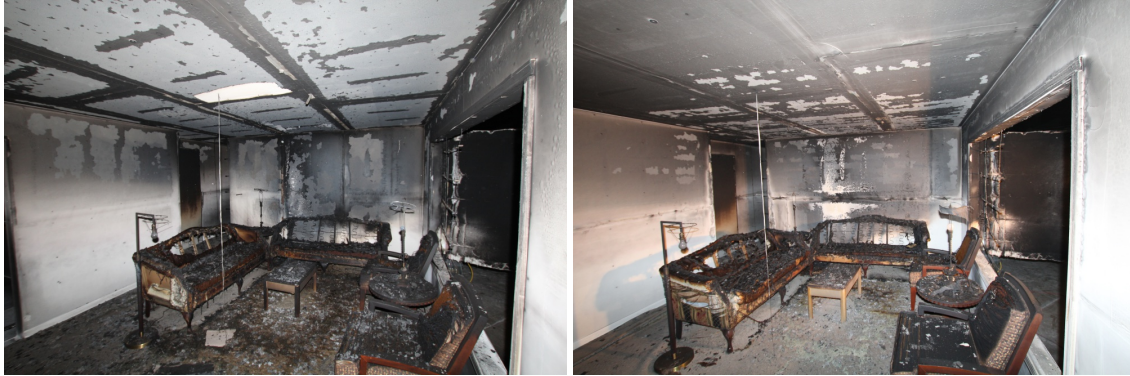
Figures 6.57 and 6.58 show the post fire suppression photographs of the living rooms that burned with no open exterior vent and with the front door open, respectively. The difference in the extent of the fire damage is clear. The open door provided an exhaust vent for oxygen-depleted combustion products and an intake vent for air. The continued supply of air supported combustion for a longer period of time. During that time, the combustion zone moved from the area of origin toward the open front door, and then later in the experiment the fire began to move back toward the area of origin.

Figure 6.57: Post-suppression comparison of living room area of origin, with closed door.

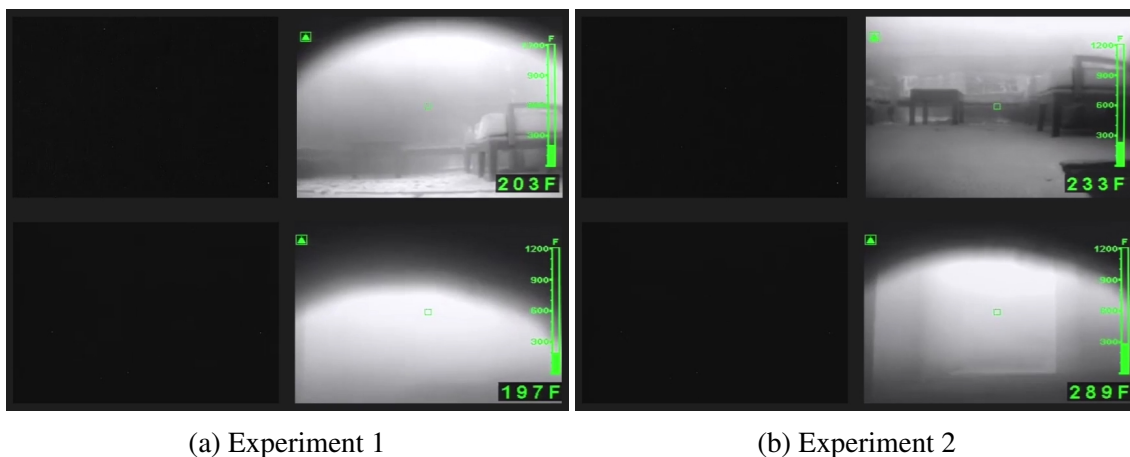
All of the images were taken at 300 s after ignition. The images in Figure 6.61 show that in Experiments 1 and 2 (exterior vents closed), the fire had depleted the oxygen levels within the structure such that the flames self-extinguished shortly after flashover. The Figure 6.62 images were from Experiments 3 and 4, which had the front door open. The air flow through the open door enabled the fire to continue to burn post-flashover. However, at this point, the fire was only burning near the open front door where the hot fuel gases could mix with oxygen entering the door (see upper images). At the same time, the gas-phase combustion near the area of origin had stopped due to a lack of oxygen (see lower images). In both open door experiments, shortly after flashover the estimated wall temperature adjacent to the point of ignition decreased to less than 200 °C (400 °F).

Figure 6.61: Pairs of video and infrared images from two views of the living room for Experiments 1 and 2 at 300 s after ignition, closed door. The two upper views in each set of images are from cameras near the front door and looking toward the area of origin. The lower two views in each set of images are from cameras in the dining room, with the center of the image view approximately 1 m to the left of the area of origin.

toward the area of origin. The lower two views in each set of images are from cameras installed in the dining room and aimed toward the living room. The center of the thermal image view was approximately 1 m (3 ft) to the left of the point of fire origin.

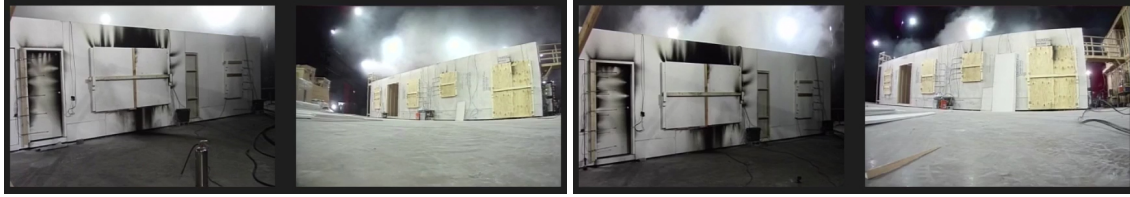
Figure 6.63 shows the lack of smoke flow out of the structure at this time. The soot marks on the front door and above and below the front window shutters are evidence that as the fire was growing, the gas pressure inside the structure was sufficient to force smoke around the edges of the closed vents. In the case of the front door, there was evidence that the smoke was all the way down to the floor when it was being forced out close to the bottom of the door. By 300 s after ignition the fires self extinguished due to a lack of oxygen. The gas temperatures have decreased and the pressure inside the structure was less then the pressure outside of the structure, so the smoke stopped pushing out.

Figure 6.63: Images of the exterior of the structure for Experiments 1 and 2 at 300 s after ignition, closed door. The left view of each pair of images shows the front side. The right view of each image pair shows the back side.

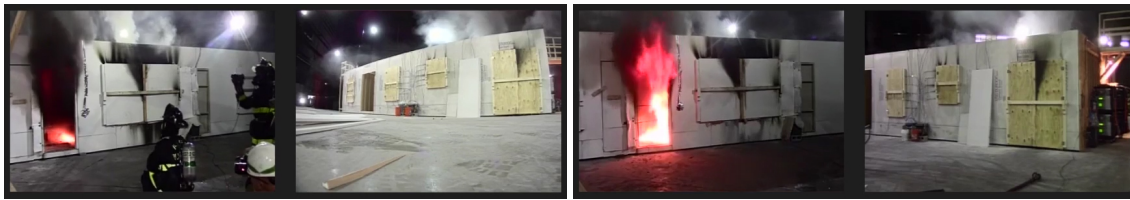
Experiments 3 and 4 had the front door open from the time of ignition. Images of the front and rear of the exterior of the structure with the open door appear in Figure 6.64. In both experiments, the fire can be seen burning in close proximity to the open door. The open door is acting as a bidirectional vent with both an air intake and an exhaust.

Figure 6.64: Images of the exterior of the structure for Experiments 1 and 2 at 300 s after ignition, open door. The left view of each pair of images shows the front side. The right view of each image pair shows the back side.

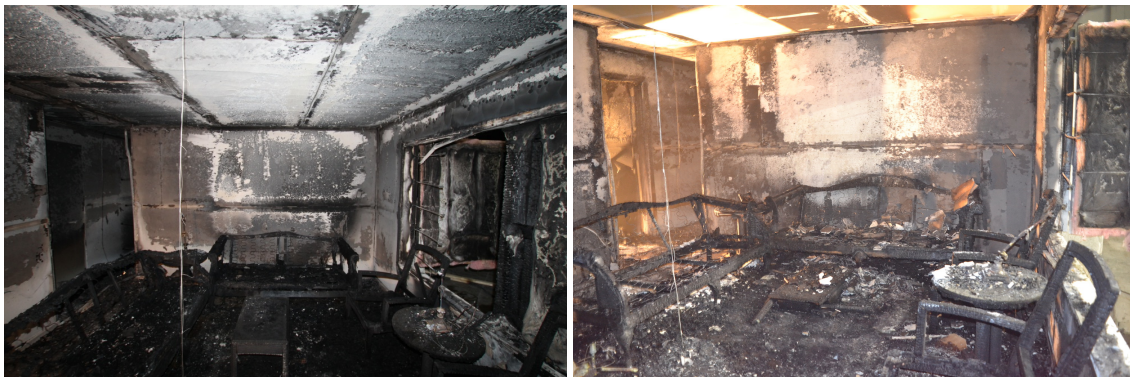
In Experiment 5, the ventilation of the structure was increased with the addition of the bedroom 3 window open for the duration of the experiment. Recall from Figure 4.25, temperatures within the living room remained elevated compared to Experiments 3/4. The increased temperatures were the result of more energy being released from the fire. As a result, the living room sustained more damage. Of particular interest in Figure 6.65, which compares Experiments 4 and 5, is the additional damage on the left side of the back wall of the living room toward the hallway. The open bedroom 3 window provided a second exhaust path for the hot combustion products to travel.

Figure 6.65: Post-suppression comparison of living room area of origin, with open door and open window (Experiment 5 only).

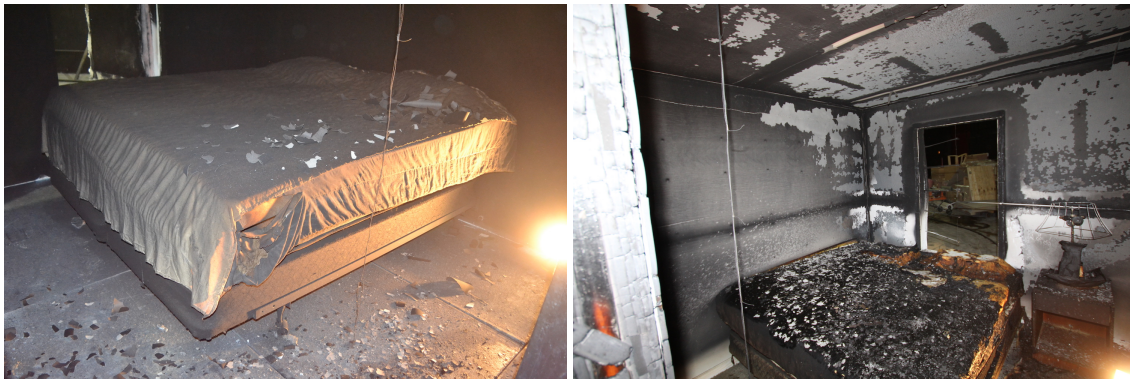
To further compare the impact of ventilation, consider the post suppression fuels in both bedroom 2 and bedroom 3. Figure 6.66 shows the differences that resulted from having a closed window (bedroom 2) and an open window (bedroom 3). In bedroom 2, there is evidence of smoke damage due to soot deposition but no indication of flame combustion. In bedroom 3, there is noticeable damage to the exterior wall and evidence of burning on the foam mattress topper of the bed. The open window allowed the high temperature unburned fuel from the living room to mix with the air entrained from the open window and ignite.

Figure 6.66: Post-suppression comparison of bedroom 2 (closed window) and bedroom 3 (open window) from Experiment 5.

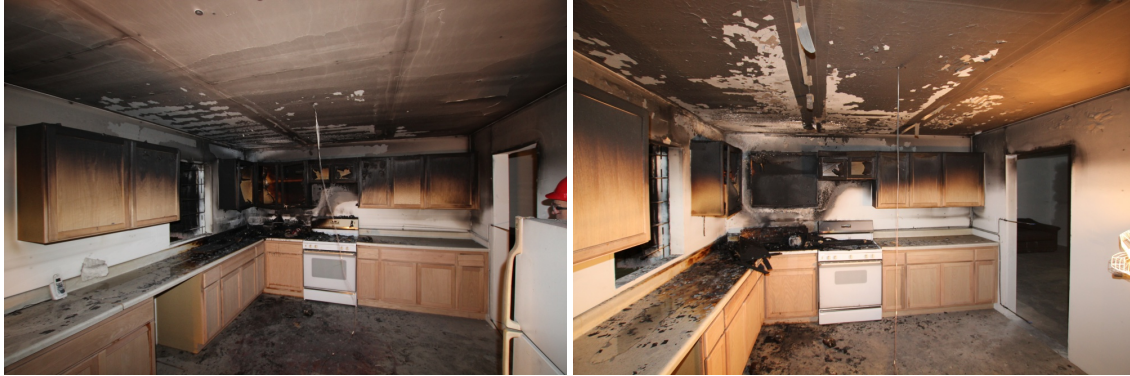
Figures 6.67 and 6.68 show the post fire suppression photographs of the both the kitchens burned with no open exterior vent and with an front door open, respectively. The difference in the extent of the fire damage is visible. The open door provided an exhaust vent for oxygen-depleted combustion products and an intake vent for air. The continued supply of air supported combustion for a longer period of time. In Experiment 10, the combustion zone moved from the kitchen toward the open front door and then flashed over the living room.

Figure 6.67: Post-suppression comparison of kitchen room area of origin with a closed door.

The kitchen fires were conducted with two different ventilation conditions: all exterior vents closed, and the front door open. The two kitchen fires conducted with no exterior ventilation grew from a small flame to flames involving cabinets and impacting the ceiling, and then in both cases the fires self-extinguished. This fire behavior resulted in a limited amount of fire damage in each kitchen. Each kitchen had a similar fire pattern that could be traced back to the area of origin.
