# Impact of Fixed Ventilation on Fire Damage Patterns in Full-Scale Structures

Daniel Madrzykowski  
Craig Weinschenk

UL Firefighter Safety Research Institute  
Columbia, MD 21045

April 18, 2019

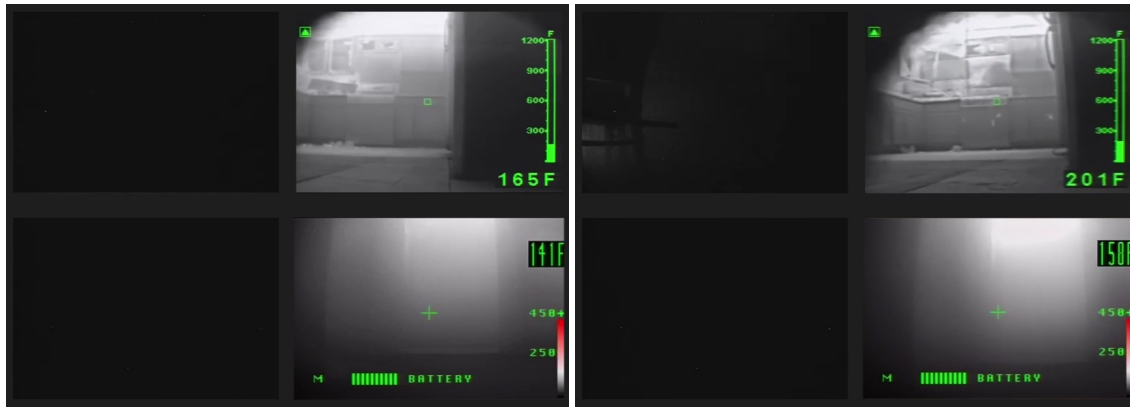
The images in Figure 6.69 show that in Experiments 6 and 8 (exterior vents closed), the fire had depleted the oxygen levels within the structure such that the flames self-extinguished shortly after flashover. These images were taken at 600 s after ignition.

Figure 6.69: Pairs of video and infrared images for the kitchen Experiments 6 and 8 at 600 s after ignition, closed door. The two upper views in each set of images are from cameras looking toward the area of origin. The lower two views in each set of images are from cameras in the dining room looking past the kitchen doorway and into the living room.

The pairs of video and infrared images are from two different positions. The two upper views in each set of images are from cameras installed next to the table and chairs in the kitchen and aimed toward the area of origin. The lower two views in each set of images are from cameras installed in the dining room and aimed toward the living room. This provides view of the hot gas flows out the kitchen doorway and the conditions in the living room.

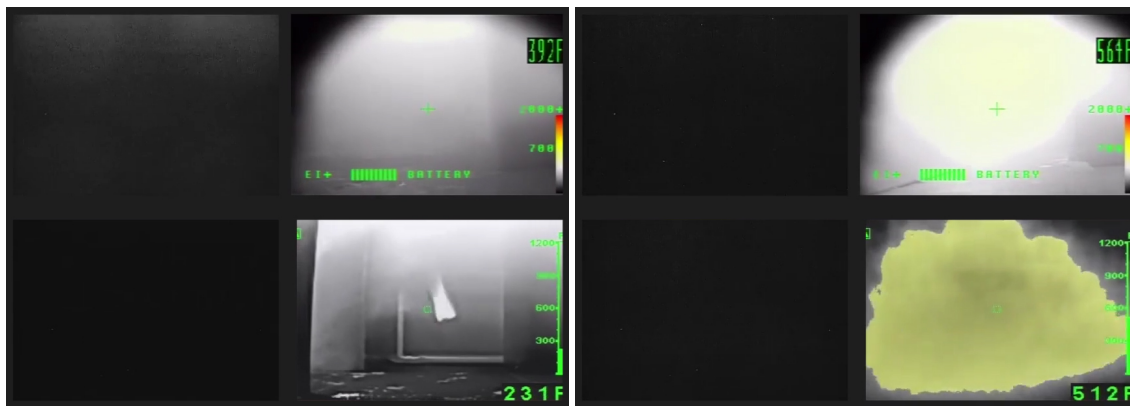
The images in Figure 6.70 were taken from Experiment 10, which had the front door open. The air flow through the open door enabled the fire to continue to burn post-flashover. The kitchen fire started to flashover at 405 s after ignition. However by 480 s, the structure was filled with smoke, the kitchen filled with smoke, and the fire size appeared to decrease (see Figure 6.70a). Five minutes later, burning continued in the kitchen, but the fire had now spread and flashed over the living room (see lower images).

Figure 6.70: Pairs of video and infrared images for the kitchen Experiments 10 and 11 at 480 s after ignition, closed door. The two upper views in each set of images are from cameras looking toward the area of origin. The lower two views in each set of images are from cameras in the dining room looking past the kitchen doorway and into the living room.

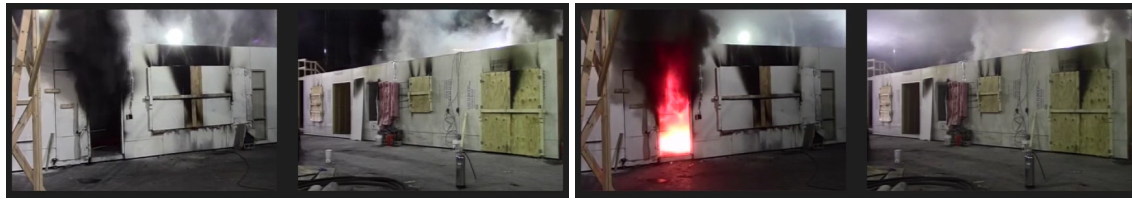
Figure 6.71 shows exterior views of the front and rear of the structure at two different times. Figure 6.71a shows black smoke flowing out of the upper half of the open front doorway during

the kitchen post-flashover. Figure 6.71b shows the exterior conditions during the flashover in the living room.

Figure 6.71: Images of the exterior of the structure for kitchen Experiment 10, closed door. The left view shows the front side. The right view shows the back side.

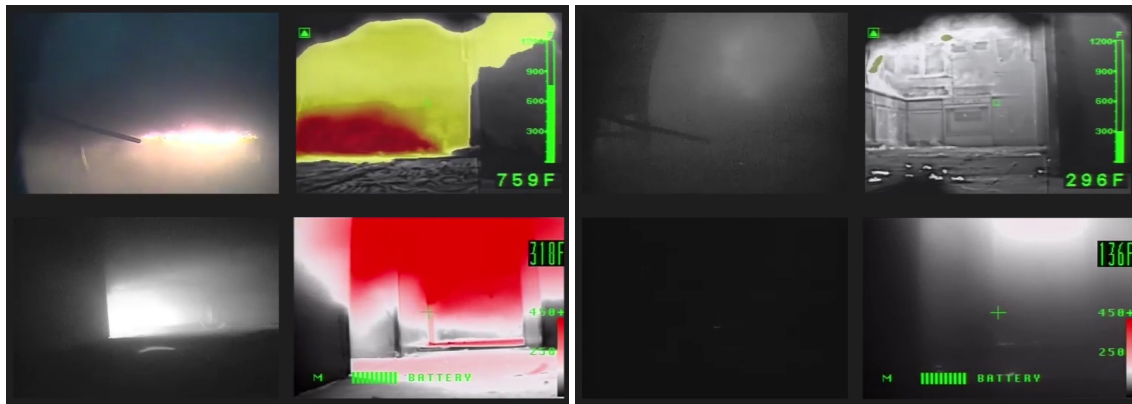
Kitchen Experiment 11 was also conducted with an open front door. Figure 6.72 shows two sets of images. The fire in the kitchen had auto-ignited the kitchen floor at 460 s after ignition. The images in Figure 6.72a were captured at 480 s after ignition. Within 10 s after this image was recorded, the fire in the kitchen began to decrease. The second set of images was taken 2 minutes after the first set, at 600 s after ignition. The temperatures within the structure were decreasing even though the front door was open and fuel was available.

Figure 6.72: Pairs of video and infrared images from two views of the kitchen Experiment 11 at 480 s and 600 s after ignition, respectively, open door. The two upper views in each set of images are from cameras looking toward the area of origin. The lower two views in each set of images are from cameras in the dining room, looking past the kitchen doorway and into the living room.

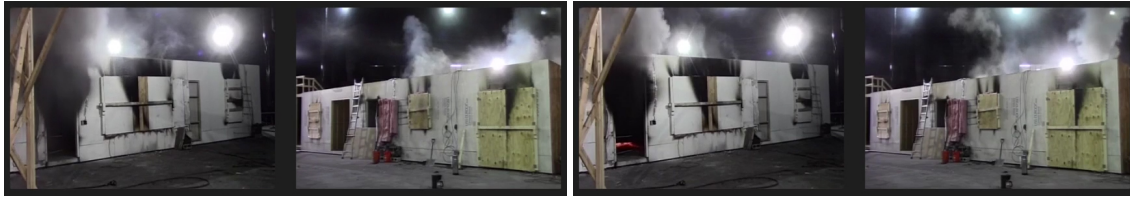
Figure 6.73 shows the front and rear exterior views of the structure at 480 s and 600 s after ignition. Looking at the latter of the two images of the front door, (Figure 6.73b), the fire can be seen in the living room, burning low to the floor.

Figure 6.73: Images of the exterior of the structure for kitchen Experiment 11, open door. The left view shows the front side. The right view shows the back side.

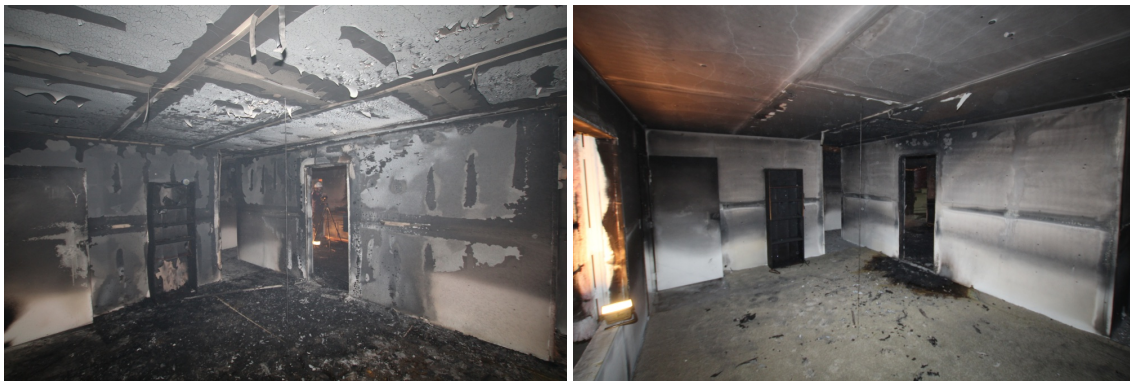
(a) Experiment 10      (b) Experiment 11

Figure 6.74: Post-suppression comparison of living room between kitchen room area of origin and open door.

Figure 6.74 shows the differences in the flow path area of the living room between the open front door and the doorway to the kitchen for Experiments 10 and 11. Closing the door prevented the flashover in the living room in Experiment 11.

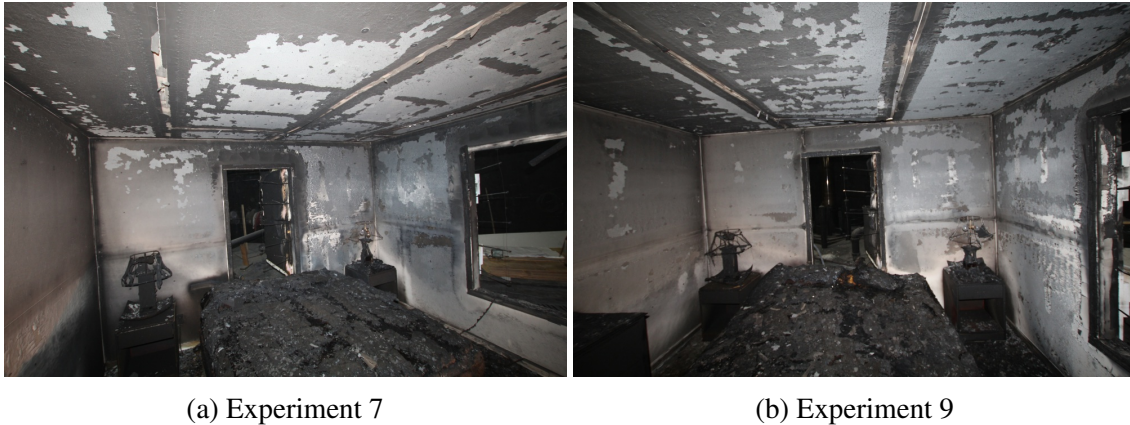
Figure 6.76: Post-suppression comparison of bedroom Experiments 7 and 9, with closed door.

Figure 6.76 shows the post fire suppression photographs of the bedroom from Experiments 7 and 9 that burned with no open exterior vent. Similar photographs appear in Figure 6.77 for Experiments 12 and 13, which were conducted with the front door and bedroom windows open. The bedroom fires with the open door and windows were able to burn for a longer time post-flashover. As a result, room of origin in Experiment 12 and 13 had more fire damage. In the experiments with the open vents, the fire also spread into the hallway, burned the door of the adjacent bedroom, and ignited the sofa in the living room. It is important to note that raising the height of the window sill above the neutral plane could change the amount of fire damage adjacent to the windows, as it

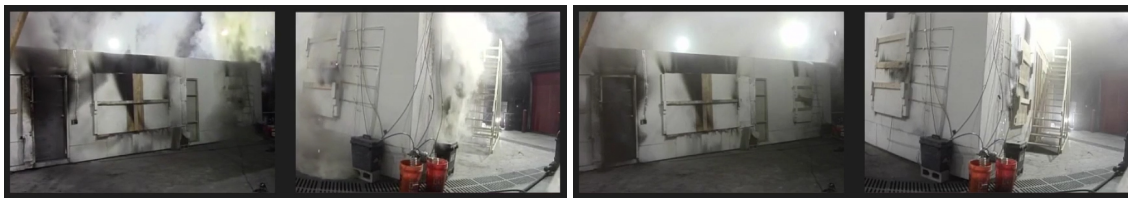
(a) Experiment 7, 240 s after ignition

(b) Experiment 7, 360 seconds after ignition

Figure 6.79: Images of the exterior of the structure for bedroom Experiment 7, closed door. The left view shows the front side. The right view shows the back side.

Video images of the exterior of the single story structure taken during Experiment 7, at the same times as the interior images were taken, are shown in Figure 6.79. In the pair of images on the left, smoke was flowing out of the structure around the edges of the closed front door and the closed bedroom window shutters. In the images on the right, captured two minutes later, the smoke out of the structure had stopped.

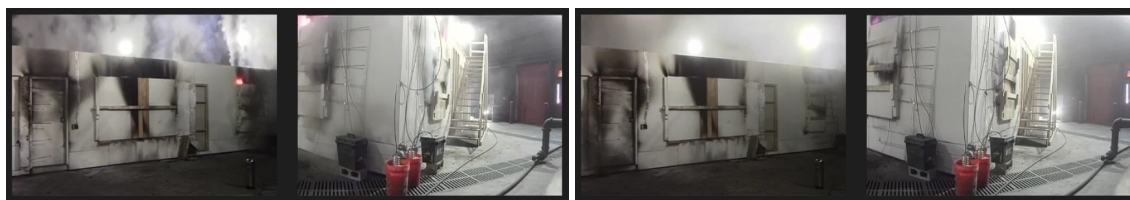
(a) Experiment 9, 330 s after ignition

(b) Experiment 9, 450 seconds after ignition

Given the similar behavior between Experiments 7 and 9 on the interior images, it comes as no surprise that the exterior images from Experiment 9 (see Figure 6.81) are also similar to those from Experiment 7. As the fire was growing and burning post-flashover, the pressure within the closed structure was building. This pressure increase resulted in smoke flowing out of the gaps and openings to the exterior. Once the fire decreased in heat release rate due to a decrease in oxygen available for combustion, the gases inside the structure cooled and the pressure inside the structure decreased. As a result, the smoke flow from the interior of the structure to the exterior stopped.

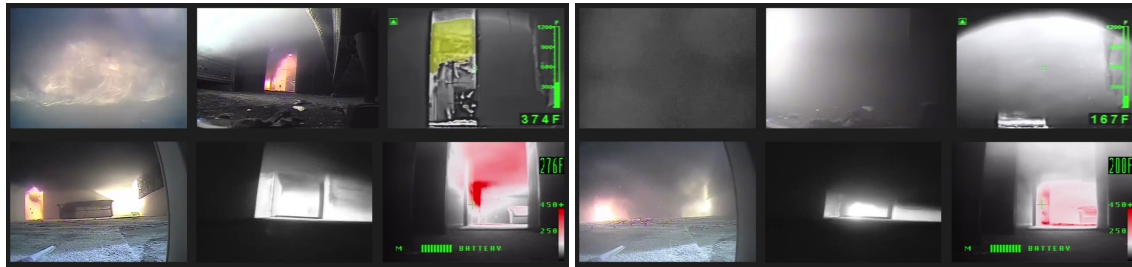
(a) Experiment 12, 160 s

(b) Experiment 12, 200 s

Figure 6.82: Video and infrared images for the bedroom Experiment 12, open door and windows. The three upper views in each set of images are from left to right: bedroom of fire origin, bedroom 2 to the hall outside of bedroom 1, and thermal image of hall outside of bedroom 1 doorway. The lower three views from the left include a living room view looking toward the bedroom hall, and a pair of video and thermal images from cameras in the dining room, looking into the living room.

Experiment 12 was another fire ignited in bedroom 1. But this time the front door and windows were open, as noted above. The supply of oxygen enabled the fire to continue burn post flashover. Figure 6.82 shows both video and thermal images of the bedroom of fire origin inside bedroom 2 looking toward the hall outside of bedroom 1, and a thermal image of the hall outside of the bedroom 1 doorway. The lower three views in each set show the living room view toward the bedroom hall and a pair of video and thermal images from cameras in the dining room looking into the living room.

The sets of images on the right were recorded at 200 s after ignition. Notice how the interior conditions changed. Flames were no longer visible in bedroom 1, the hot gas flow out of bedroom 1 in to the hall had cooled, smoke was down to the floor in bedroom 2, the smoke layer in the living room had descended further, and the fire on the burning carpet was spreading to the sofa. Even though the bedroom appeared to have darkened down, flames were still burning out of the

bedroom 1 window opening and the smoke flow out of the structure was the same as 40 s earlier. Basically, the increased burning inside the structure created additional fuel inside the structure, which resulted in a fuel-rich or ventilation-limited condition. Excess fuel gases were building up in the structure and only burning where they had sufficient oxygen and heat. In this case, that meant outside of the bedroom windows and near the floor in the hallway and living room.

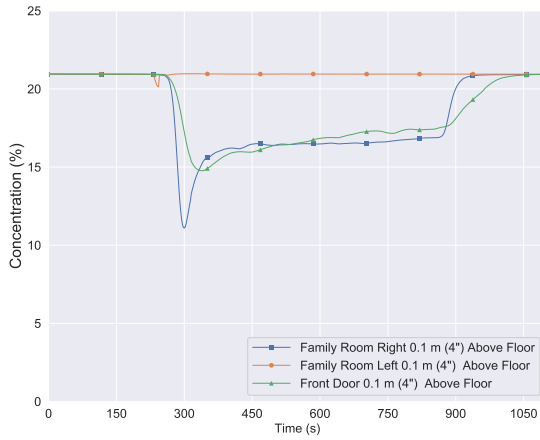
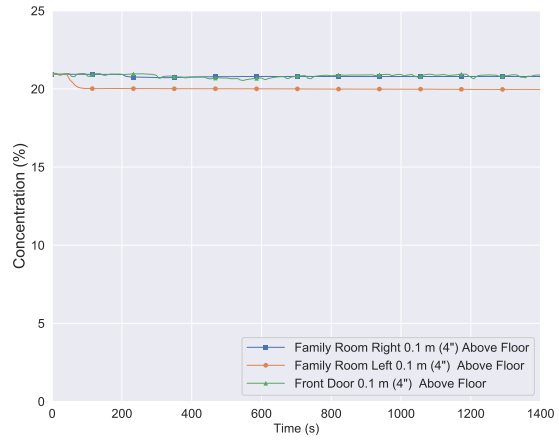
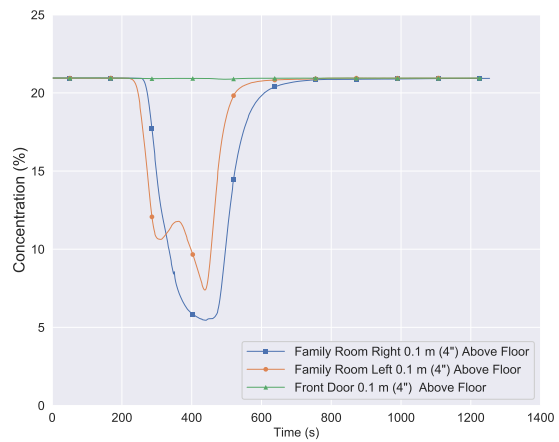
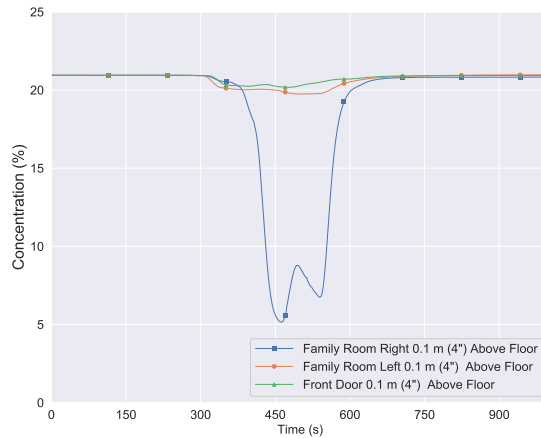
Figure 6.86: Experiments 1–4 and 8, oxygen at 0.1 m above the floor comparison.

Experiments 3 and 4 (see Figure 6.84c and Figure 6.84d) both had vents on the upper level that were nearly equal in area to the open front door or larger. As a result, less of the front door opening was needed as an exhaust vent and more of the doorway was used as an air intake vent. This allowed the fire in both of these experiments to maintain a higher heat release rate for a longer period of time than the other three experiments. Looking at the oxygen concentration measurements taken at 1.2 m (4 ft) above the floor in Figure 6.85c and Figure 6.85d, the values are approximately 5% for Experiment 3 (one open door and window on the upper level) and approximately 10% for Experiment 4 (two open doors and windows on the upper level). The oxygen concentration values at the 0.1 m (4 in.) above the floor measurement locations dropped roughly 5% in both of these experiments, with the exception of the oxygen sampling location in the foyer near the open front door. At the front door location, the oxygen levels remained at approximately 21% throughout the duration of the fire as shown in Figure 6.86c and Figure 6.86d.

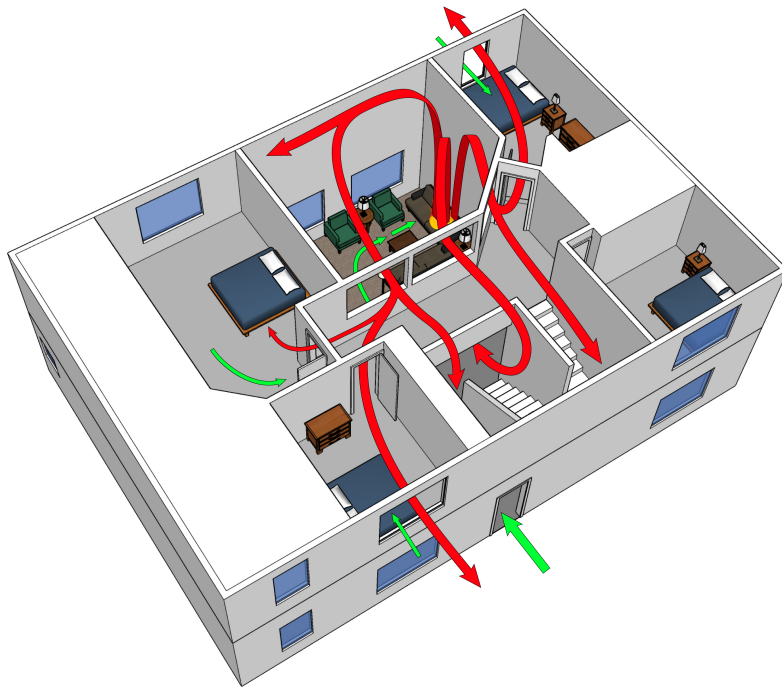
Figure 6.94: Drawing of the pre-flashover flows within the colonial structure family room fire with open front door, bedroom 3 and 4 doors and windows.

Figure 6.94 highlights the pre-flashover flows in the structure for Experiment 4 while Figure 6.95 shows the post-flashover flows within the structure. The pre-flashover drawing shows how the plume of hot gases (see red arrows) impacted the ceiling of the family room and spread across the hallway into the open bedrooms and out their respective open windows, as well as into the foyer and then down the front side of the structure. The oxygen-laden fresh air (see green arrows) was pulled in from the open windows, but being remote from the fire it was less significant than the air pulled in through the open door. The post-flashover drawing (see Figure 6.95) shows that the front door became a bi-directional vent with the higher pressure hot smoke exiting near the top of the doorway, while the rest the open doorway served as an air intake. The windows had transitioned to be primarily exhaust vents, and additional recirculation took place on the second story.

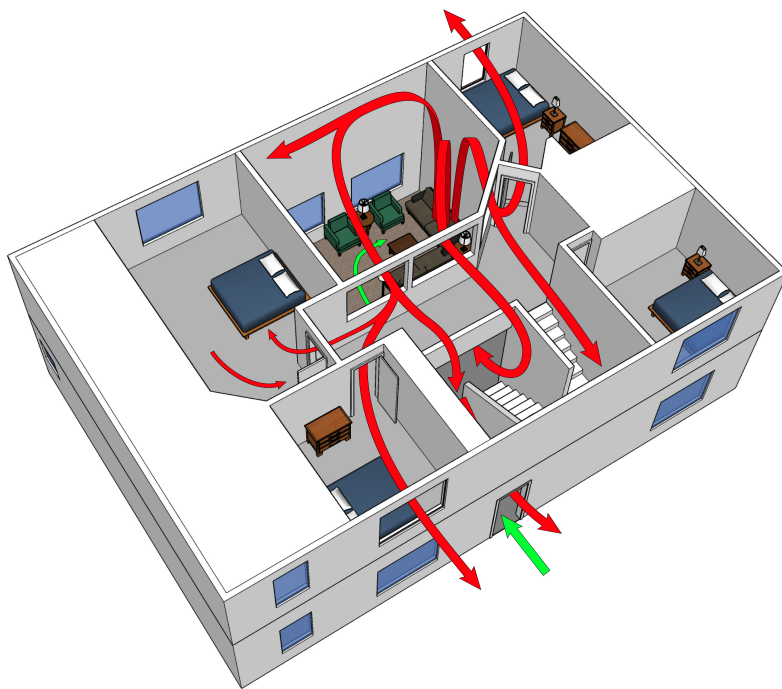
Figure 6.95: Drawing of the post-flashover flows within the colonial structure family room fire with open front door, bedroom 3 and 4 doors and windows.

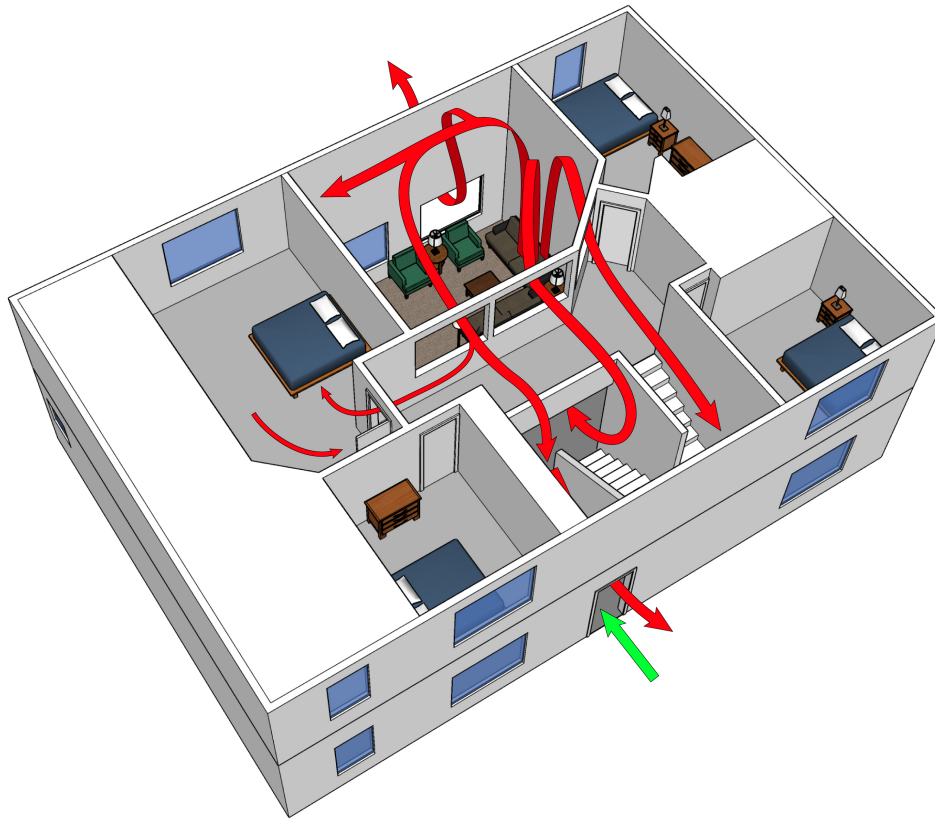
Figure 6.97: Drawing of the post-flashover flows within the colonial structure family room fire with open front door and family room window.

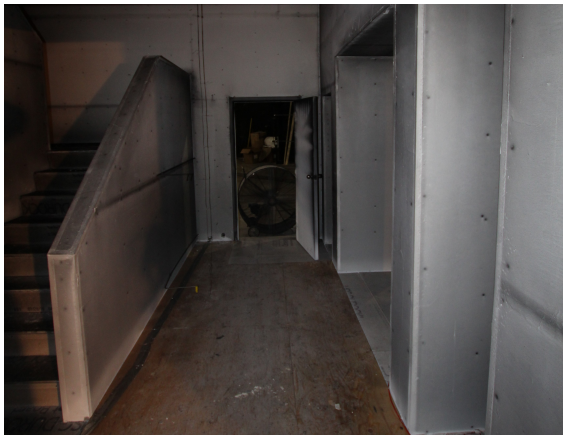
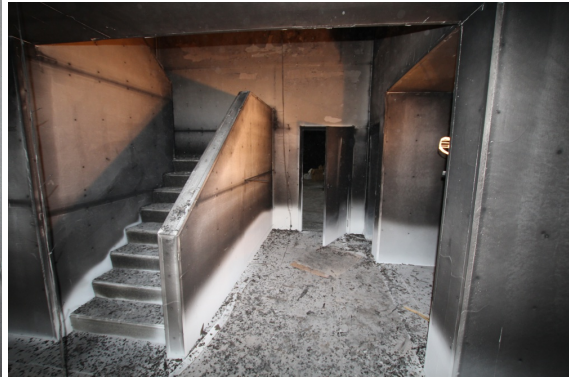
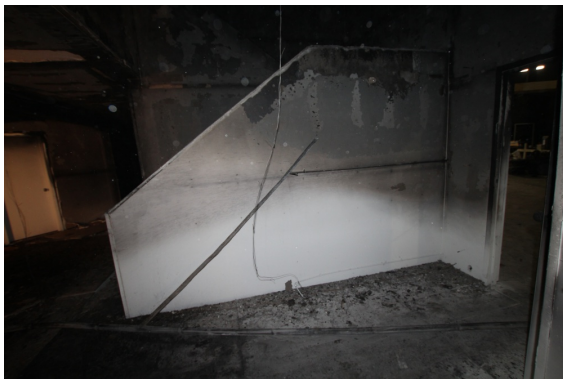
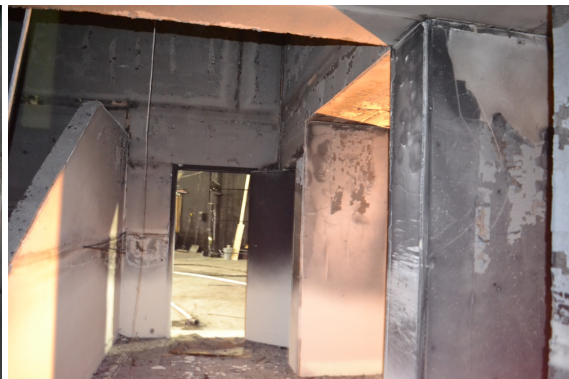
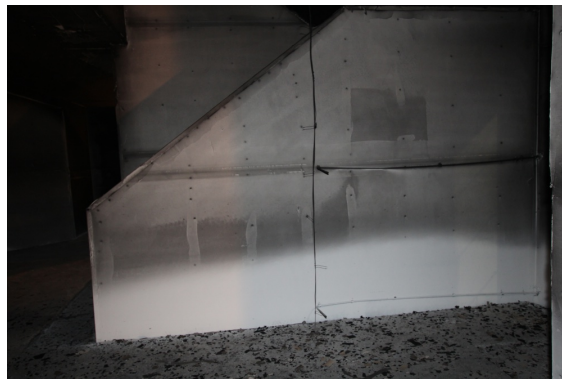
Figure 6.98: Experiments 1–4 and 8, line of demarcation in the foyer.

The front door was a key vent for four of the five different ventilation configurations used with the family room fires. On the foyer wall just to the right of the front door as you would enter the house, a line of demarcation, typically from condensed soot, was generated by each of the experiments. Figure 6.98 contains a post-fire image from each of the family room experiments.

The upper level vents were closed for Experiment 8, and the family room window closest to the ignition sofa was opened along with the front door. This resulted in a flattening of the condensed soot line on the foyer wall and a reduction in thermal damage. Between the oxygen sampling tubes and the front wall, the height of the line of demarcation varied from 0.61 m (2.0 ft) to 0.43 m (1.4 ft).

While conditions at the front door changed through the development of each fire, it would appear that the post-flashover conditions had the most impact on the soot deposition and thermal damage.

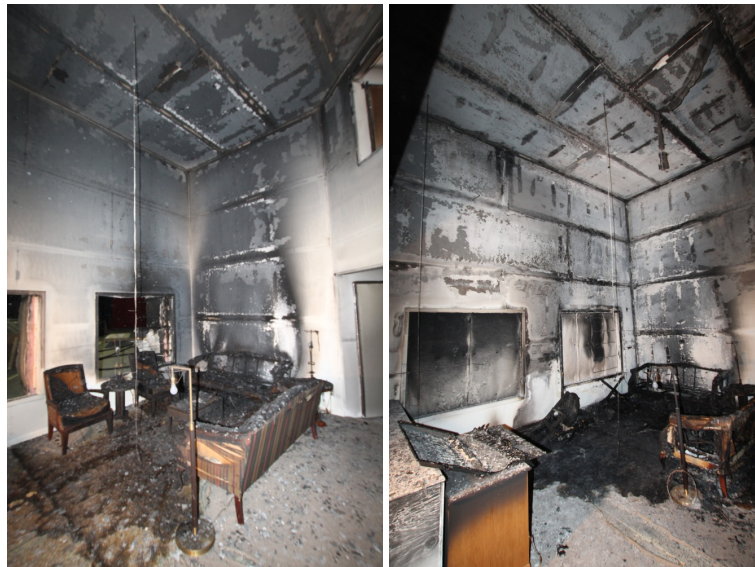
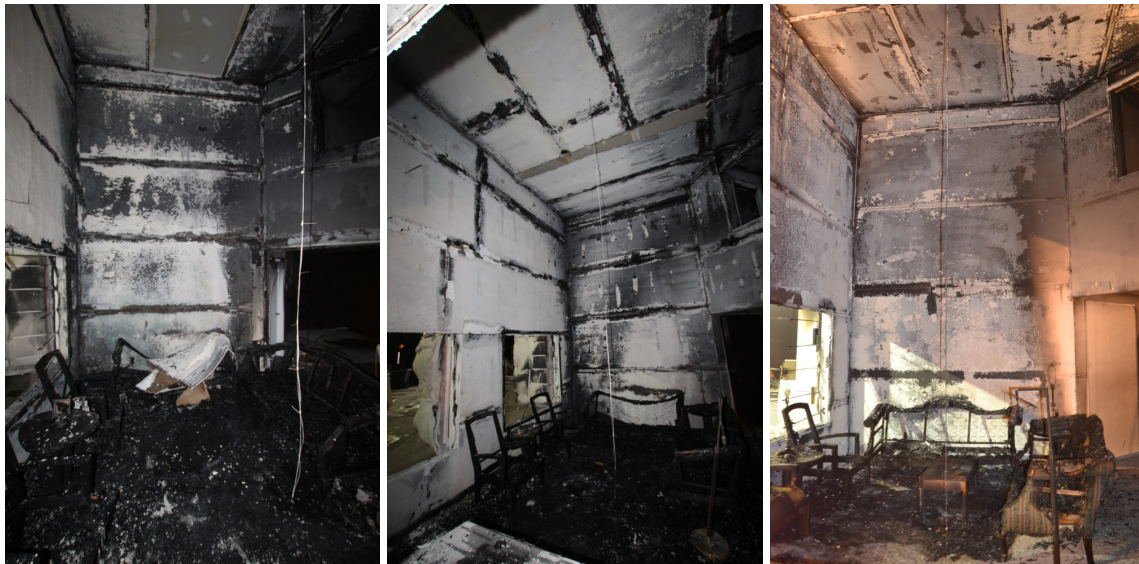
(a) Exp. 1 No Open Vents

(b) Exp. 2 Open Front Door

(c) Exp. 3 Open Front Door & Bedroom 3 Window

(d) Exp. 4 Open Front Door & Bedroom 2 & 4 Windows

Figures 6.99 and 6.101 feature photographs from the family room fire experiments. The ventilation configuration for each experiment is appears in the sub-caption for each photograph.

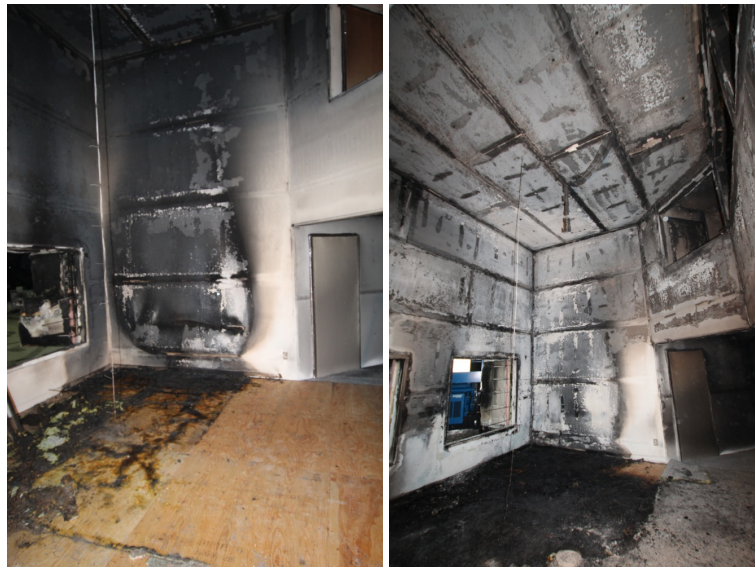
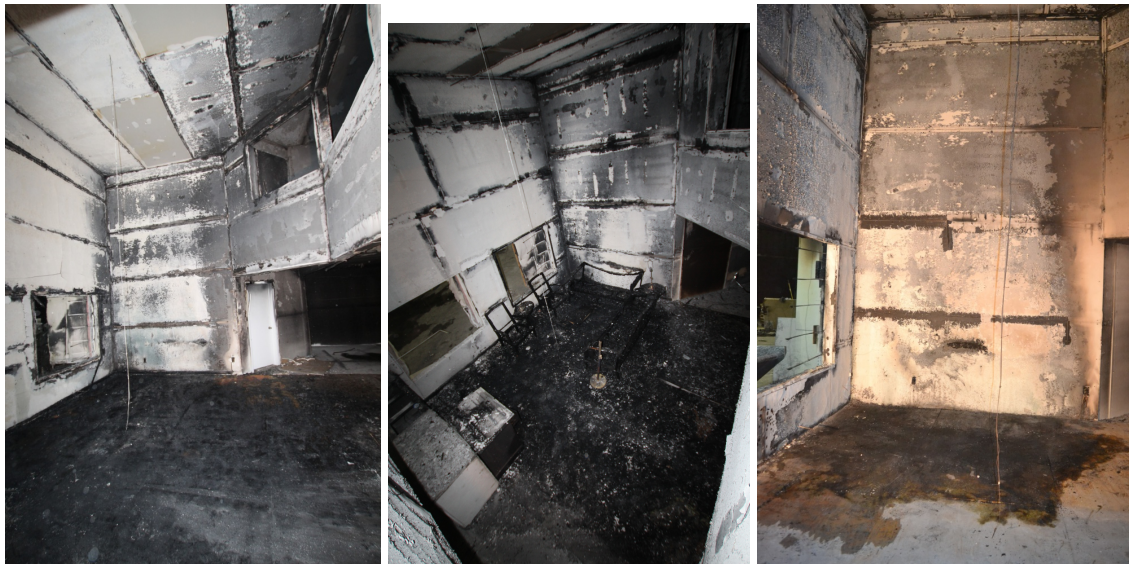
(a) Exp. 1 No Open Vents

(b) Exp. 2 Open Front Door

(c) Exp. 3 Open Front Door & Bedroom 3 Window

(d) Exp. 4 Open Front Door & Bedroom 2 & 4 Windows

Figure 6.100 features photographs of the family room area of origin to provide a better view of the fire damage on the walls and floor. In Experiment 1, the fire damage to the carpet, padding, and sub-floor plywood was limited to the area bound by the furniture. However, for Experiments 2 through 4 the burning on the floor and the area of the floor burned increased with the increase in ventilation. As a result, it became difficult to separate the burned carpet and padding from the charred plywood sub-floor. In Experiment 2 the carpet burn line of demarcation was half way between the end of the target sofa and the TV stand. In Experiments 3 and 4, almost all of the carpet and padding was burned to some degree. The damage to the floor area in Experiment 8 was similar to the amount of fire damage to the floor in Experiment 1. It was mainly in the furnished area of the family room.

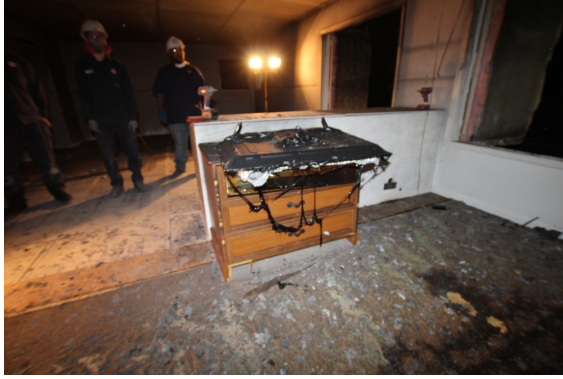
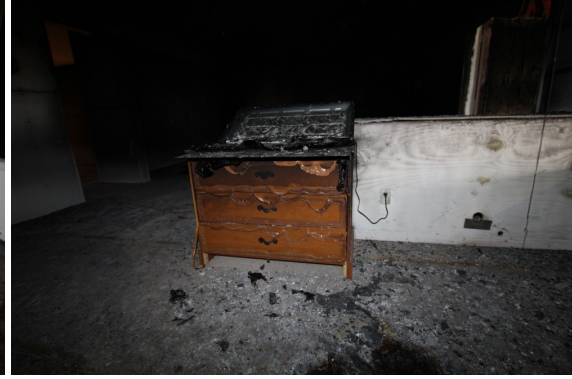
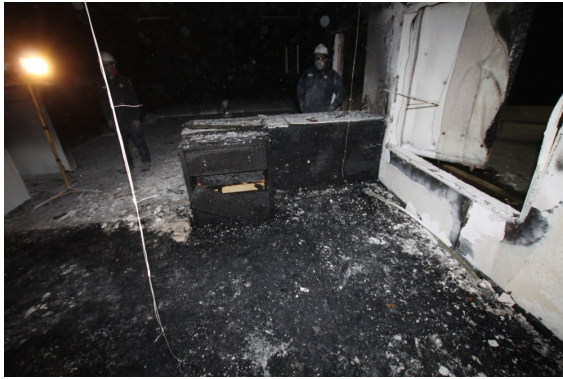
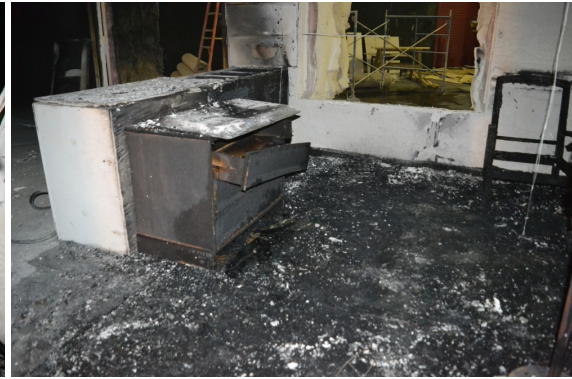
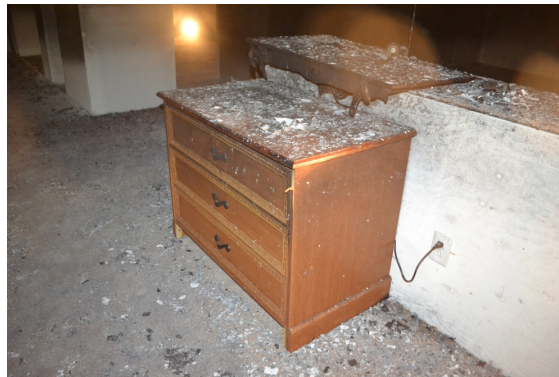
Figure 6.101: Experiments 1–4 and 8, fire damage in the family room, TV and stand.

Experiment 1. However, in Experiment 2 there was also heat damage to the TV stand in the form of melted plastic components and a condensed soot line of demarcation across the top front drawer and the sides of the stand. The carpeting around the TV stand was not burned.

The fire damage from Experiments 3 and 4 on this end of the family room was similar. Most of the plastic components of the TV have burned away leaving a steel shell. The TV stand was burned and charred, as was the plywood wall next to the TV stand. The carpet, padding and plywood around the TV stand was also burned.

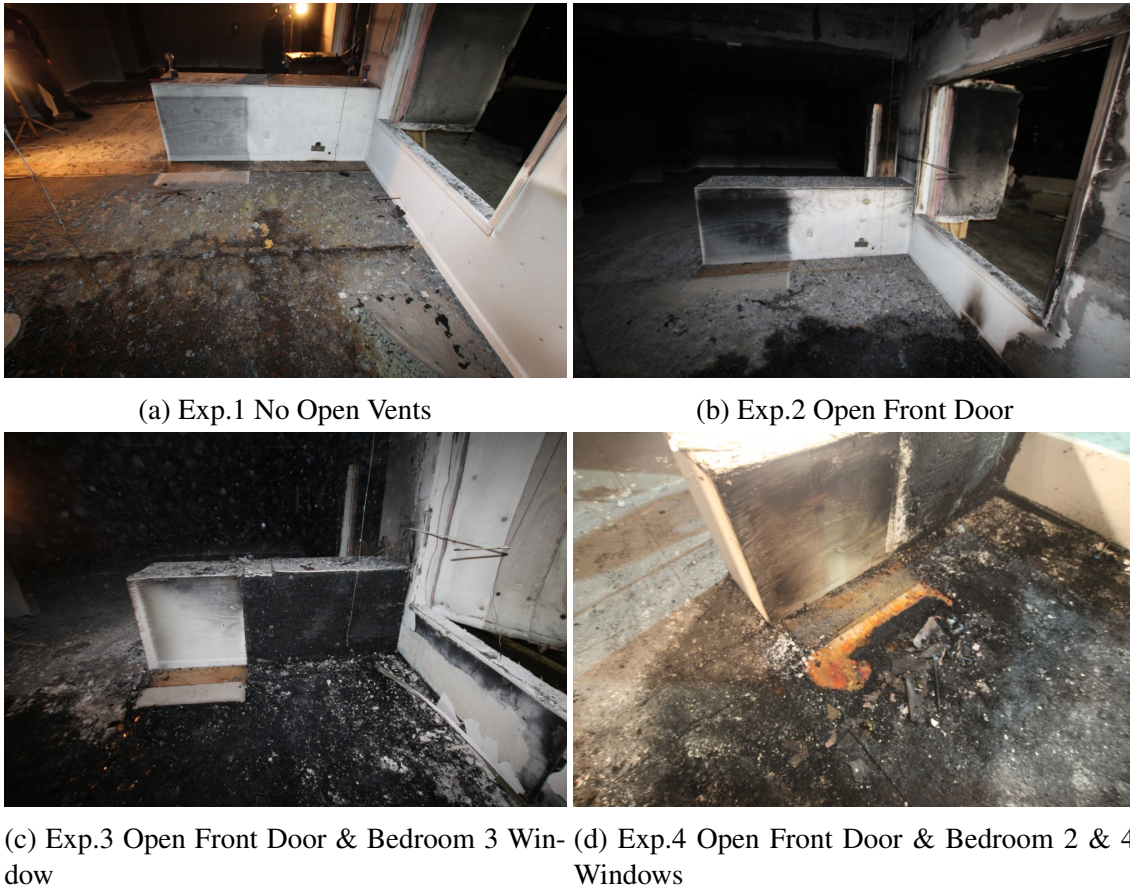
Figure 6.102: Experiments 1–4, fire damage in the family room TV area after removal of furniture.

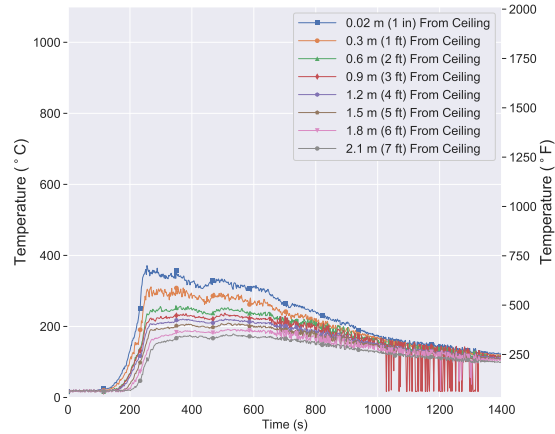
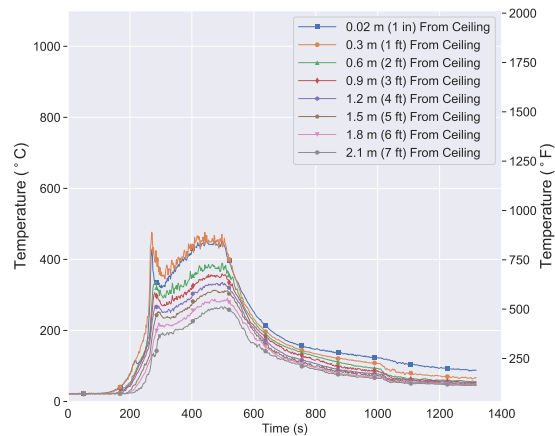
Figure 6.103: Experiments 1–4 and 8, bedroom 1 temperature comparison.

Bedroom 1 was the most remote open area in the family room area of fire origin. The door to bedroom 1 was open during each of the family room experiments. However, there was never a vent open to the exterior from bedroom 1. The temperatures in bedroom 1 can be compared in Figure 6.103. The peak temperatures occurred near the ceiling in each experiment, and the range of the peak temperatures near the ceiling was approximately 350 °C (660 °F) to 470 °C (880 °F). The lowest temperatures were recorded at a position 2.1 m (7 ft) below the ceiling or 0.3 m (1 ft) above the floor. The highest temperatures near the floor ranged from 165 °C (330 °F) to 260 °C (500 °F).

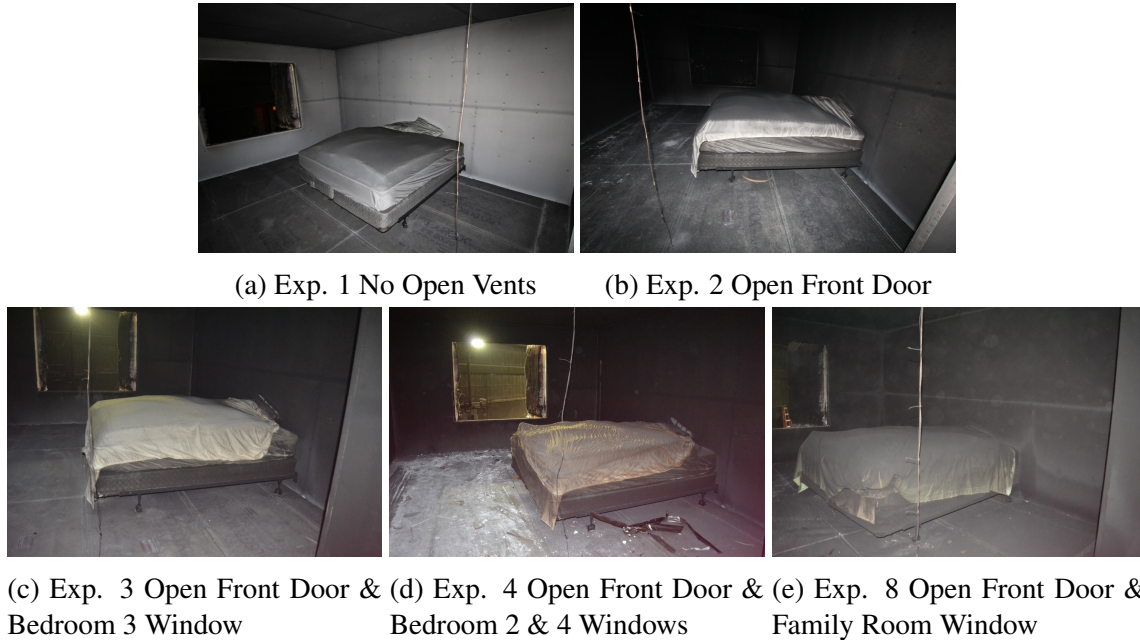
Figure 6.104: Experiments 1–4 and 8, bedroom 1 bed post-experiment.

The mattress, box spring, and polyurethane pad were covered with a new bed sheet for each experiment. Given the temperature gradient discussed above, no thermal damage occurred to any of the bed components for any of the experiments. As shown in Figure 6.104, soot deposition on the sheets was the extent of the fire damage to the bed.

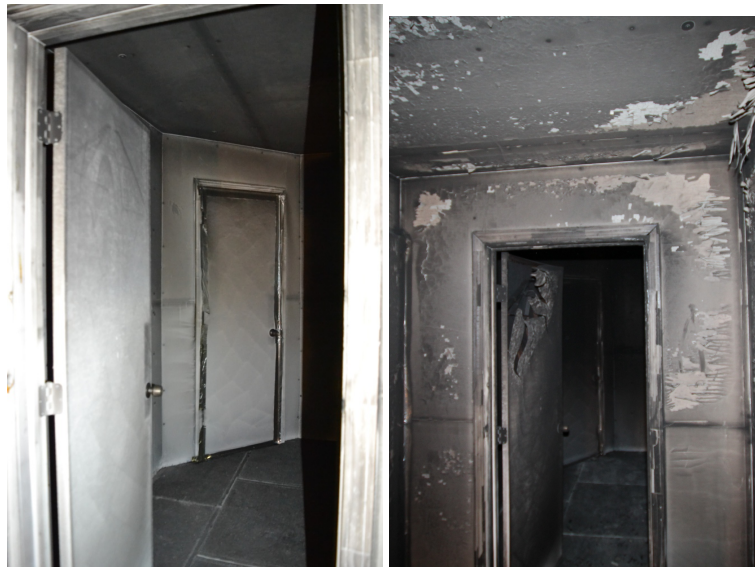
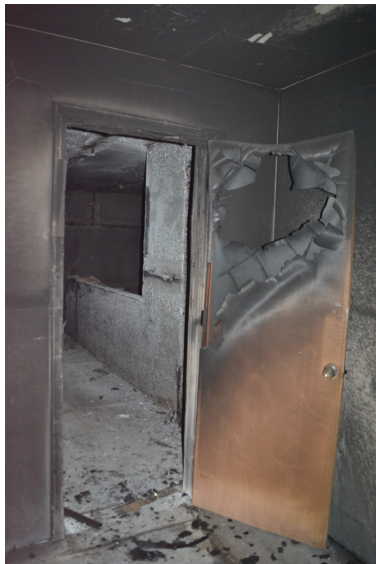
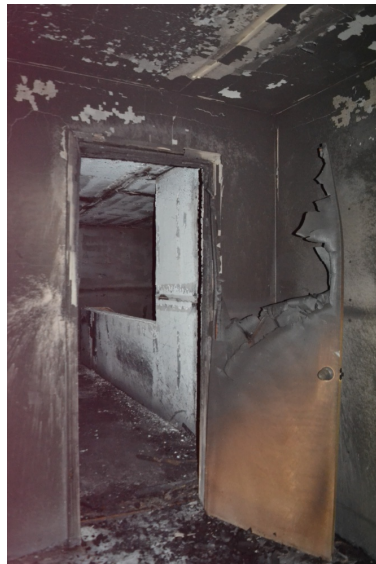
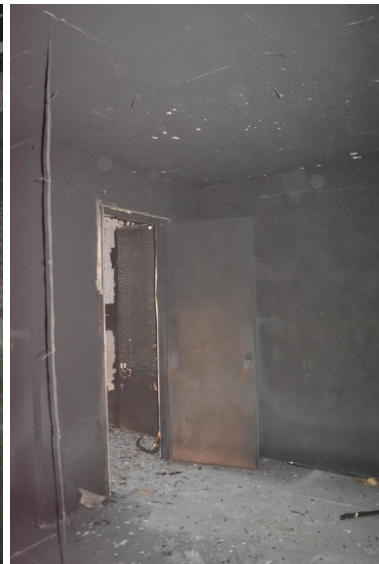
Figure 6.105: Experiments 1–4 and 8, bedroom 1 door post-experiment.

Figure 6.105 shows the amount of fire damage to the door to Bedroom 1 from each of the five experiments. The door was in the open position for each experiment. Experiment 1, with no exterior vents, deposited soot on the door, and there was no thermal damage (see Figure 6.105a). With the open front door in Experiment 2, the upper corner of the door had burned away and the entire face of the door had been covered with soot (see Figure 6.105b), which indicates a fuel-rich condition on the upper level. While the peak temperatures in bedroom 1 were slightly higher for Experiment 1, the duration of the exposure in Experiment 1 was less.

Approximately a third to half of each bedroom 1 door exposed in Experiments 3 and 4 was burned away (see Figures 6.105c and 6.105d). With exhaust vents on the upper level and additional oxygen for combustion entrained through the front door, more flaming combustion was sustained on the upper level. As a result, there was less soot available for deposition on the lower part of the door, and the door was likely heated such that condensation of the soot available was less likely.

penetrating the surface of the door face. Figure 6.105e shows the door had less soot deposition than Experiment 2 but more soot deposition than Experiments 1, 3, and 4.

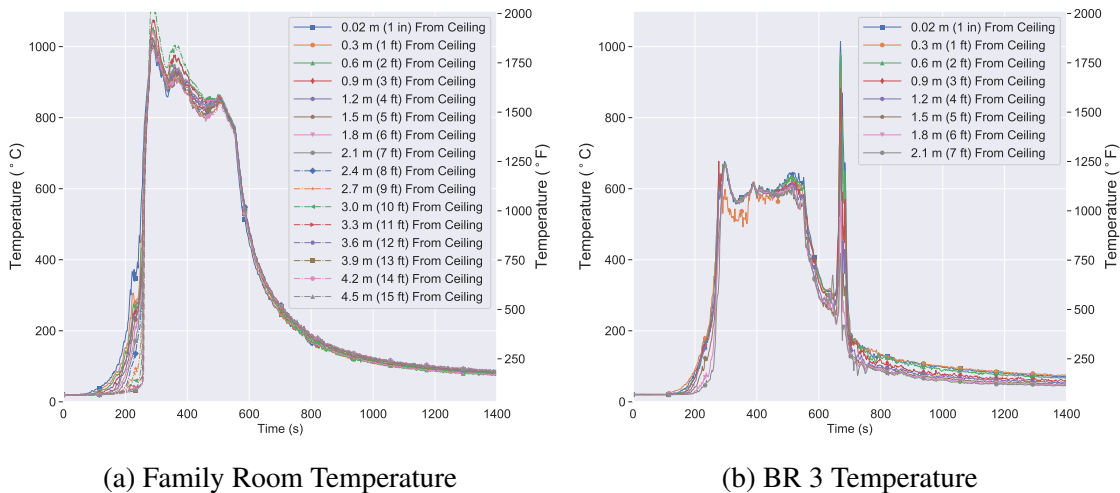
Figure 6.106: Experiment 3, family room and bedroom 3 temperature comparison.

Figure 6.106 includes a comparison of the Experiment 3 temperatures from the family room and the bedroom 3. Both the family room and bedroom 3 had flashed over, based on the idea that a fire room that has just transitioned through flashover will have a single well-mixed combustion zone with temperatures in excess of 600 °C (1112 °F). The temperature spike that occurred after 600 s in bedroom 3 was the result of the interior fire attack. Firefighters had to flow water prior to reaching the seat of the fire in bedroom 3. The environment inside the structure was disturbed and additional air entered the bedroom, which resulted in rapid fire growth until water was applied inside the compartment. In this case the additional burn time was short, but that may not be the case in an actual fire attack. Therefore, it is important for investigators to interview the firefighters at a fire scene, not only to understand what they saw on arrival, but also to understand what tactics were used and how the firefight progressed.

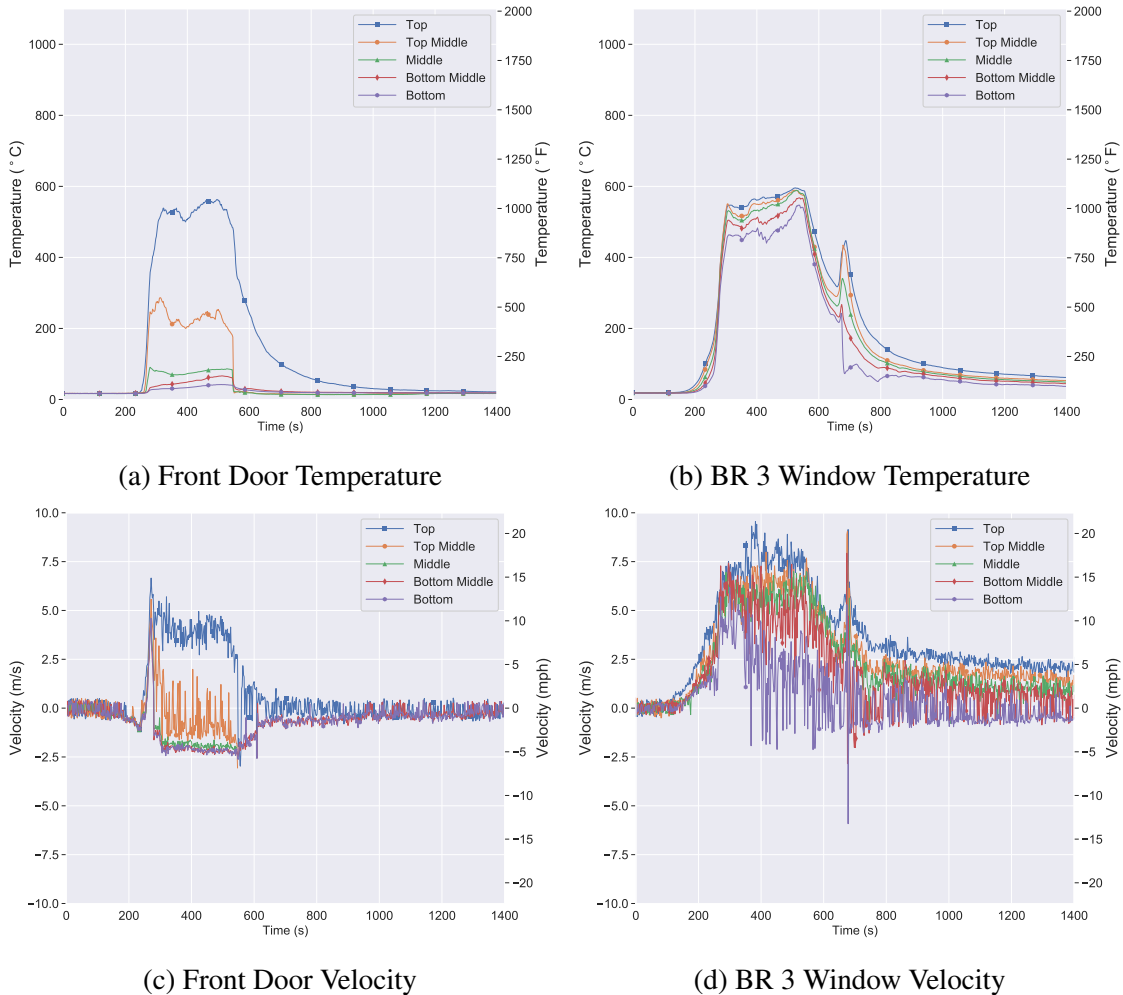
Figure 6.107: Experiment 3, front door and bedroom 3 window comparison.

Figure 6.107 includes a comparison of the temperatures and velocities in the open front doorway and the bedroom 3 window. From the doorway temperature and velocity profile, the doorway was a bi-directional vent for most of the post-flashover portion of the fire. More than half of the doorway opening acted as an air intake, so it stands to reason the bedroom window was acting primarily as a unidirectional hot gas exhaust vent.

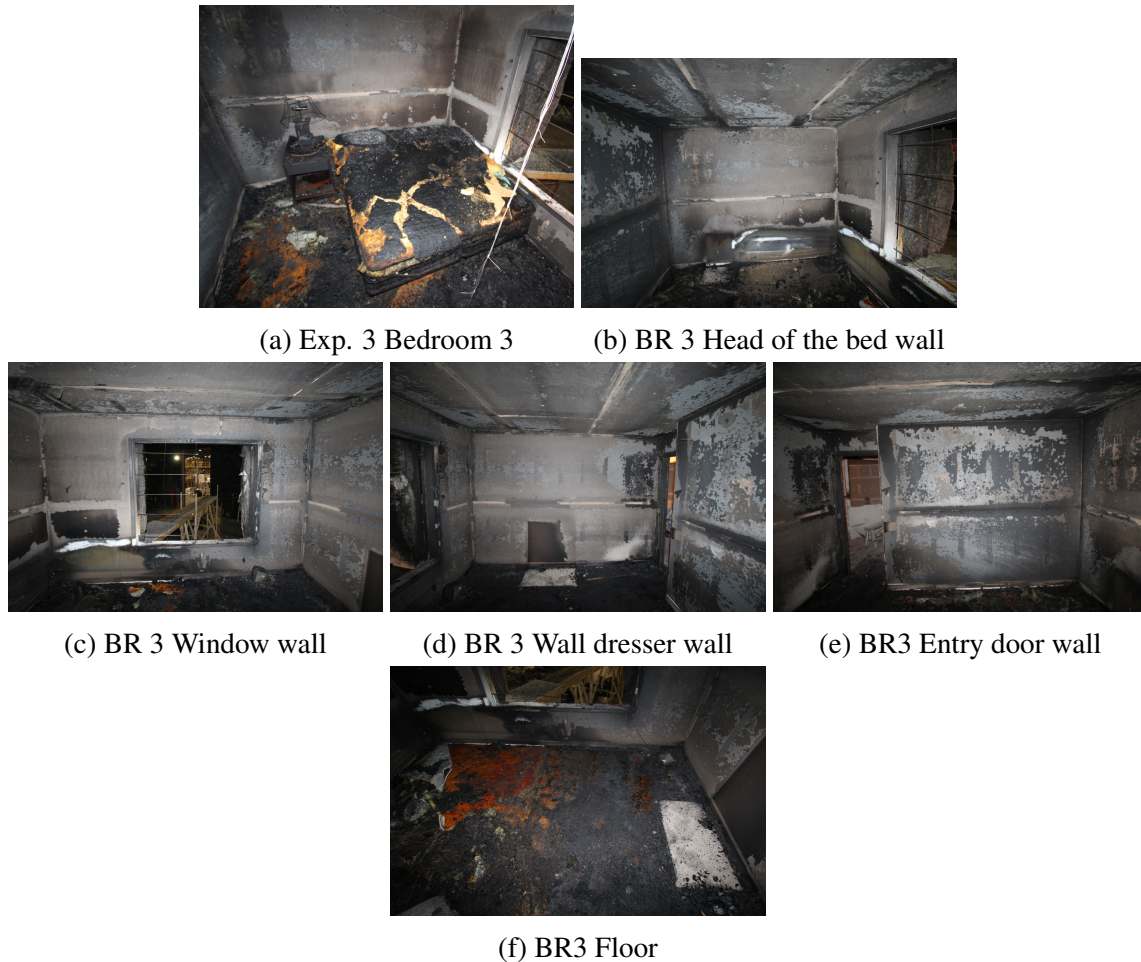
Figure 6.108: Experiment 3, bedroom 3 post-experiment photographs.

Post fire-suppression photographs of bedroom 3 appear in Figure 6.108. A significant amount of fuel remained in bedroom 3 at the end of the experiment. Most of the polyurethane foam bed pad was intact, and the plywood floor between the wall and the bed (not in the direct flow path) was exposed but mostly unburned. The wood nightstand and dresser were charred but did not burn through. The corner of the bed close to the window appeared to have burned to a greater extent than the rest of the bed. The lowest gas velocity probe in the bedroom 3 window (see Figure 6.107d) shows that the gas velocity was pulsing from positive (hot gas exhaust) to negative (air intake) at regular intervals starting around 400 s after ignition. Perhaps the air entering low in the window aided in the additional burning on the top layer of the corner of the bed.

In general, the fire damage in bedroom 3 was consistent with post flashover damage. The door to the bedroom was burned completely. As it collapsed and burned, the door created a fire damage pattern just inside the doorway near the floor on the left wall (see Figure 6.108e). This fire damage is distinct from the other damage in the room.
