# Impact of Fixed Ventilation on Fire Damage Patterns in Full-Scale Structures

Daniel Madrzykowski  
Craig Weinschenk

UL Firefighter Safety Research Institute  
Columbia, MD 21045

April 18, 2019

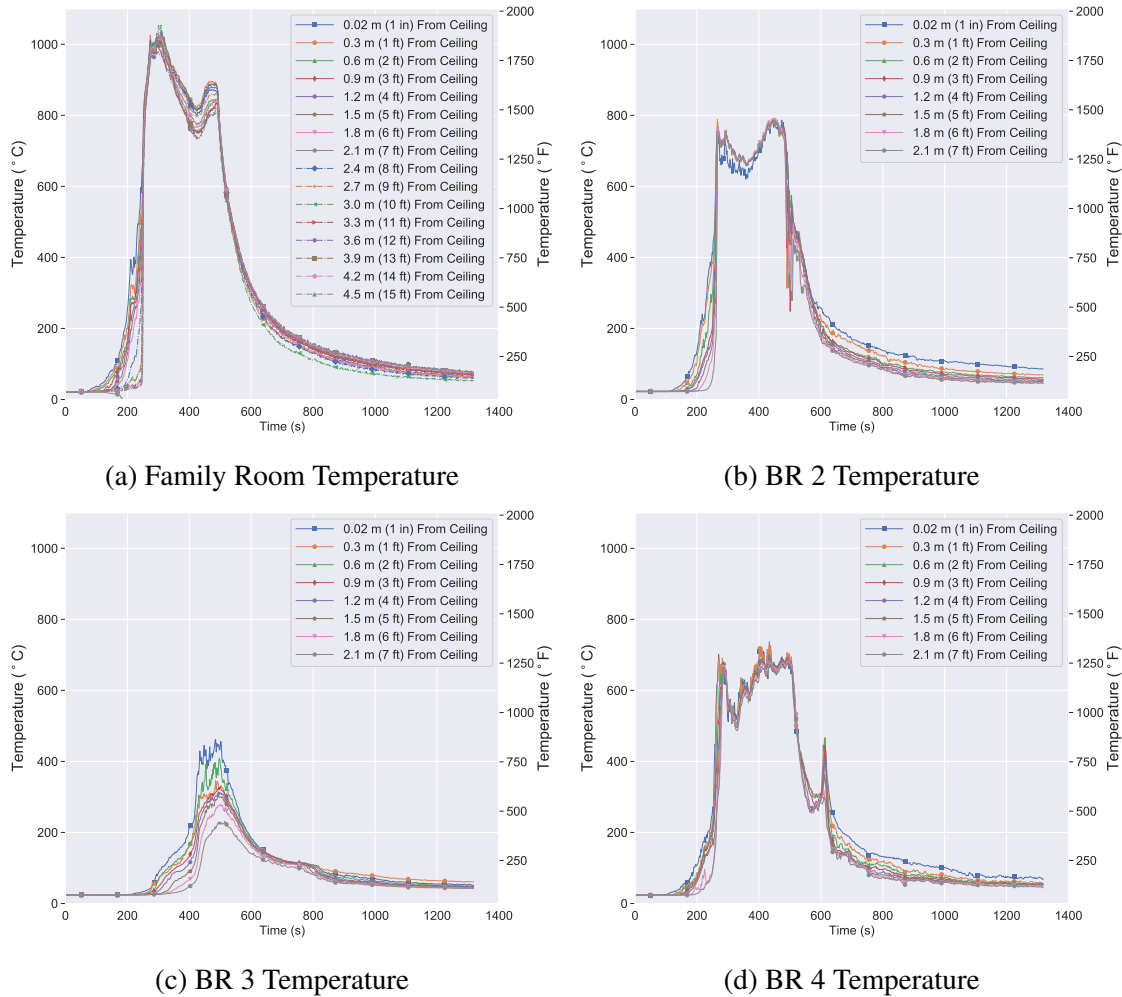
Figure 6.109 shows the temperature comparisons of the family room and bedroom 2, 3, and 4. Both bedroom 2 and 4 reached flashover conditions. Based on temperatures, bedroom 4 was burning more efficiently than bedroom 2. Flames were observed exiting the window of bedroom 4 shortly after flashover. The flow out of the bedroom 2 window was black smoke changing to flames just prior to suppression. The delay of heat entering bedroom 3 appears in Figure 6.109c. Based on the temperature increase in bedroom 3, the hollow-core wood door held up to post-flashover exposures for at least 2 min.

Figure 6.109: Experiment 4, Family room, Bedroom 2, 3 and 4 temperature comparison.

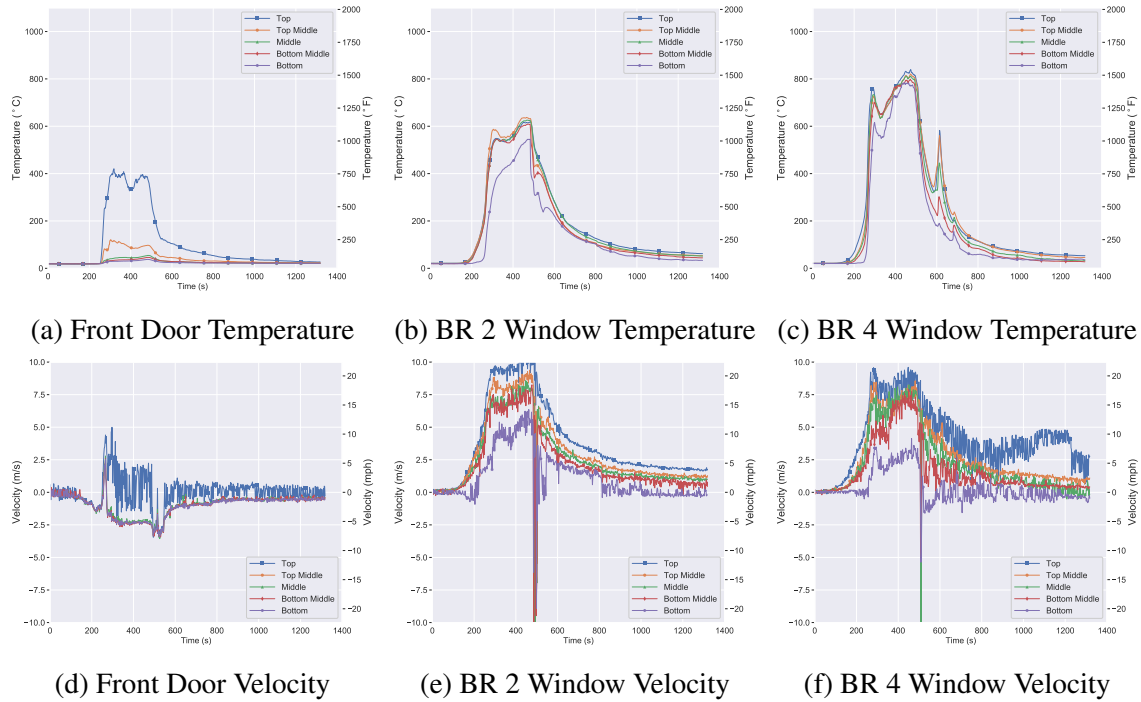
Figure 6.110 compares the temperatures and velocities in the three open exterior vents. During the period that the fire was growing and then transitioning to flashover, the front door was a unidirectional intake vent. A similar flow behavior was seen in Experiment 3 but it did not last as long as the total inflow in this experiment, which was approximately 100 s. The flow in the front doorway then changed to full exhaust before settling into a bidirectional flow. Three-quarters of the front door acted as an air intake vent during most of the post-flashover burning period. Both windows exhibited unidirectional exhaust flow post-flashover. The large negative velocity data spikes were caused by suppression water impacting the velocity probes.

Figure 6.110: Experiment 4, front door, bedroom 2 and 4 window comparison.

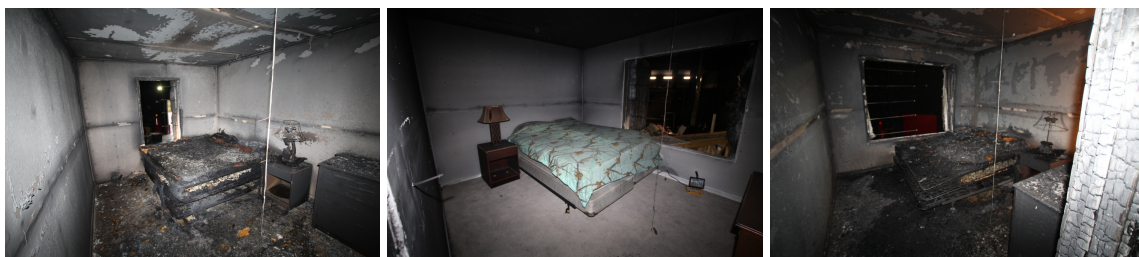
Figure 6.112 shows photographs of fire damage inside bedrooms 2, 3, and 4. Bedrooms 2 and 4 had fire damage from the ceiling down to the floor that was consistent with a post flashover fire environment. Bedroom 4 had the most gypsum wallboard area that was clean burned. Bedroom 2 had more soot on the ceiling and walls than bedroom 4. Bedroom 3 had thermal damage to plastic material in the lamp shade, and the burned door. The only other damage in bedroom 3 was a coating of soot on all of the surfaces.

(a) Bedroom 2 (b) Bedroom 3 (c) Bedroom 4

Figure 6.112: Experiment 4, bedroom 2, 3, and 4 post-experiment photographs.

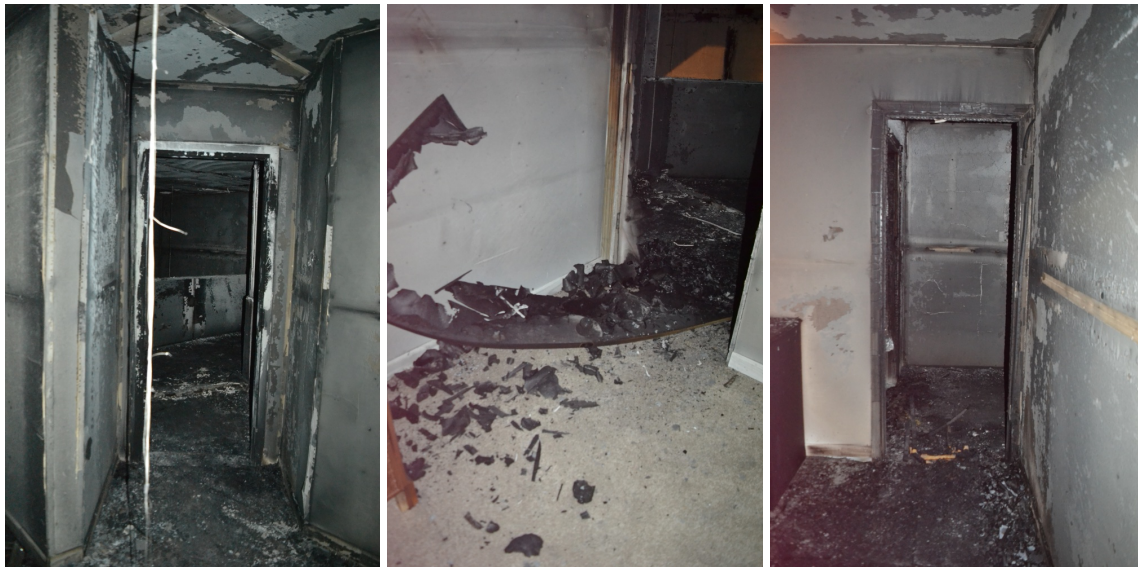
Figure 6.113 shows the doorways of the three bedrooms. The doors to bedrooms 2 and 4 had burned away completely. In each case, the combustion of the door against the wall (right of each doorway in the photographs) generated a distinct pattern. The remains of the door to the bedroom may have collapsed post-suppression because there were no burn marks in the carpeting.

(a) BR 2 Door

(b) BR 3 Door

Figure 6.113: Experiment 4, Bedroom 2, 3, and 4 door post-experiment photographs.
